Date: 11 November 2022

Novare Project No. 3321

***INITIAL SEISMIC ASSESSMENT OF WATERLOO RAIL STATION UP-MAIN AMENITIES BUILDING***

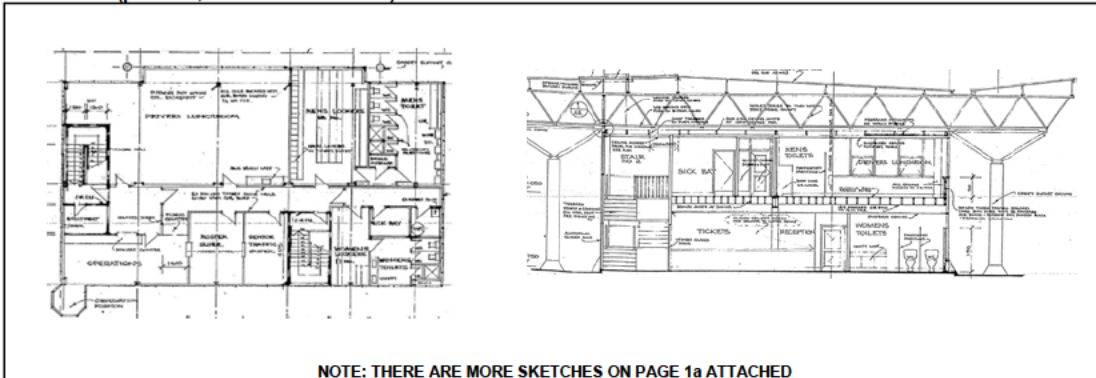
#### 1.2 Sketches (plans etc, show items of interest)

For the Amenities building the structural system is shown on the drawings to be moment connections in the longitudinal direction along the centre frame on grid A2 with the columns cantilevering from the first floor level. In the transverse direction it appears to be steelwork by portal action at each end of the building, although, the drawings are not conclusive. The ground floor is a suspended hollowcore floor with a mesh topping, it does not appear to be far from the ground and should be locked in place around the platform (little drift expected at this level). The first floor appears to be lightweight timber. The roof is a lattice of structural steelwork with a lightweight covering. The integral canopy roof is supported by cantilever columns, piles caps and piles.
