# **WATERLOO TRAIN STATION CANOPY REASSESSMENT**

Greater Wellington Regional Council

| <b>DOCUMENT</b> | Canopy Reassessment Report |

| <b>DATE OF ISSUE</b> | 20/05/2024 |

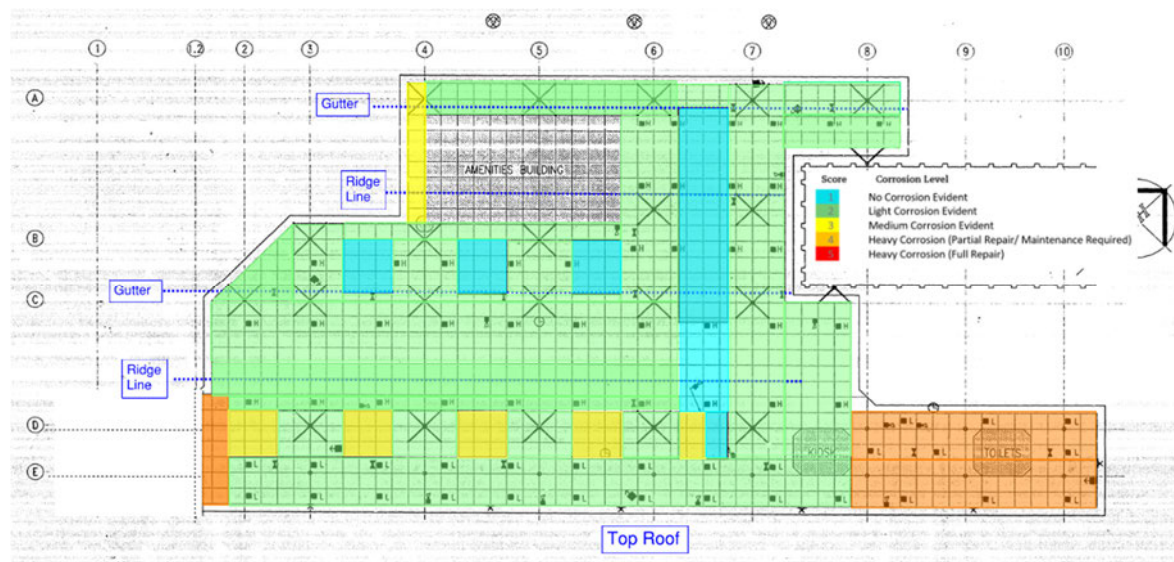
#### Top Roof Corrosion Score Map

The top roof sheeting is showing signs of corrosion at the interfaces with the internal gutters as well as lifting of the flashings around the seismic gap with the adjacent building.

The internal gutters to both the upper and lower levels are showing signs of heavy corrosion in isolated areas.

Most of the hold-down screws connecting roof sheeting to purlin are showing heavy corrosion.

- Power wash the entire roof
- Touch up the areas of corroded sheeting around the internal gutters.
- Replace the corroded areas of internal gutters at the upper and lower levels.
- Replaced the corroded hold-down screws between sheeting and purlin.
- Block all pigeon/vermin entry points.
- Power wash pigeon droppings.
- Fix the ridge overlapping and flashing details at joints/corners.
- Paint touch up required in the areas of corroded bottom roof sheeting below the ridge line.

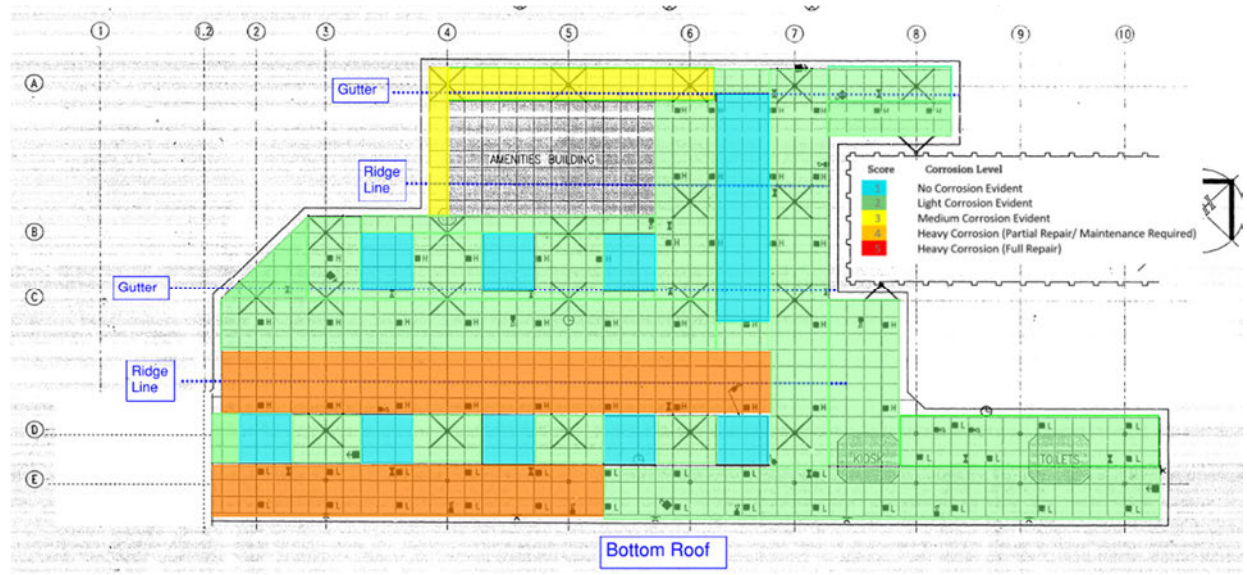
**Bottom Roof Corrosion Score Map**

The bottom roof sheeting is also showing heavy corrosion under the ridgeline location.

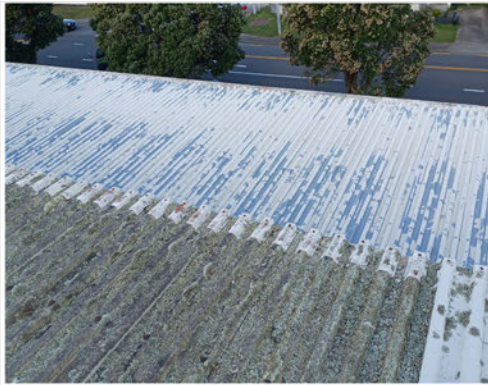
Some of the Clearlite panels were replaced recently and are in good condition. However, the old Clearlite panels are brittle and are in poor condition with the seams being lifted due to the ingress of moss.

Roof Clearlite Panel corrosion score 3

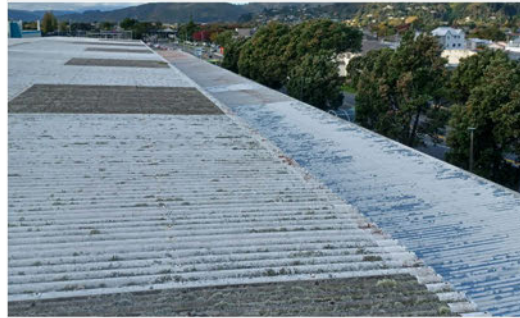
Orange Lyceum on lower roof corrosion score 4

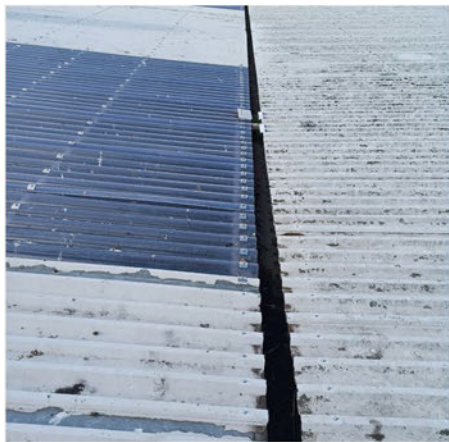
Internal Gutter corrosion score 2

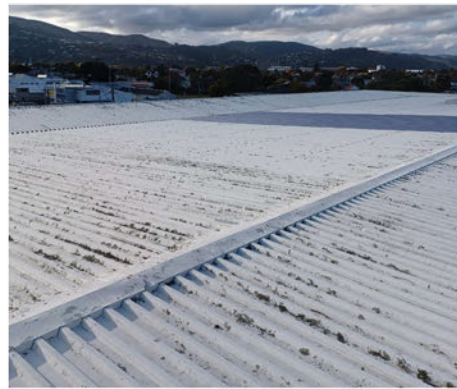
Ridge Capping corrosion score 2

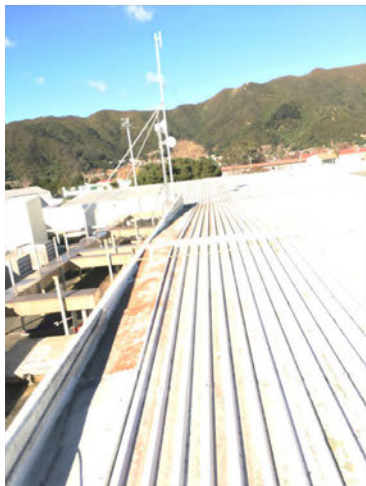
Roof seismic joint corrosion score 3

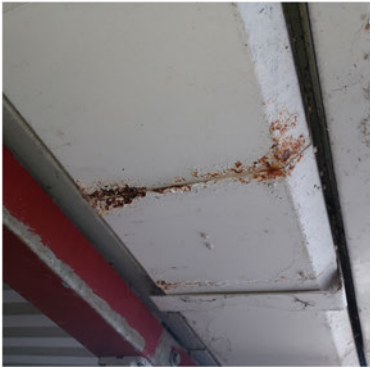
Corrosion at lower internal gutter corrosion score 4

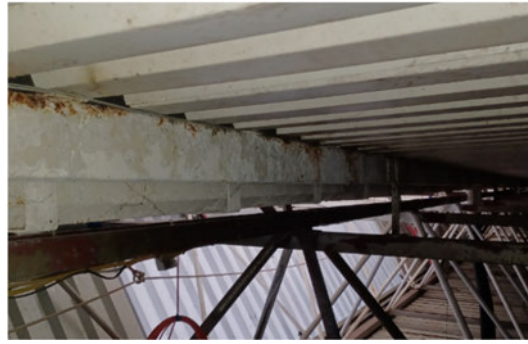
Corrosion at lower internal gutter corrosion score 4

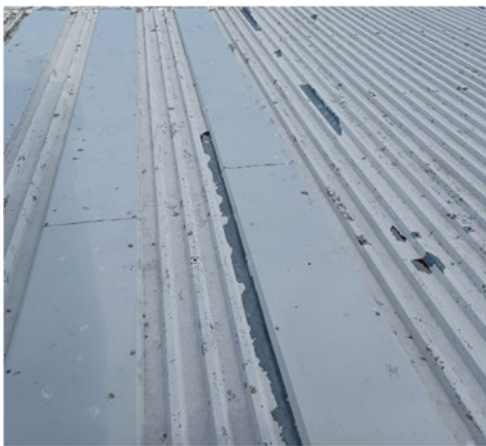
Paint flaked off

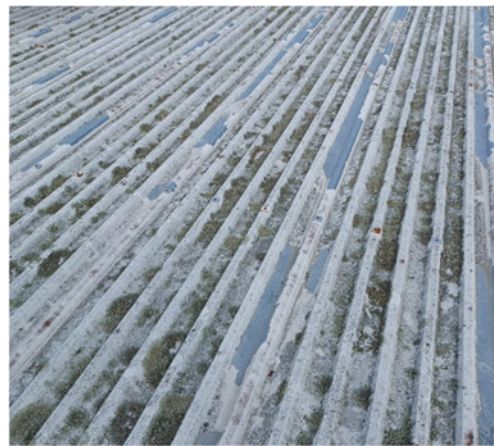
Corrosion at hold-down screws corrosion score 4

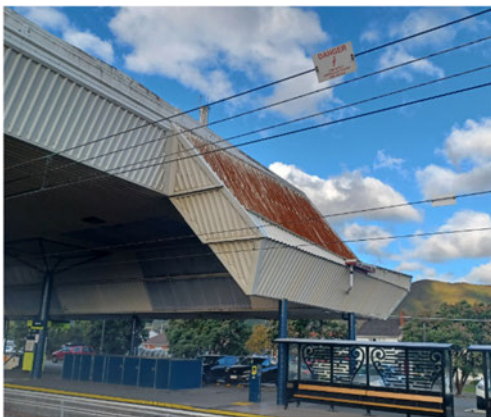
Orange Lyceum on lower roof corrosion score 4

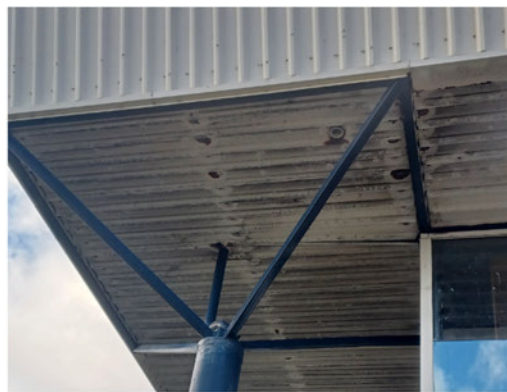
Corrosion at bottom roof sheeting corrosion score 3

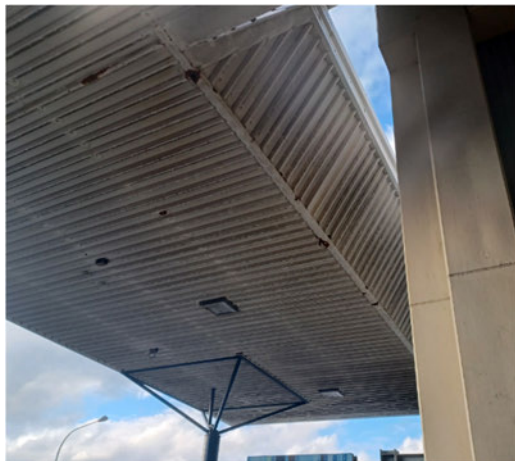
Corrosion at bottom roof sheeting corrosion score 3

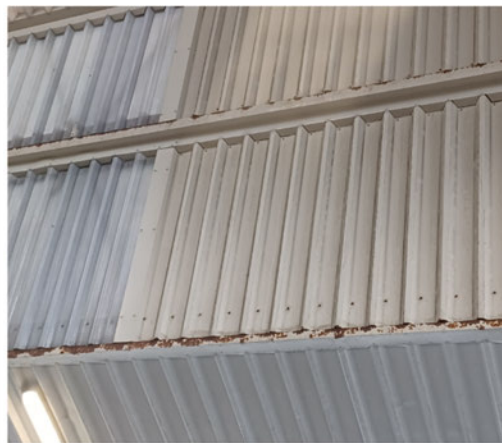
Corrosion at the intersection of upper and lower roofs due to flashing at the corner, corrosion score of 4

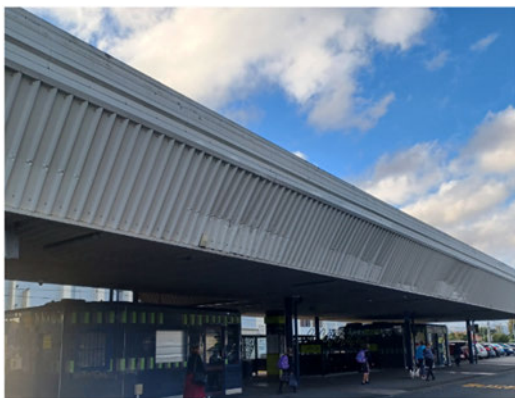
Damage to the sheeting wall on the Southside

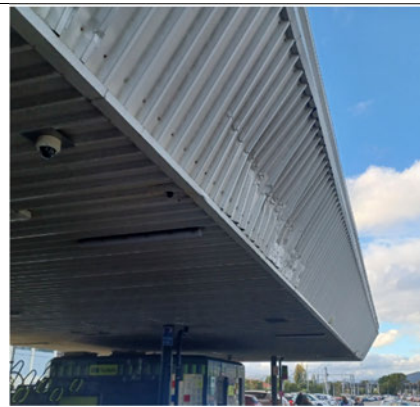
Damage to the sheeting wall on Southside

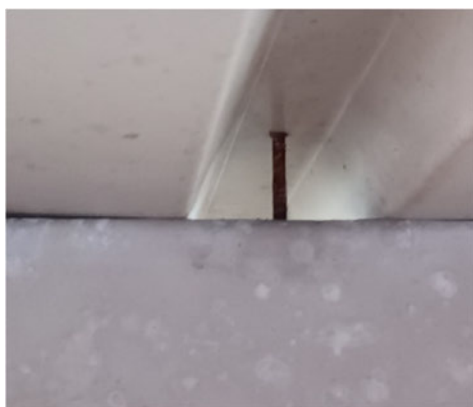
Corrosion at hold-down screws corrosion score 4

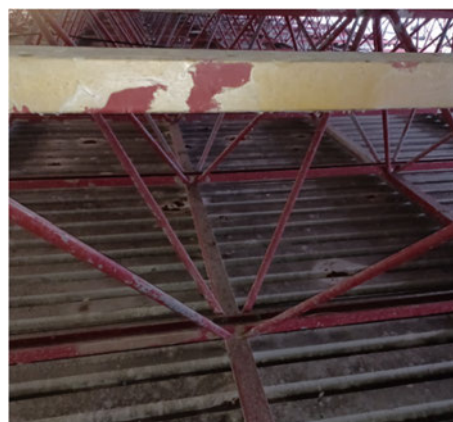
Corrosion at bottom roof sheeting corrosion score 4

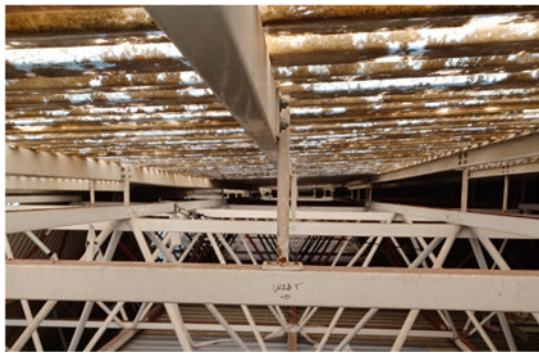
Moss at the top of translucent sheeting

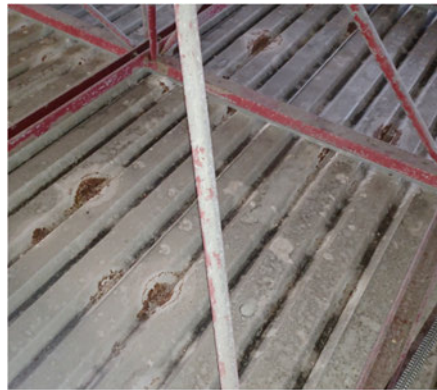
Corrosion at bottom roof sheeting corrosion score 4

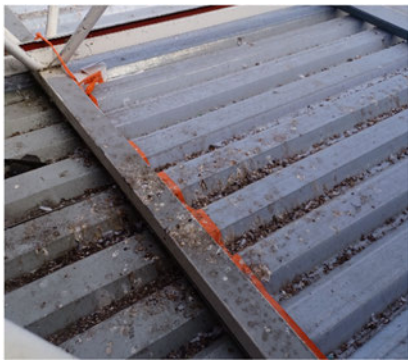
On the northeast side, most of the bottom roof sheeting and walls are covered by Pigeon droppings, accelerating the corrosion process.

Accumulated Pigeon droppings

All pigeon access holes to the roof cavity must be blocked and the affected areas cleaned up.

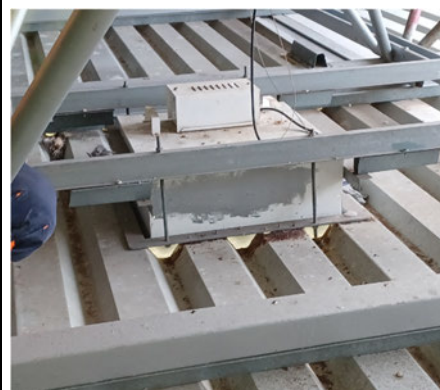
Corrosion spreading due to light fixings

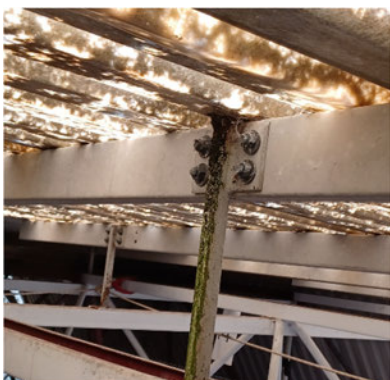
Leakage due to cracks in sheet

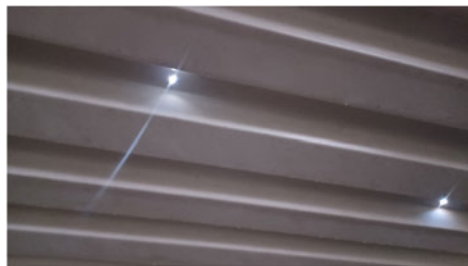
Holes in top roof sheeting

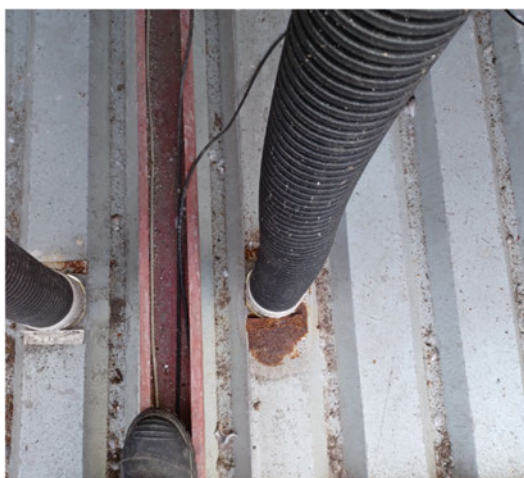
Corrosion spreading due to pipe fixings

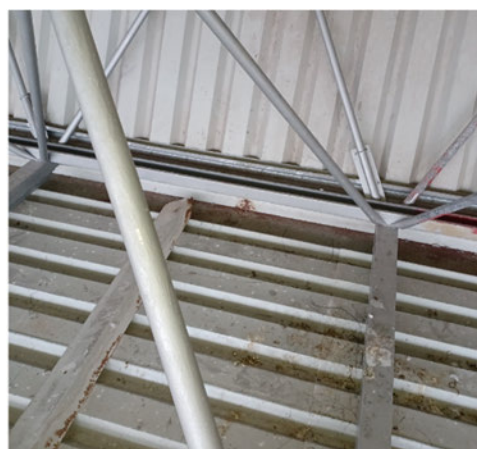
Corrosion spreading due to spare member

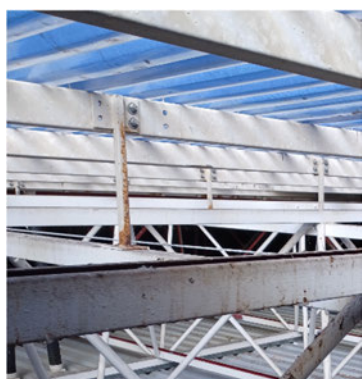
Missing bolts to purlin

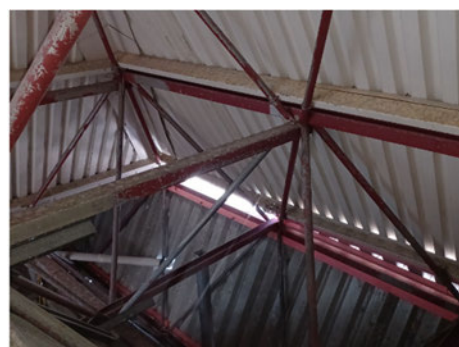
Opening for birds' entry

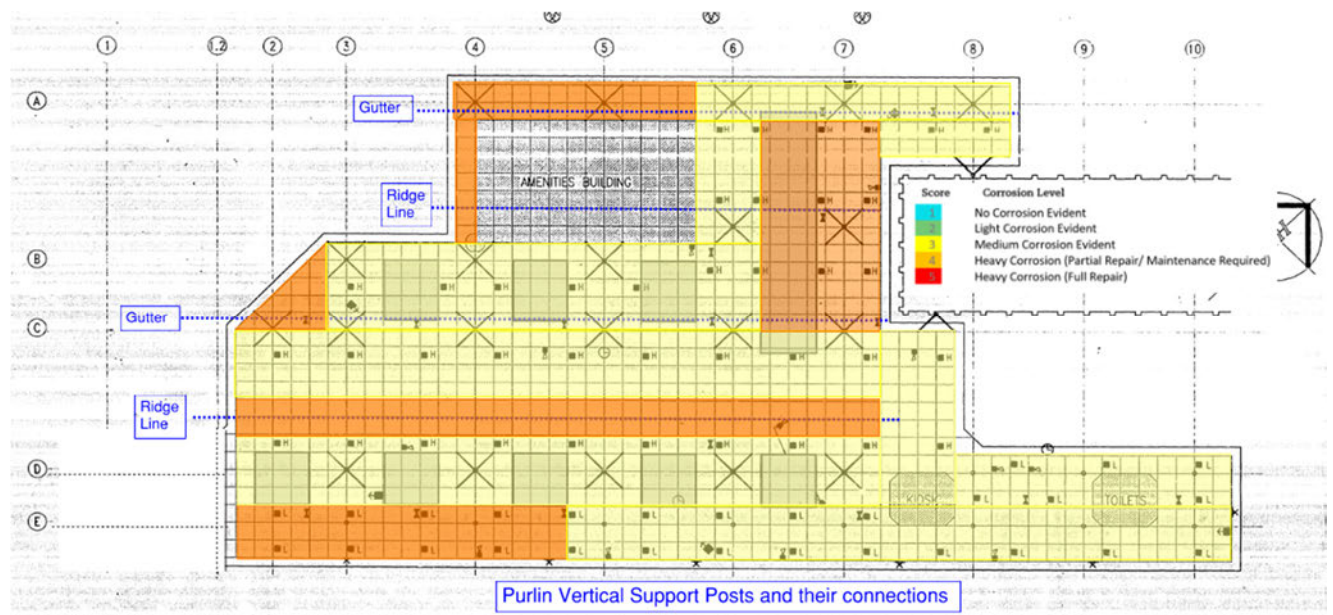
**Purlin Supports Corrosion Score Map**

The purlin support members display the heaviest corrosion of all the canopy elements. We estimate that maintenance to some of these elements will be required in approximately the next 6 to 12 months to prevent more extensive repairs (possibly even member replacement) being required.

The area of most concern is highlighted in the corrosion map, where the supports have a corrosion score of 4.

- Abrasive blast and re-paint the square hollow section supports and connections in the upper and lower-level portions of the roof.

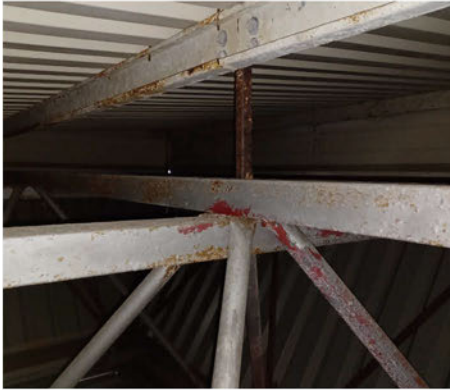
Purlin support corrosion score 4

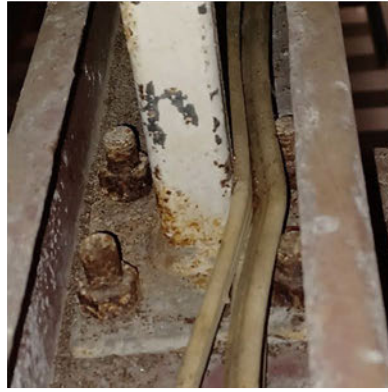
Purlin support corrosion score 3

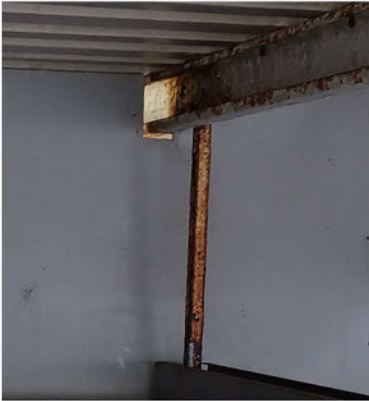
Purlin support corrosion score 4

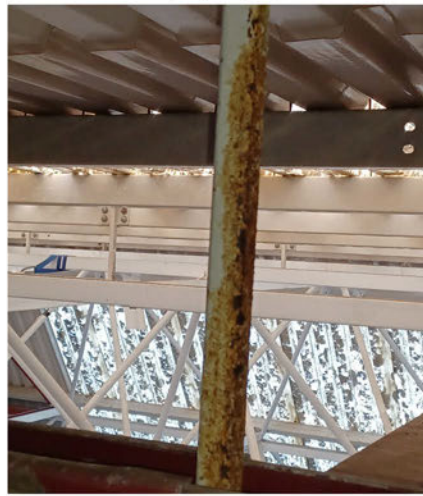
Purlin support corrosion score 3

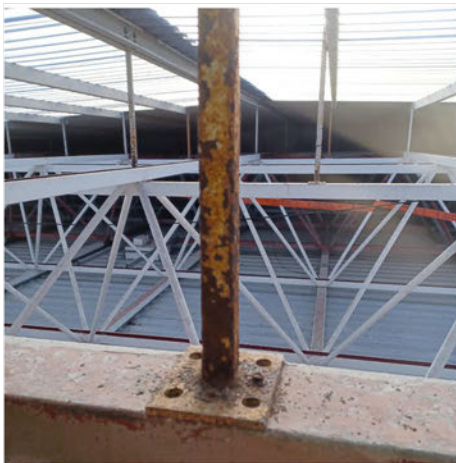
Purlin support corrosion score 4

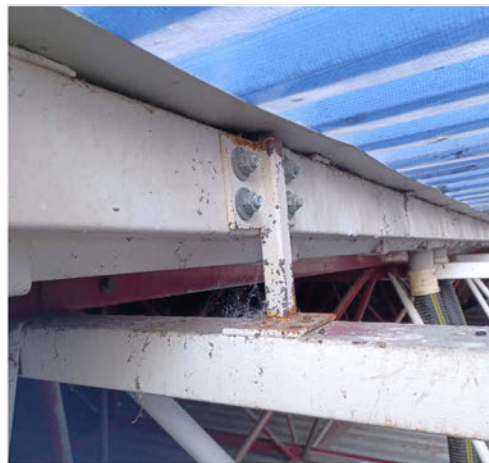
Purlin support corrosion score 4

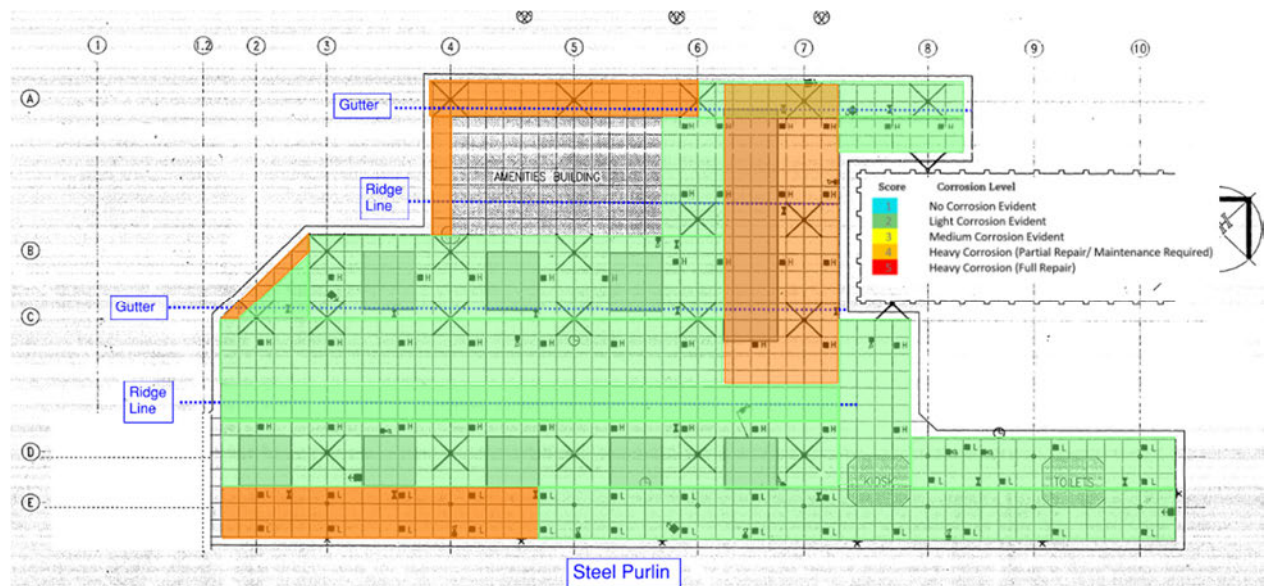
**Purlin Corrosion Score Map**

The purlins are generally in good condition with a corrosion score of 2.

Only isolated cases require remediation in the next 18 to 24 months due to them being corrosion level 4.

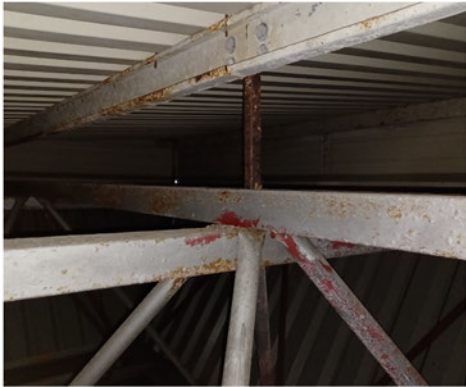
Purlin corrosion score 4

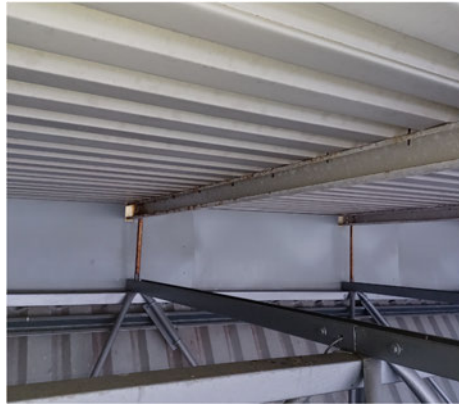
Purlin corrosion score 4

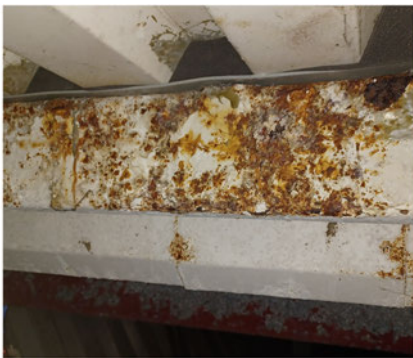
Purlin corrosion score 4

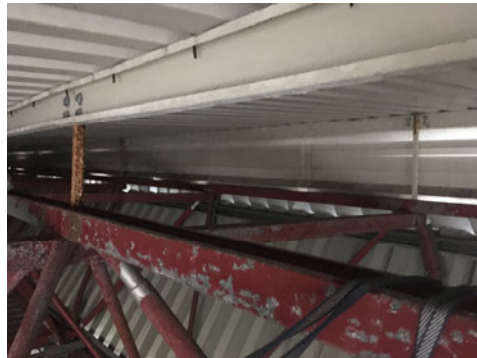
Purlin corrosion score 2

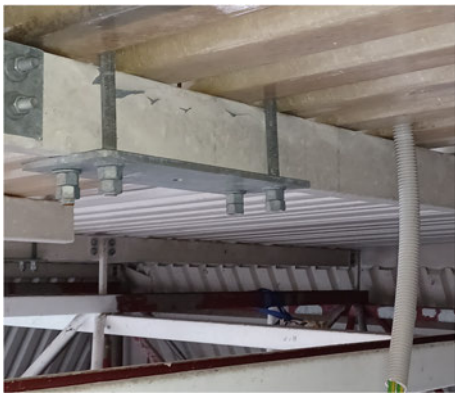
Purlin corrosion score 2

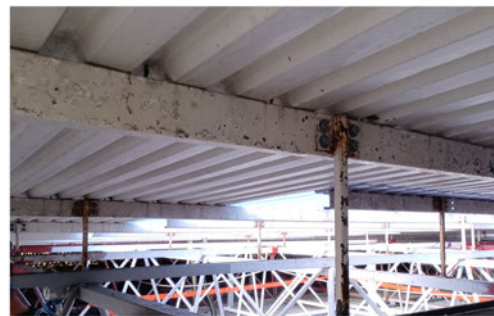
Purlin corrosion score 2

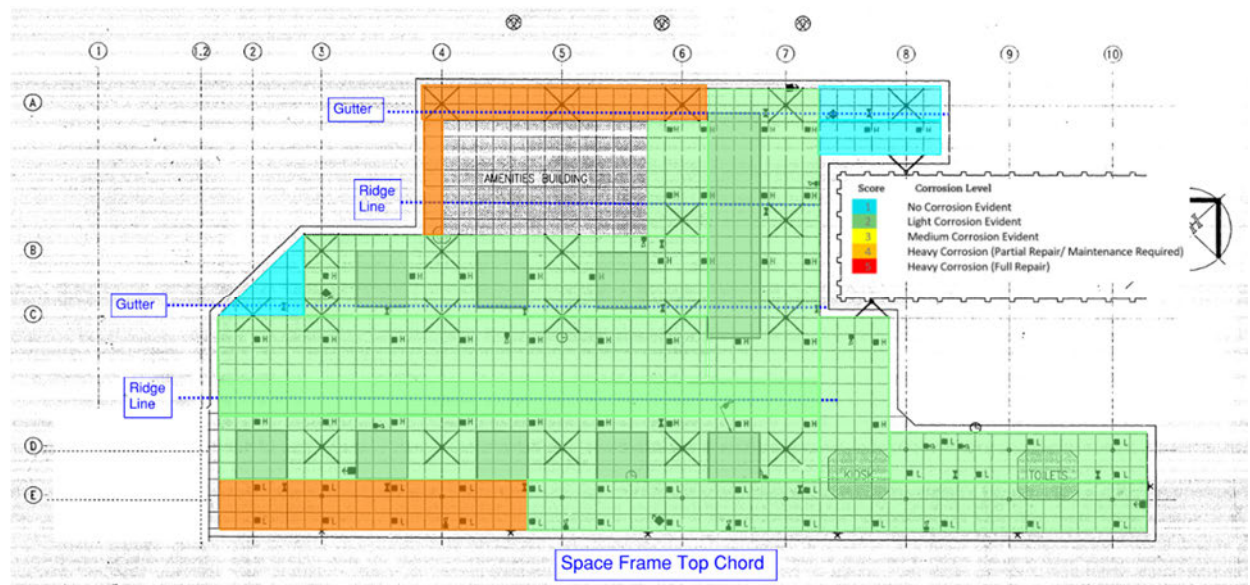
**Top Chord Corrosion Score Map**

The top chords are generally in good condition with a corrosion score of 1 or 2. However, there are areas of heavier corrosion located in the southwest corner with a corrosion score of 4.

The paint in some areas was observed to have flaked off the top chord members, which can accelerate the corrosion process.

Most of the connection bolts display medium-level corrosion.

- Abrasive blast and re-paint the top chord connection bolts. Also, repaint the chord members to prevent corrosion as most paint has already flaked off.

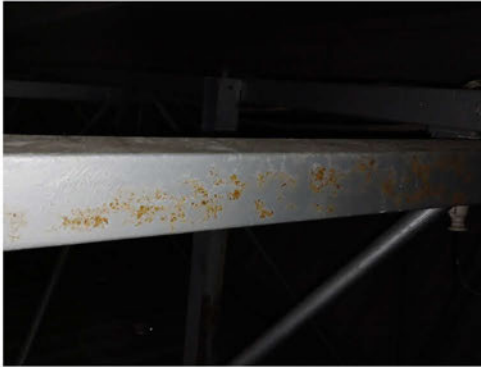
Truss top chord corrosion score 2

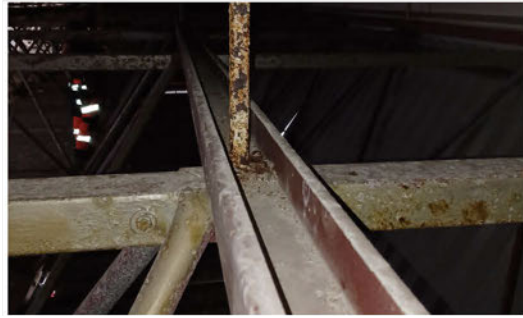
Truss top chord corrosion score 4

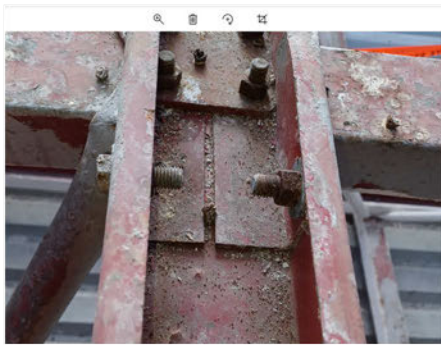
Truss top chord connection corrosion score 3

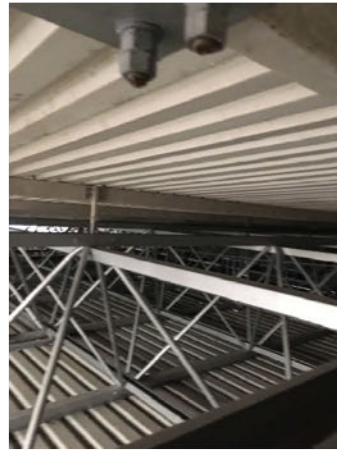
Truss top chord corrosion score 1

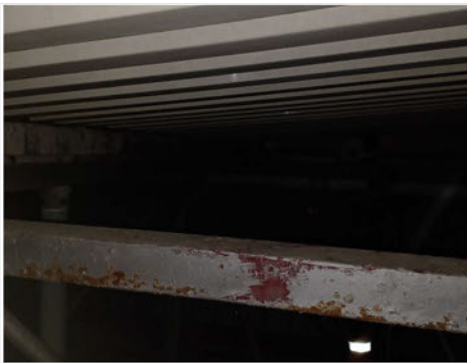
Truss top chord corrosion score 3

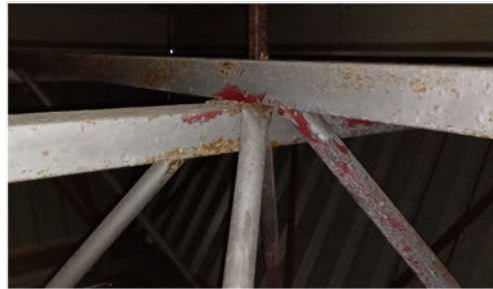
Truss top chord corrosion score 3

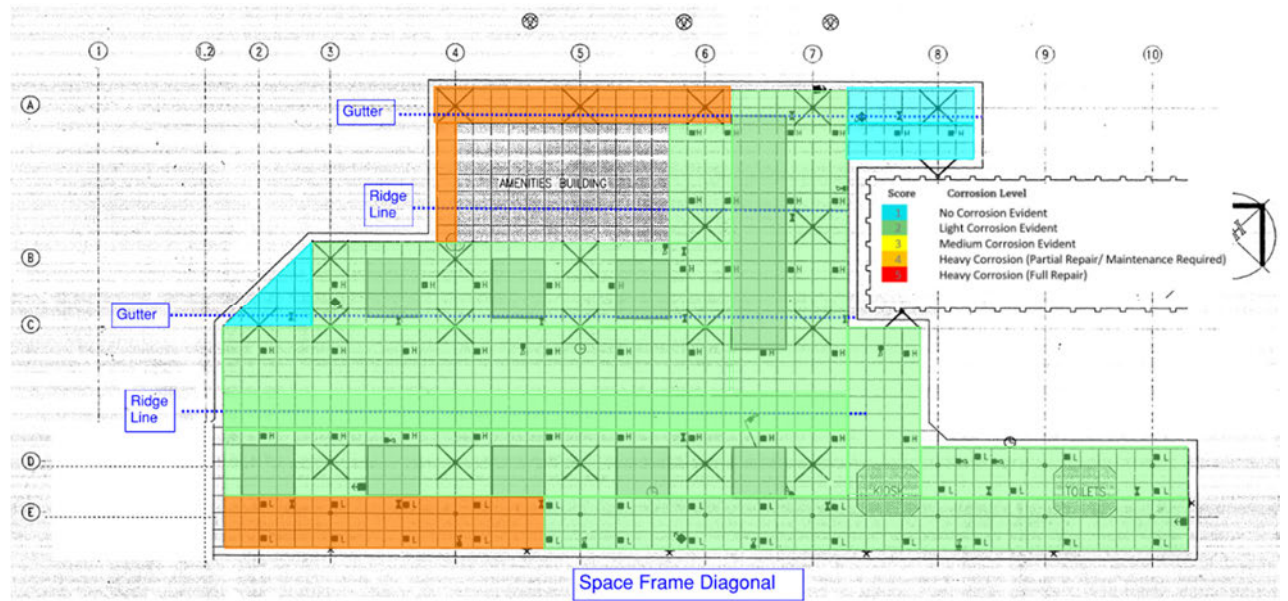
**Diagonals Corrosion Score Map**

The diagonals are generally in good condition with a corrosion score of 1 or 2. However, there are areas of heavier corrosion located in the southwest corner with a corrosion score of 4.

The paint in some areas was observed to have flaked off the diagonal members, which can accelerate the corrosion process.

- Repaint the diagonal member to prevent the start of the corrosion as most of the paint has been flaked off.

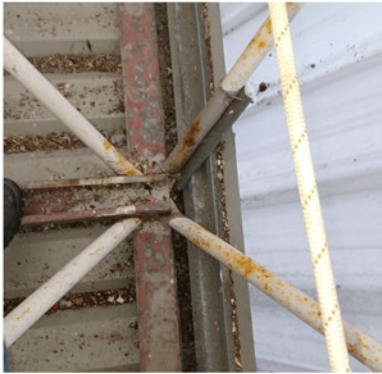
Diagonal corrosion score 3

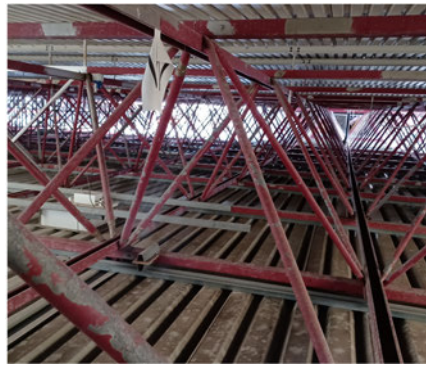
Diagonal corrosion score 2

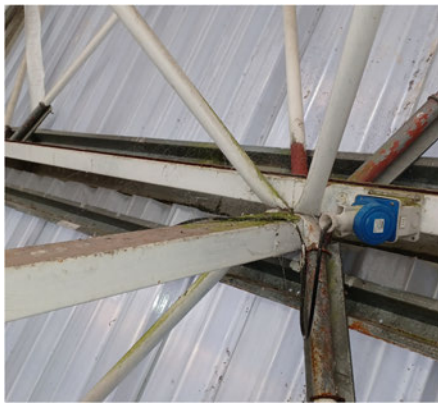
Diagonal corrosion score 3

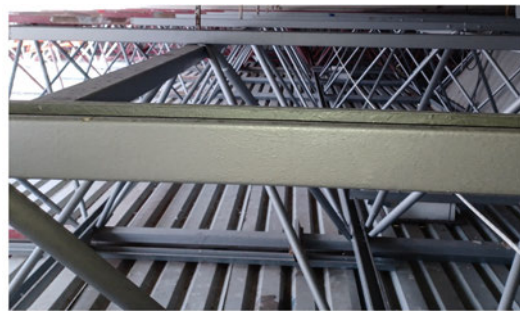
Diagonal corrosion score 1

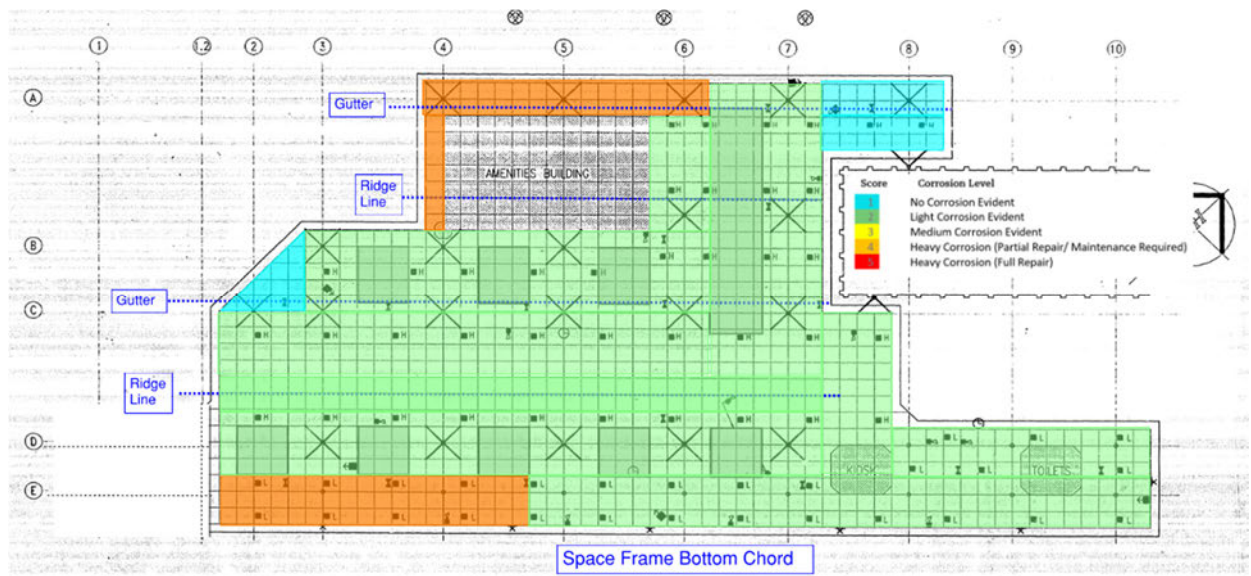
**Bottom Chord Corrosion Score Map**

The bottom chords are generally in good condition with a corrosion score of 1 or 2. However, there are areas of heavier corrosion located in the southwest corner with a corrosion score of 4.

The paint in some areas was observed to have flaked off the bottom chord members, which can accelerate the corrosion process.

Some of the connection bolts display medium-level corrosion.

- Repaint the bottom chord members to prevent corrosion as most paint has already flaked off.

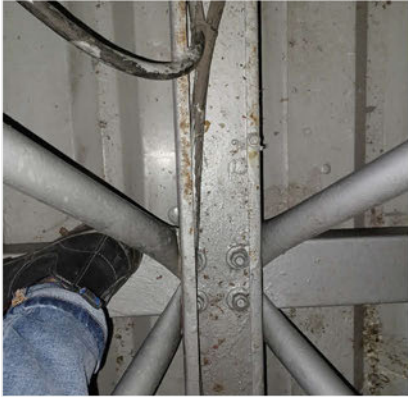
Bottom chord corrosion score 2

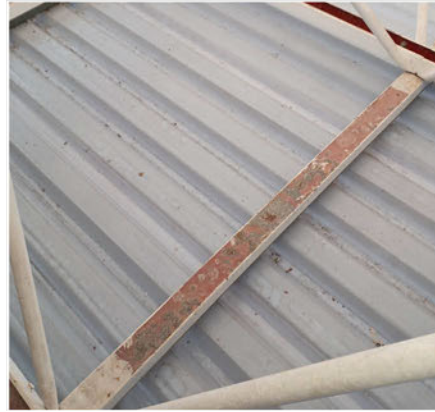
Bottom chord corrosion score 3

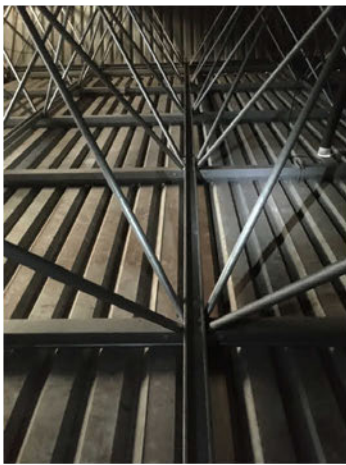
Bottom chord corrosion score 1

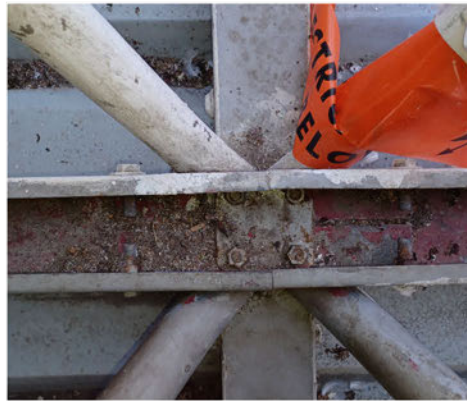
Bottom chord corrosion score 2

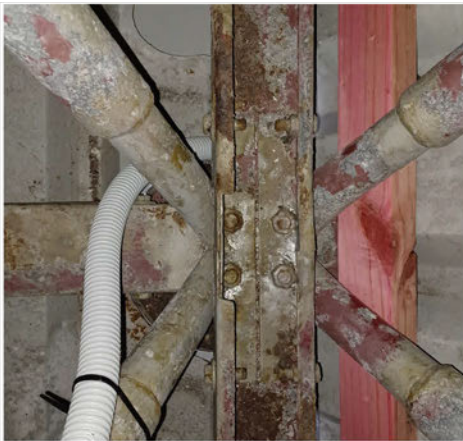
Bottom chord corrosion score 4

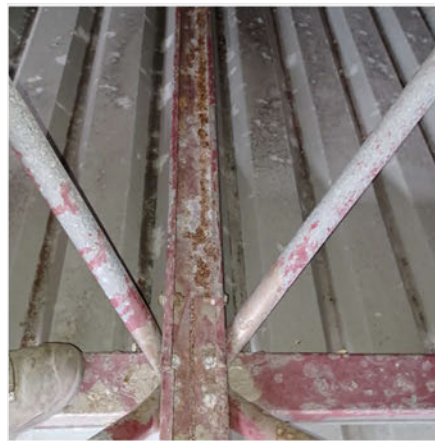
Bottom chord corrosion score 3

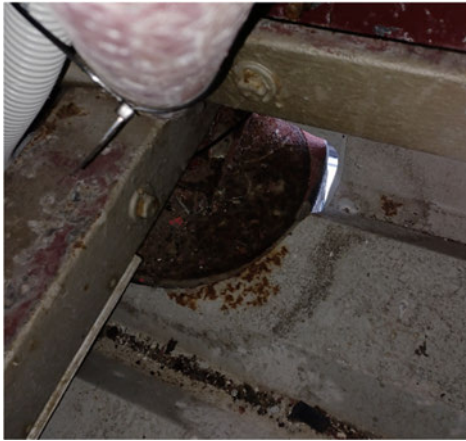
Plate between column and bottom chord  
corrosion score 4

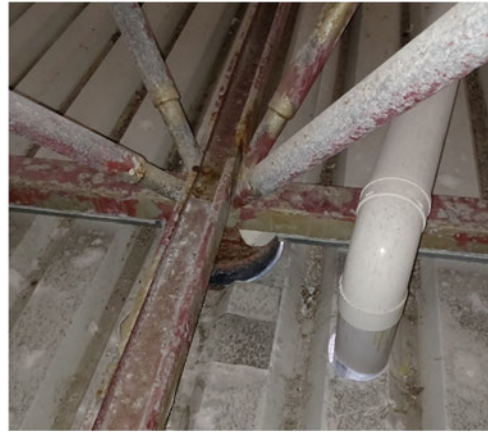
Plate between column and bottom chord  
corrosion score 4
