# **WATERLOO TRAIN STATION CANOPY REASSESSMENT**

Greater Wellington Regional Council

| HG DOCUMENT NO. | REP002-A2414842.01_KTT_MTL |
| DOCUMENT | Canopy Reassessment Report |

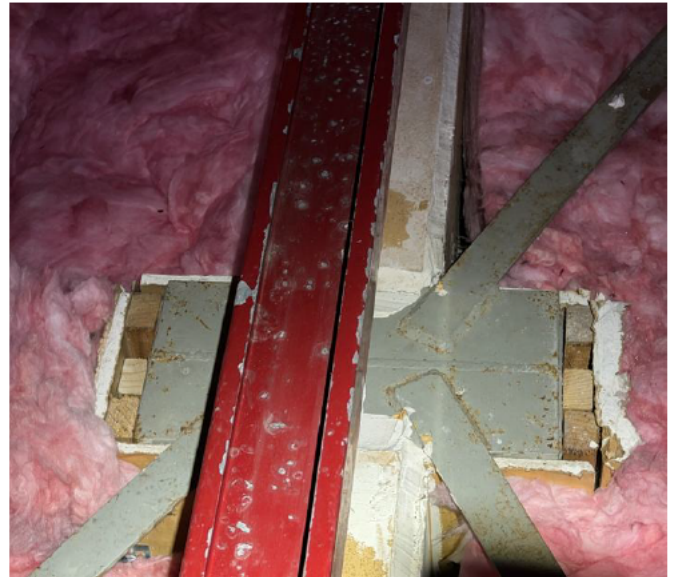
The roof bracing at the Amenities Building/Bus Building exhibits visible corrosion, assessed at a corrosion rating of 2 or 3.

Photo 012 – Roof Bracing (Amenities Building/Bus building).

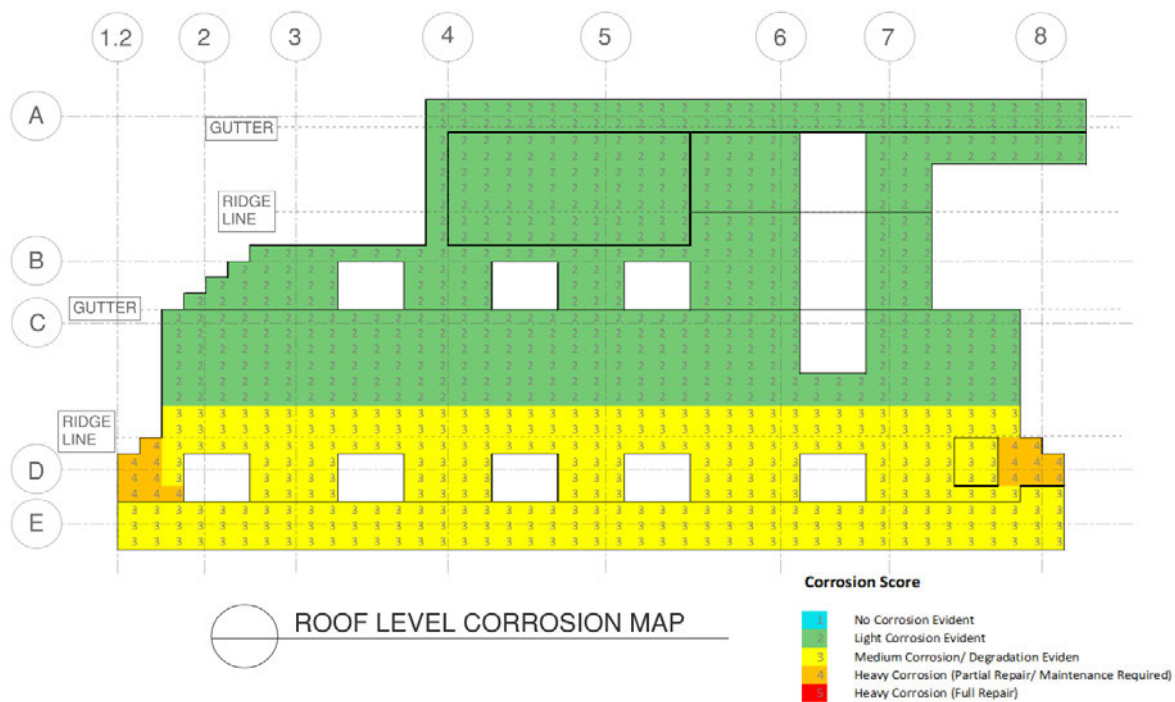
Top Roof Corrosion Score Map

The top roof sheeting exhibits widespread deterioration, including visible corrosion and the presence of moss, particularly on the southern side of the station. Significant corrosion was observed on a roof sheet adjacent to a newly replaced panel on the northeast, while the northeast edge roofing generally shows heavy corrosion and/or dense moss growth. Roof sheeting near the ticketing office and across the southeast portion of the station also displays evident rusting. In multiple locations, the protective paint coating on the roof sheeting has flaked away, exposing the substrate.

Water ponding was observed within the internal box gutters, preventing a full assessment of the extent of corrosion in these areas.

Some screws have been replaced in sections where roof sheeting was recently renewed, hold-down screws in other areas show heavy corrosion.

- Power-wash the entire roof.
- Touch up the areas of corroded sheeting around the internal gutters.
- Replace the corroded areas of internal gutters at the upper and lower levels.
- Replaced the corroded hold-down screws between sheeting and purlin.
- Block all pigeon/vermin entry points.
- Power wash pigeon droppings.
- Fix the ridge overlapping and flashing details at joints/corners.
- Paint touch-up required in the areas of corroded bottom roof sheeting below the ridge line.

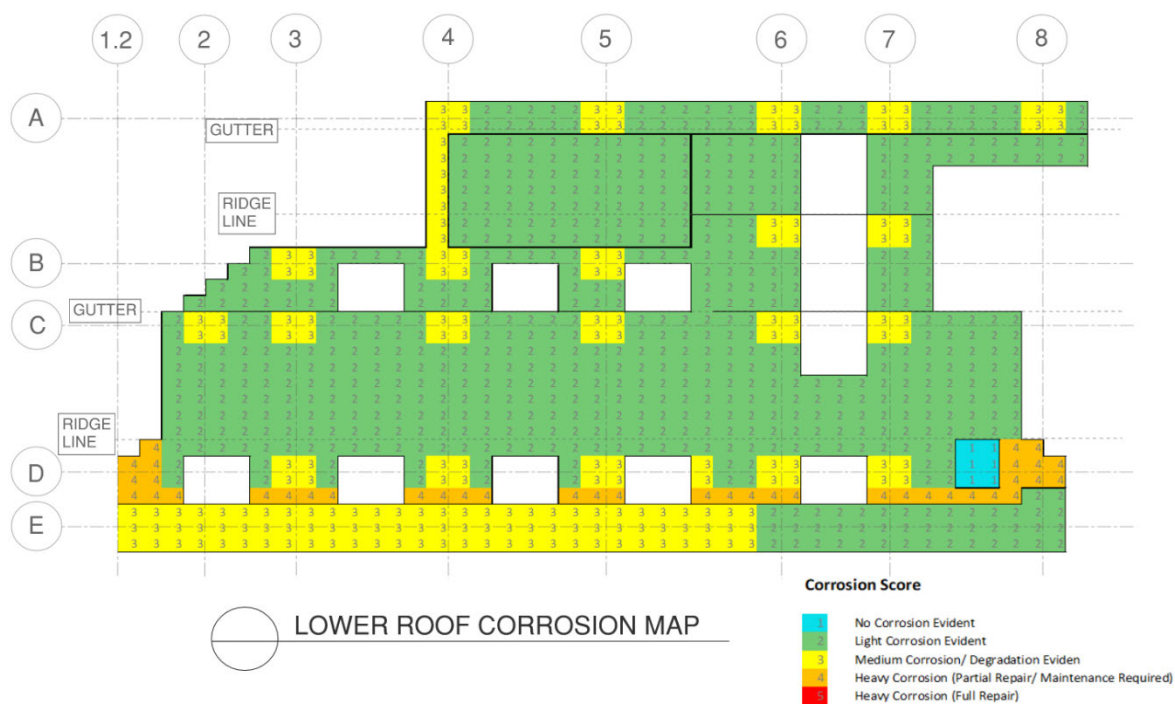
Bottom Roof Corrosion Score Map

The lower roof sheeting presents corrosion along sheet overlaps, with localized corrosion noted between gridlines GL 4-6 and GL C-D.

Corrosion is evident on the underside of the roof sheeting supported by canopy columns, particularly at beam and truss junctions, and nail fixings connecting the roof sheeting to the purlins are heavily corroded.

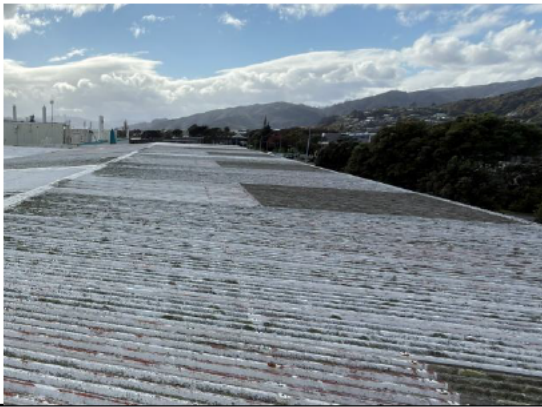
Photo 001 – Roof Level Clearlite Panel corrosion score 3

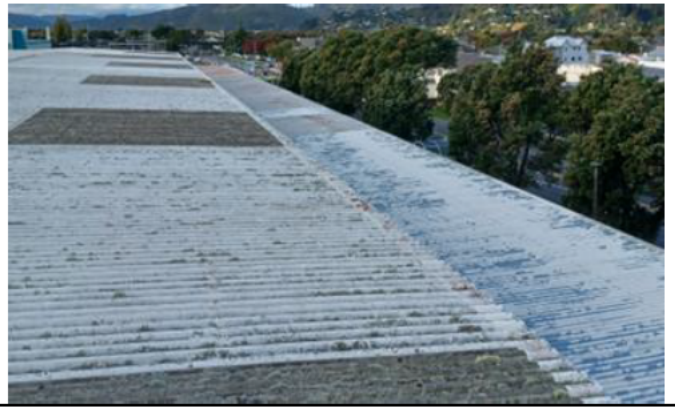
Photo 002 – Orange Lyceum on lower roof corrosion score 4. Photo is from 2024 as this area was not deemed to be safely accessible.

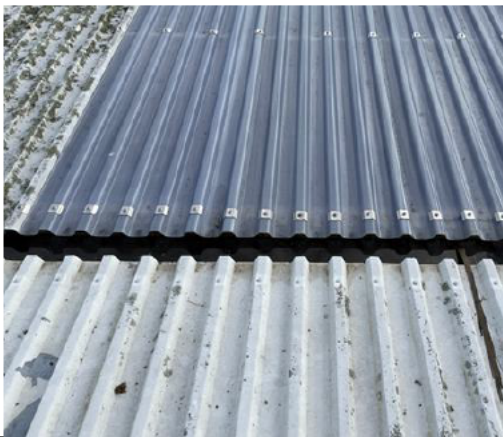
Photo 003 – Internal Gutter corrosion score 2. Water ponding was observed on the southern side of the station.

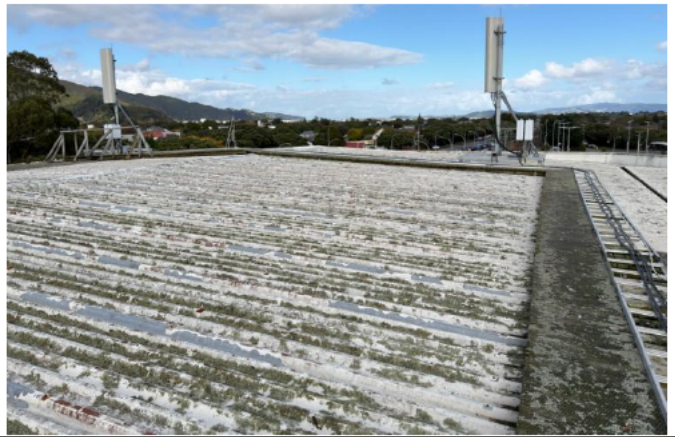
Photo 004 – Heavy presence of moss on the roof sheeting and roof walkway was observed mostly on the southern side.

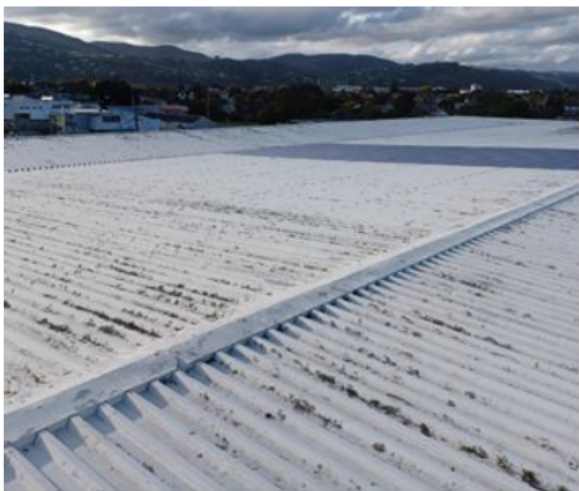
Photo 005 – Ridge capping at roof level corrosion score 2.

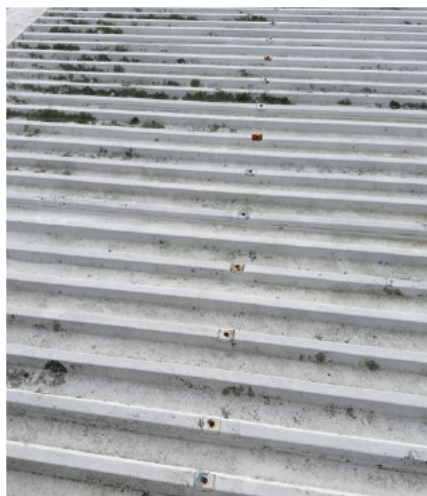
Photo 007 – Roof hold down screws in most areas show heavy corrosion with corrosion level score 4.

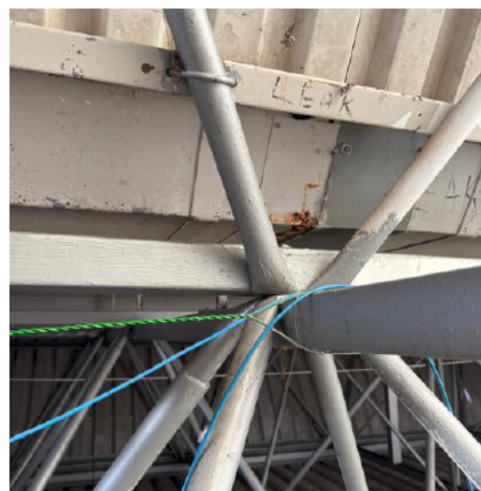
Photo 008 – Corrosion at lower internal gutter. Corrosion level 4.

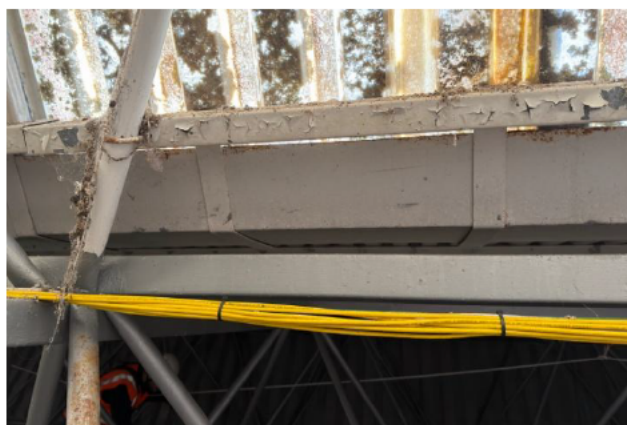
Photo 009 – Corrosion at lower internal gutter. Corrosion level 4.

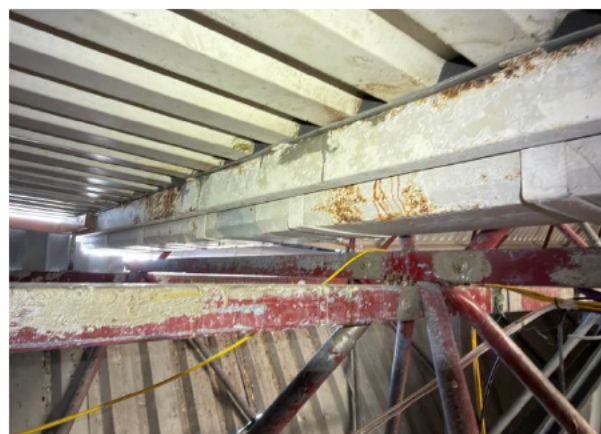
Photo 010 – Corrosion at lower internal gutter. Corrosion level 4.

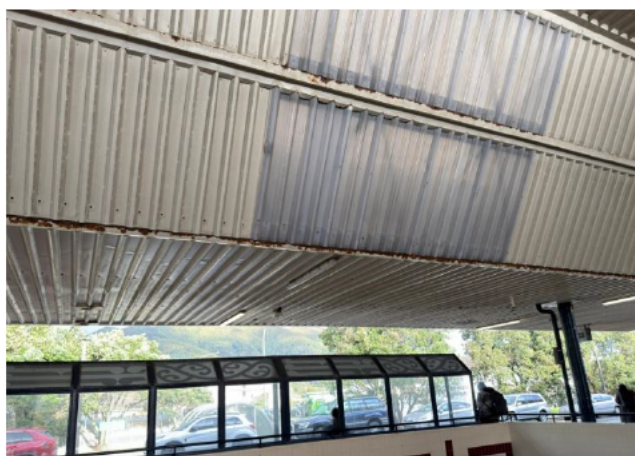
Photo 011 – Corrosion at intersection of upper and lower roof due to flashing at the corner. Corrosion level 4 on East side of the station.

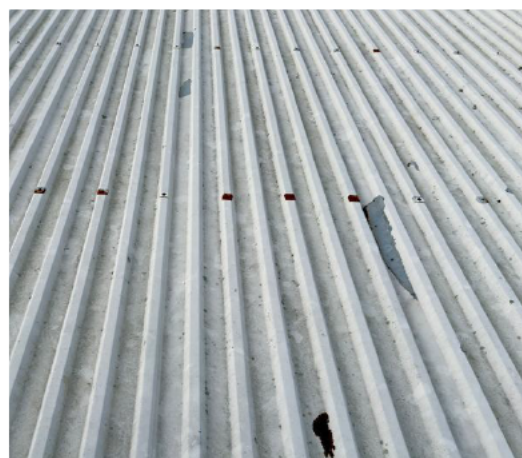
Photo 012 – Paint at the roof sheeting flaked off.

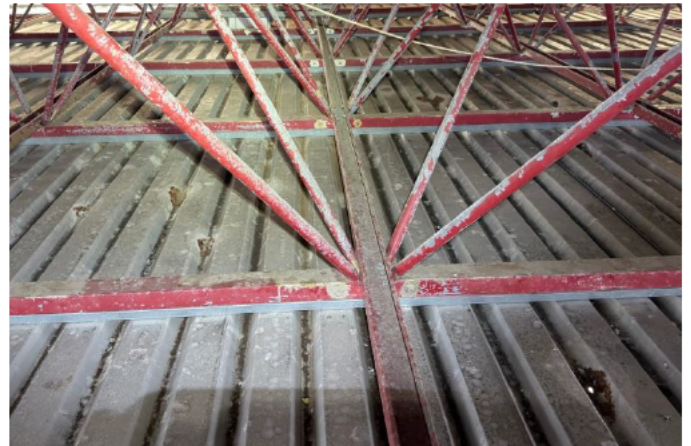
Photo 014 – Corrosion at the roof sheeting (Truss Level) between GL 4-6/ GL C-D. Corrosion score 3.

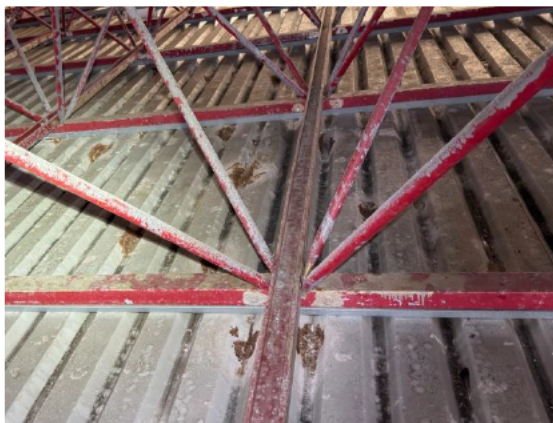
Photo 015 – Corrosion at the bottom roof sheeting (Truss Level) between GL 4-6/ GL C-D. Corrosion score 4.

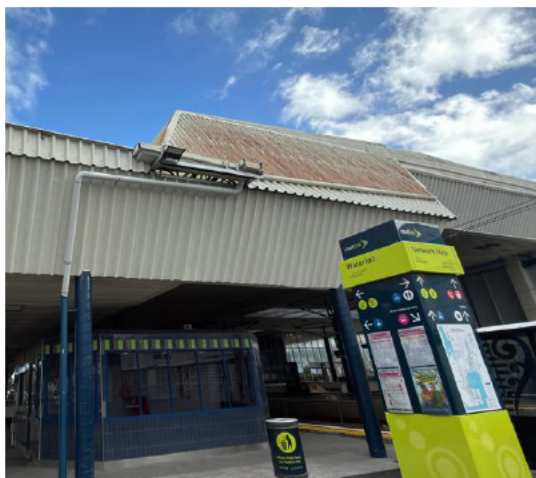
Photo 017 – Roof sheeting at Northern side of the station. Corrosion score 4.

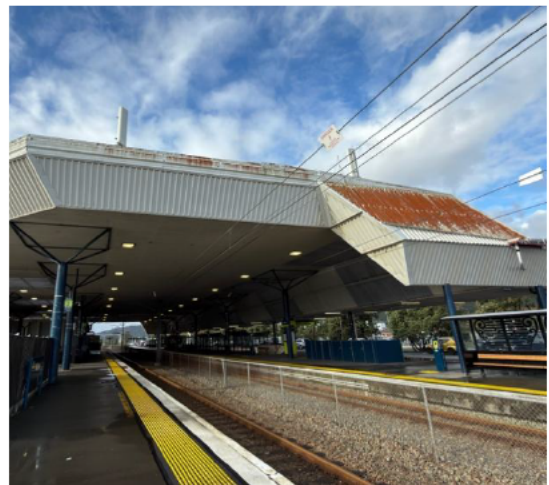
Photo 018 – Roof sheeting at Southern side of the station. Corrosion score 4.

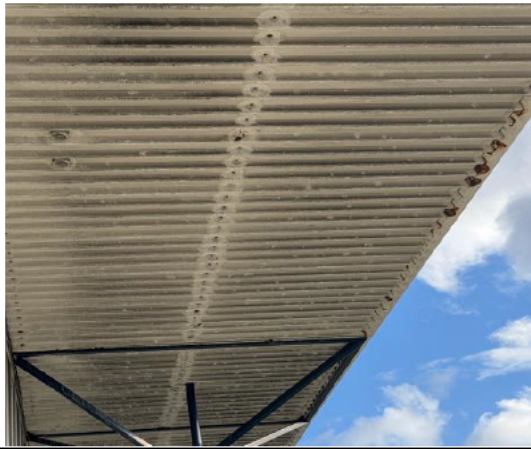
Photo 019 – Corrosion at the bottom of roof sheeting on the Western side. Corrosion score 3.

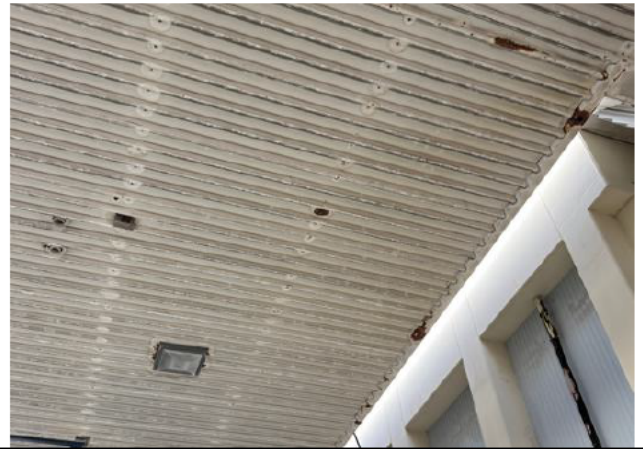
Photo 020 – Corrosion at the bottom of roof sheeting on the Western side. Corrosion score 3.

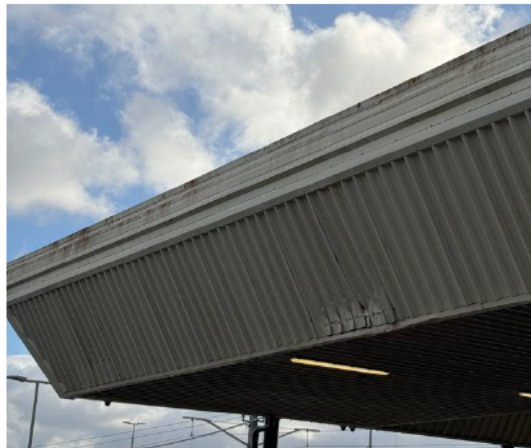
Photo 021 – Damage to the roof sheeting on the Eastern side of the station.

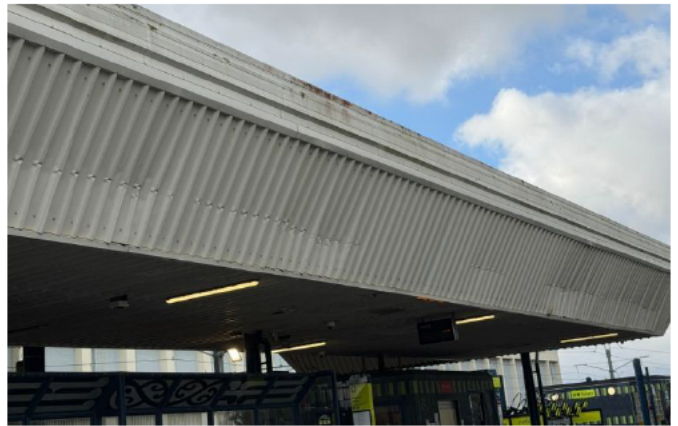
Photo 022 – Damage to the roof sheeting on the Eastern side of the station.

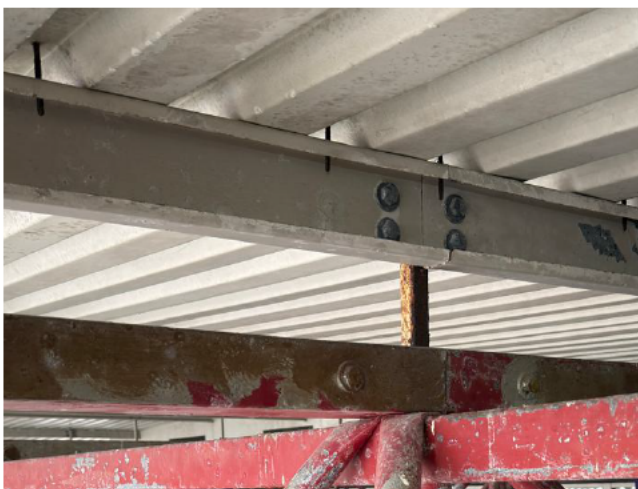
Photo 023 – Heavy corrosion at hold down screws connecting the roof sheeting to the purlins. Corrosion score 4.

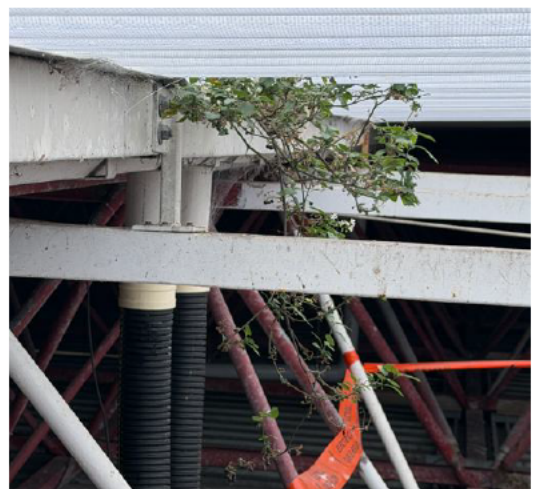
Photo 024 – Vegetation growth was observed in one area on the western side.

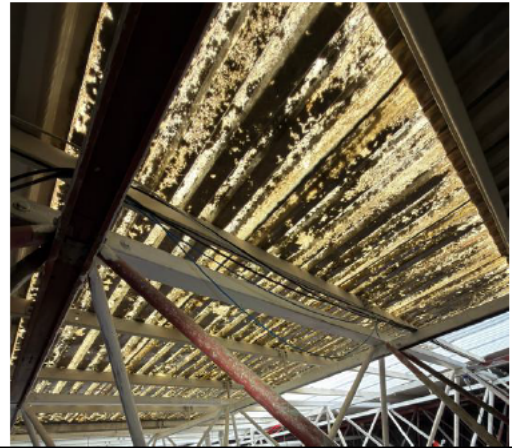
Photo 026 – Translucent sheeting covered in moss.

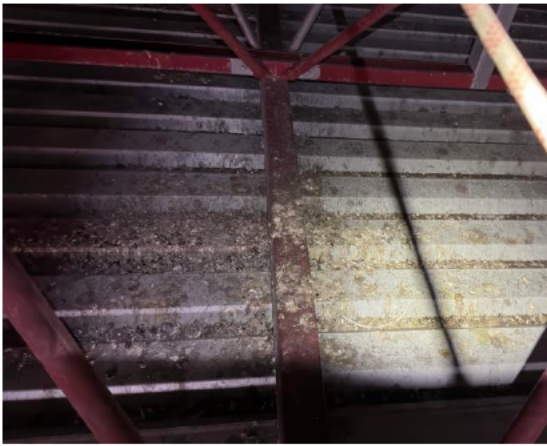
Photo 027 – Pigeon droppings observed in Truss level.

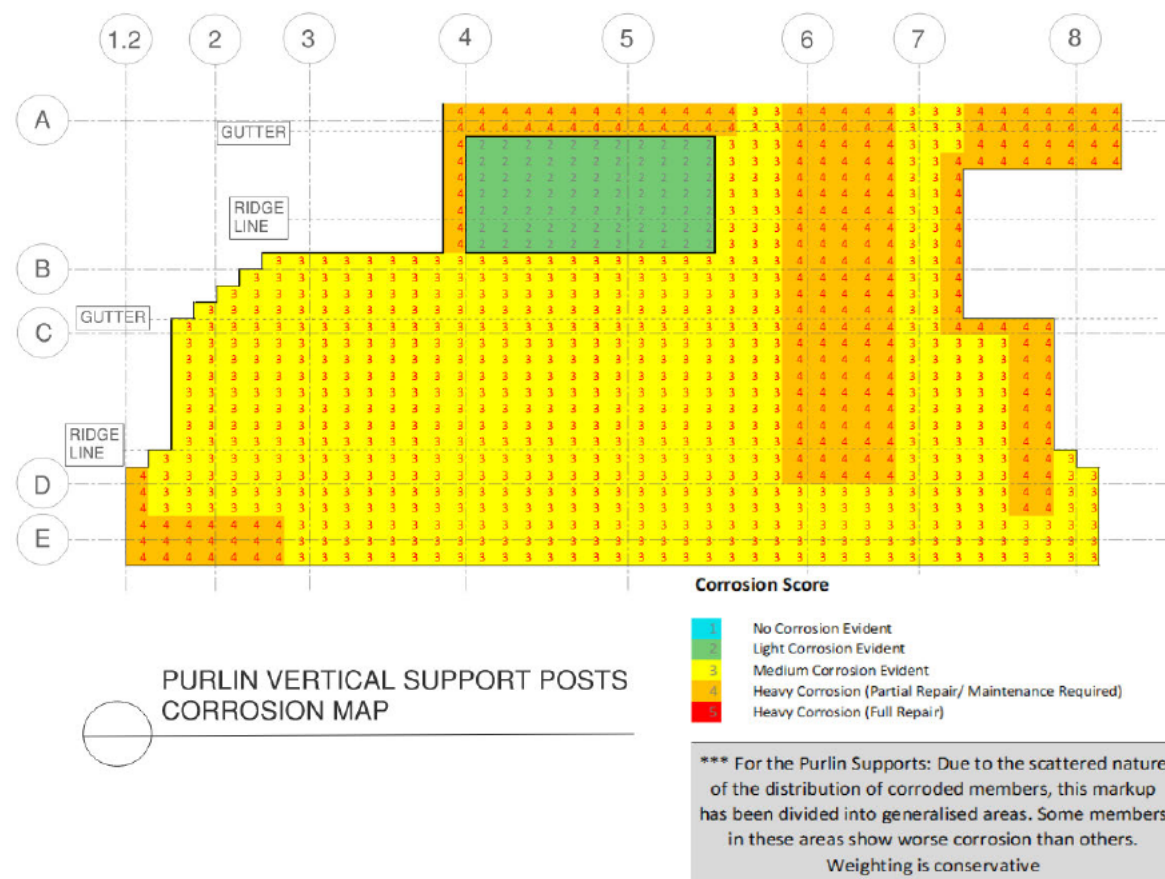
**Purlin Vertical Support Posts Corrosion Score Map**

The purlin support members display the heaviest corrosion of all the canopy elements.

The vertical flat roof sheeting on the North side of the station (ticketing side) is fixed to a new timber plank, which is attached to the purlin's vertical support post; however, it is in a severely corroded condition, with a corrosion rating of 4.

The area of most concern is highlighted in the corrosion map where the supports have a corrosion score of 4.

We estimate that maintenance to some of these elements will be required immediately where we rated the corrosion score to 4 to prevent more extensive repairs (possibly even member replacement) being required.

- Abrasive blast and re-paint the square hollow section supports and connections in the upper and lower-level portions of the roof. Replaced as required where the steel is flaking due to corrosion.

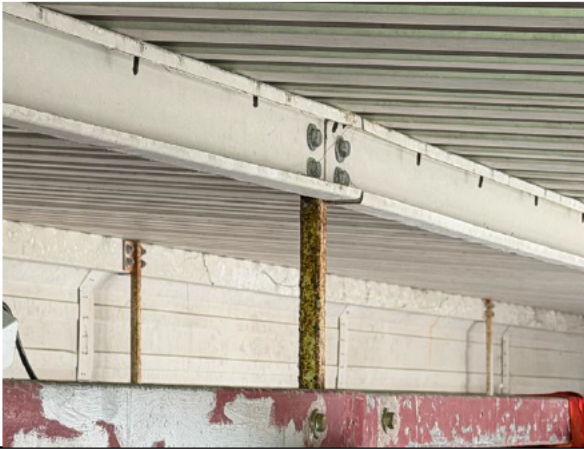
Photo 001 – Purlin Vertical Support Post Eastern side. Corrosion score 4.

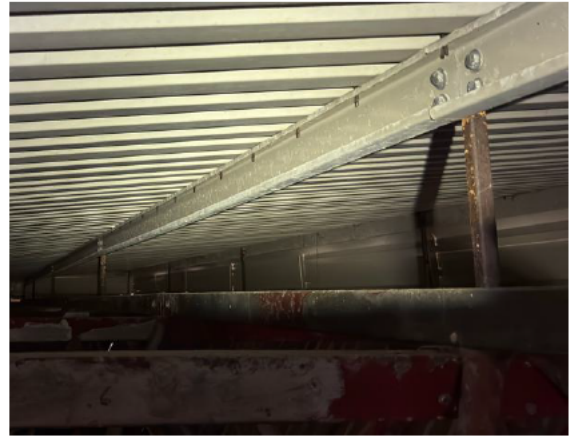
Photo 002 – Purlin Vertical Support Post Eastern side. Corrosion score 4.

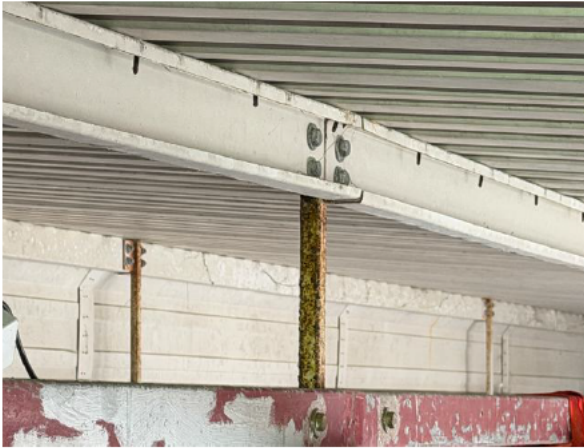
Photo 003 – Purlin Vertical Support Post. Corrosion score 4.

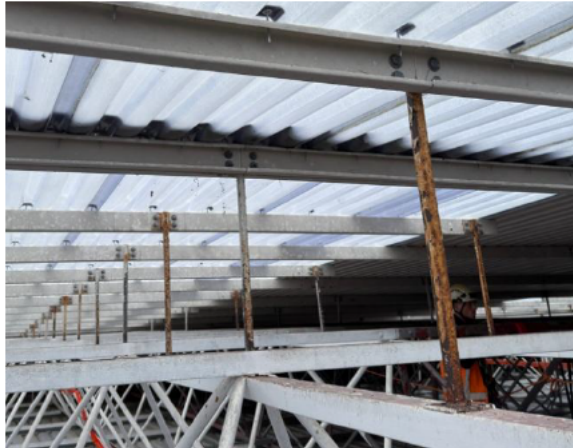
Photo 004 – Purlin Vertical Support Post. Corrosion score 4.

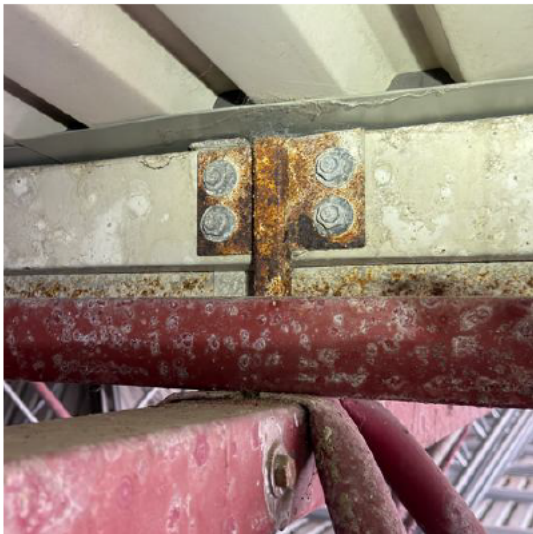
Photo 005 – Purlin Vertical Support Post northern side. Corrosion score 4.

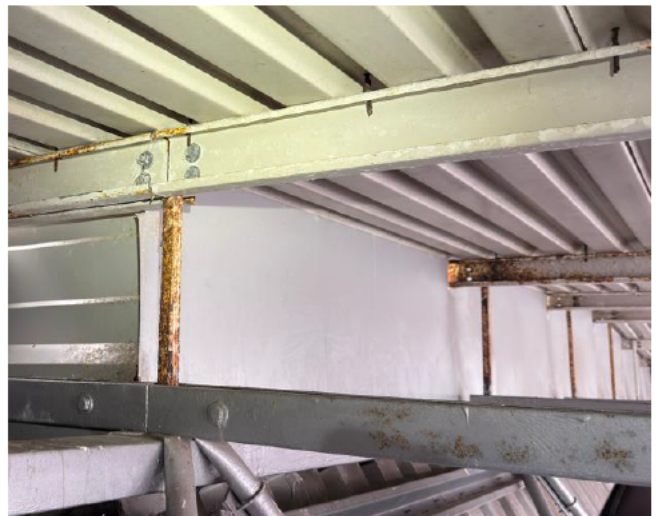
Photo 006 – Purlin Vertical Support Post northern side. Corrosion score 4.

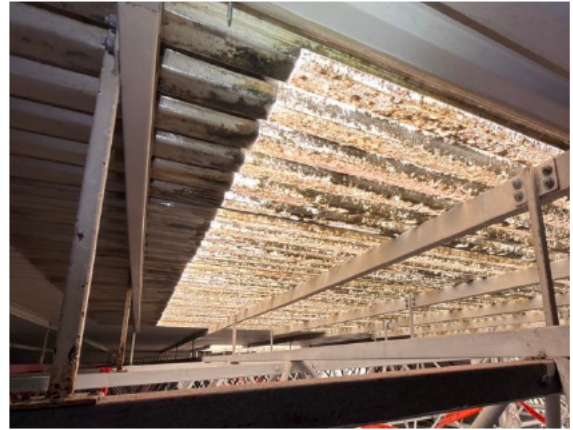
Photo 008 – Purlin Vertical Support Post. Corrosion score 3.

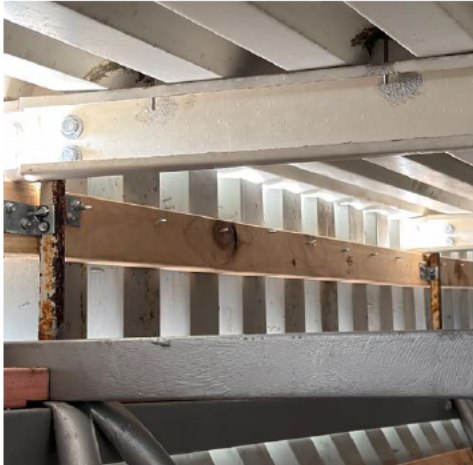
Photo 009 – Purlin Vertical Support Post lower roof northern side. Corrosion score 4.

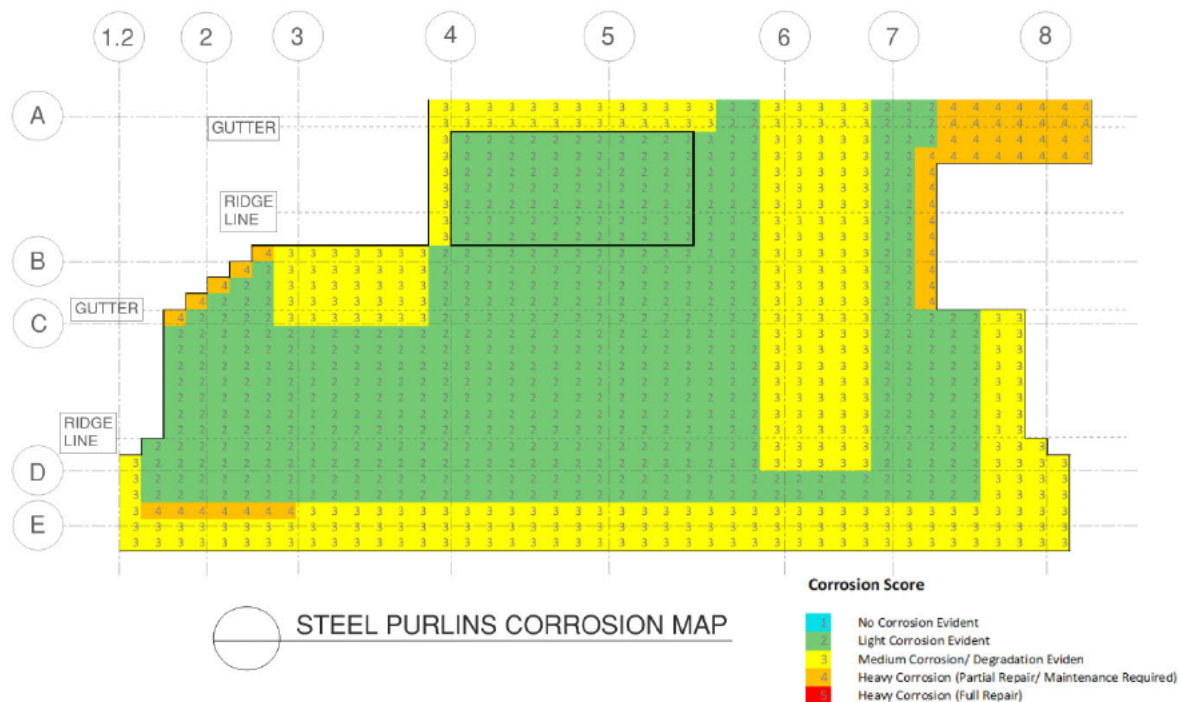
**Steel Purlin Corrosion Score Map**

These purlins are generally in good condition with a corrosion score of 2. With only isolated cases requiring remediation in the next 12 months due to them having a corrosion score of 4.

Most of the nails connecting the purlins to the roof sheeting exhibit corrosion with a corrosion score of 4. The plate connecting the purlins to the vertical support post have a corrosion score of 4 in localised areas. Paint flaking is evident in some purlins.

Vegetation growth was observed in one area on the purlin.

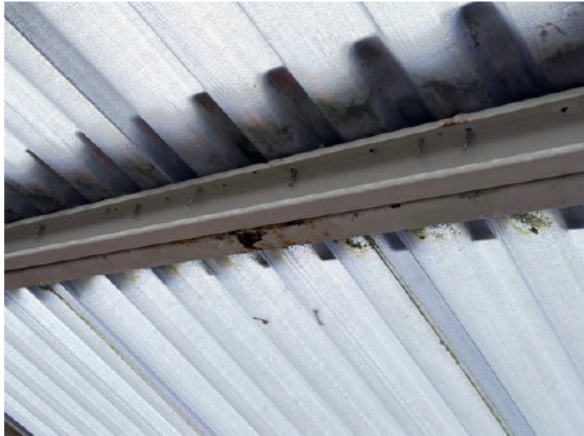
Photo 001 – Purlin corrosion. Corrosion score 3.

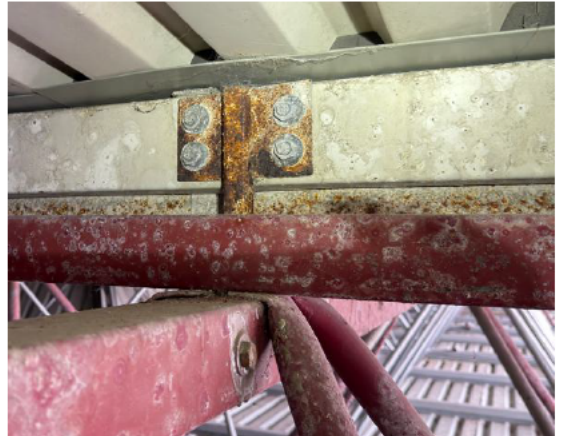
Photo 002 – Purlin corrosion. Corrosion score 4.

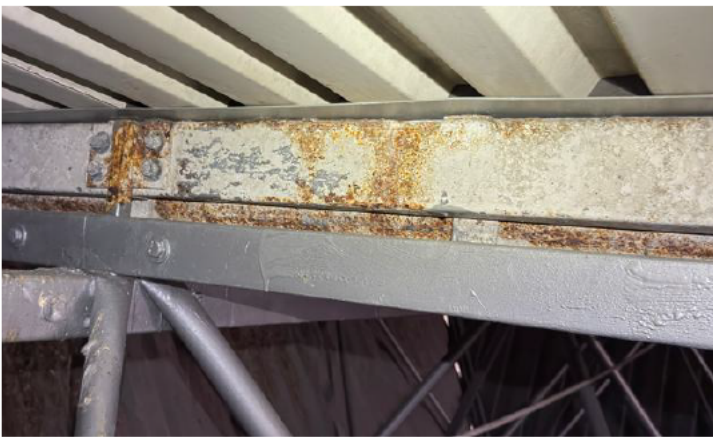
Photo 003 – Purlin corrosion. Corrosion score 4.

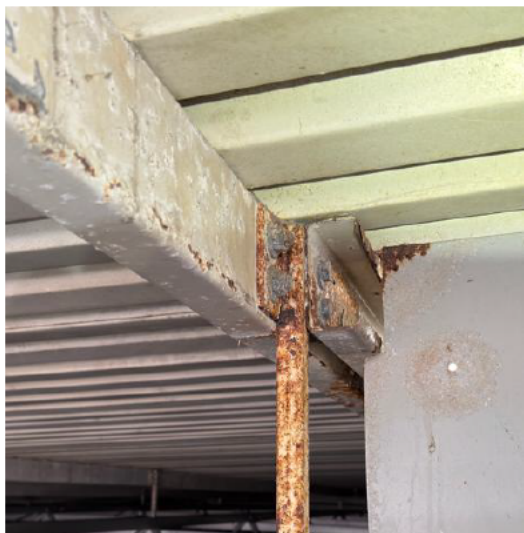
Photo 005 – Purlin corrosion. Corrosion score 4.

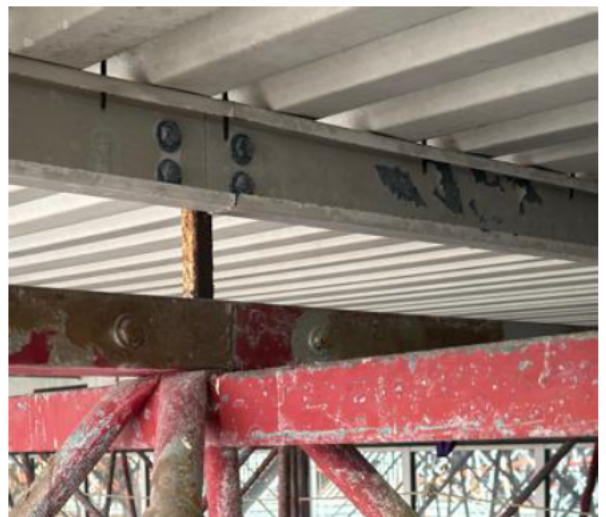
Photo 006 – Purlin corrosion. Corrosion score 2.

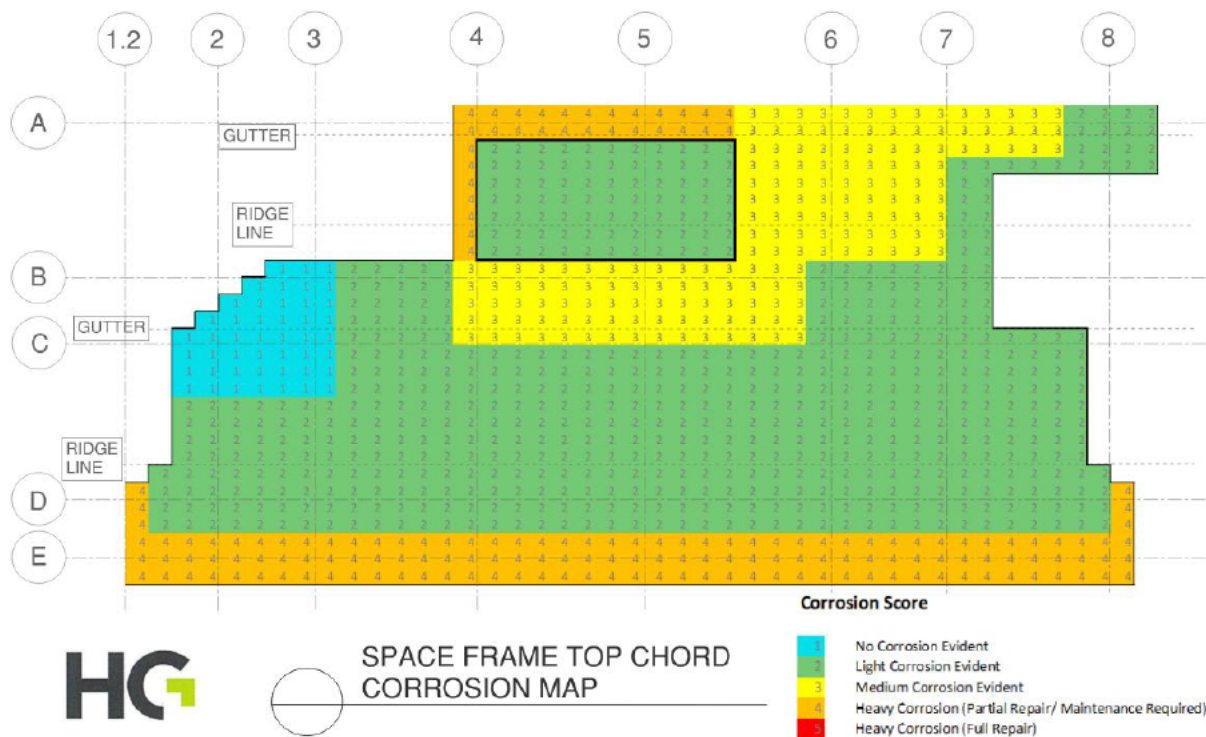
**Space Frame Top Chord Corrosion Score Map**

The top chords are generally in good condition with a corrosion score of 1 or 2. However, there are areas of heavier corrosion located in the Southwest corner with a corrosion score of 4.

Most of the bolts connecting the top chord members display medium-level corrosion. The recommended corrective measures must be actioned within 12 months before there is a need to replace these bolts and nuts.

The paint in some areas was observed to have flaked off the top chord members, which can accelerate the corrosion process.

\*\*\* For the Space Frame Top Chord: Due to the scattered nature of the distribution of corroded members, this markup has been divided into generalised areas. Some members in these areas show worse corrosion than others. Weighing is conservative

- Abrasive blast and re-paint the top chord connection bolts. Also, repaint the chord members to prevent corrosion as most paint has already flaked off.

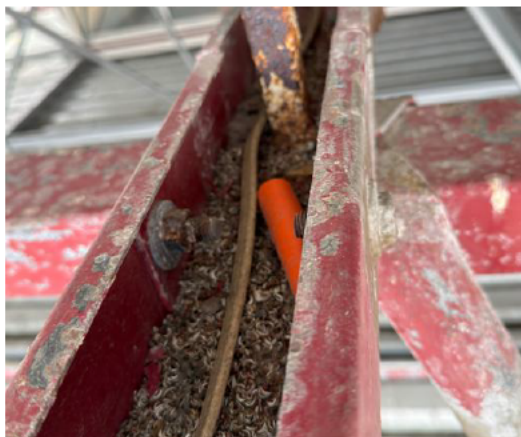
Photo 001 – Truss Top chord. Corrosion score 2.

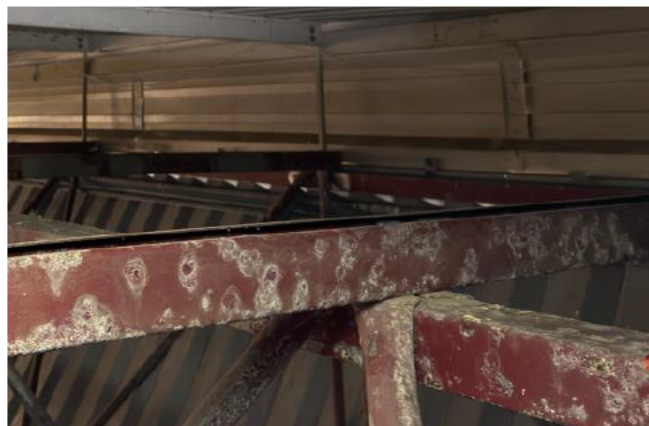
Photo 002 – Truss Top chord. Corrosion score 3.

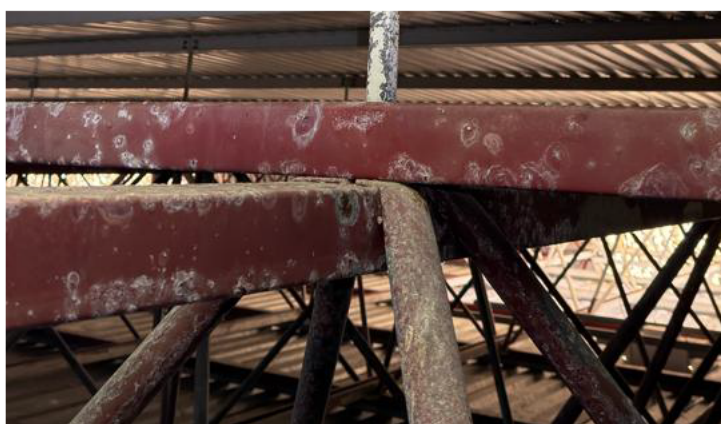
Photo 003 – Truss Top chord. Corrosion score 4.

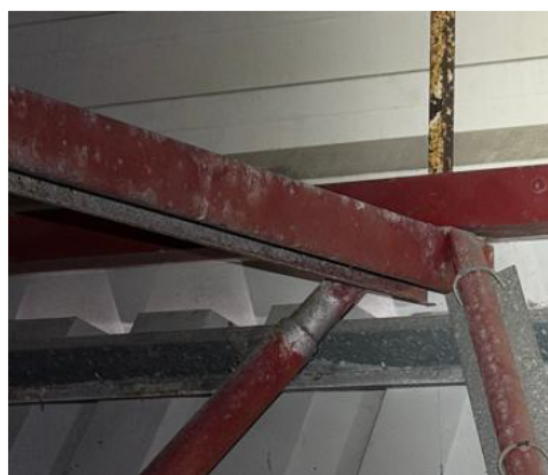
Photo 004 – Truss Top chord. Corrosion score 4.

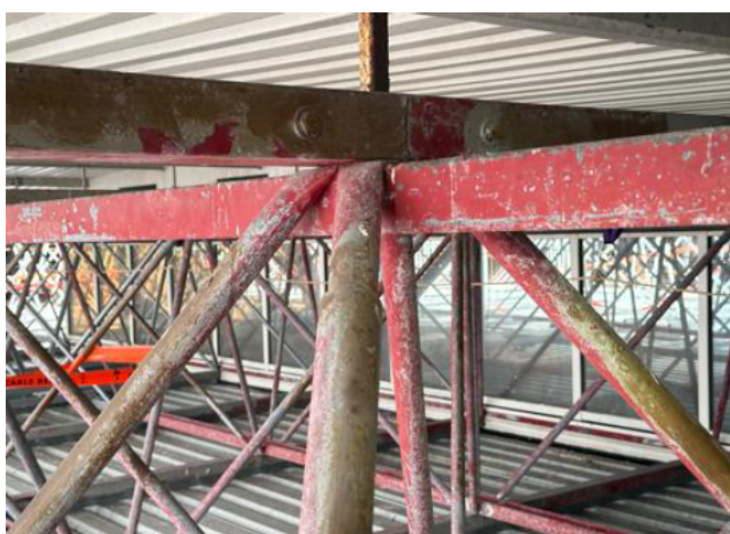
Photo 005 – Truss Top chord corrosion. Corrosion score 3.

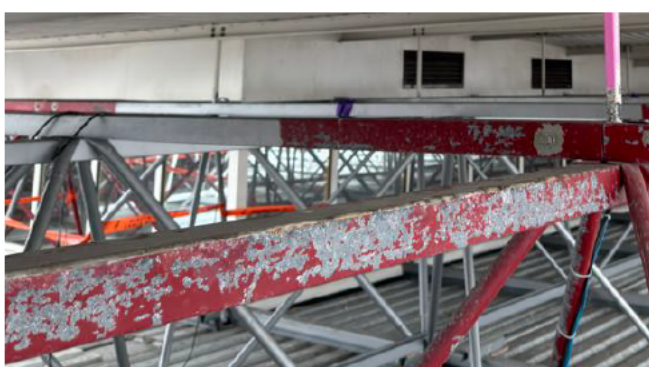
Photo 006 – Truss Top chord corrosion. Corrosion score 3.

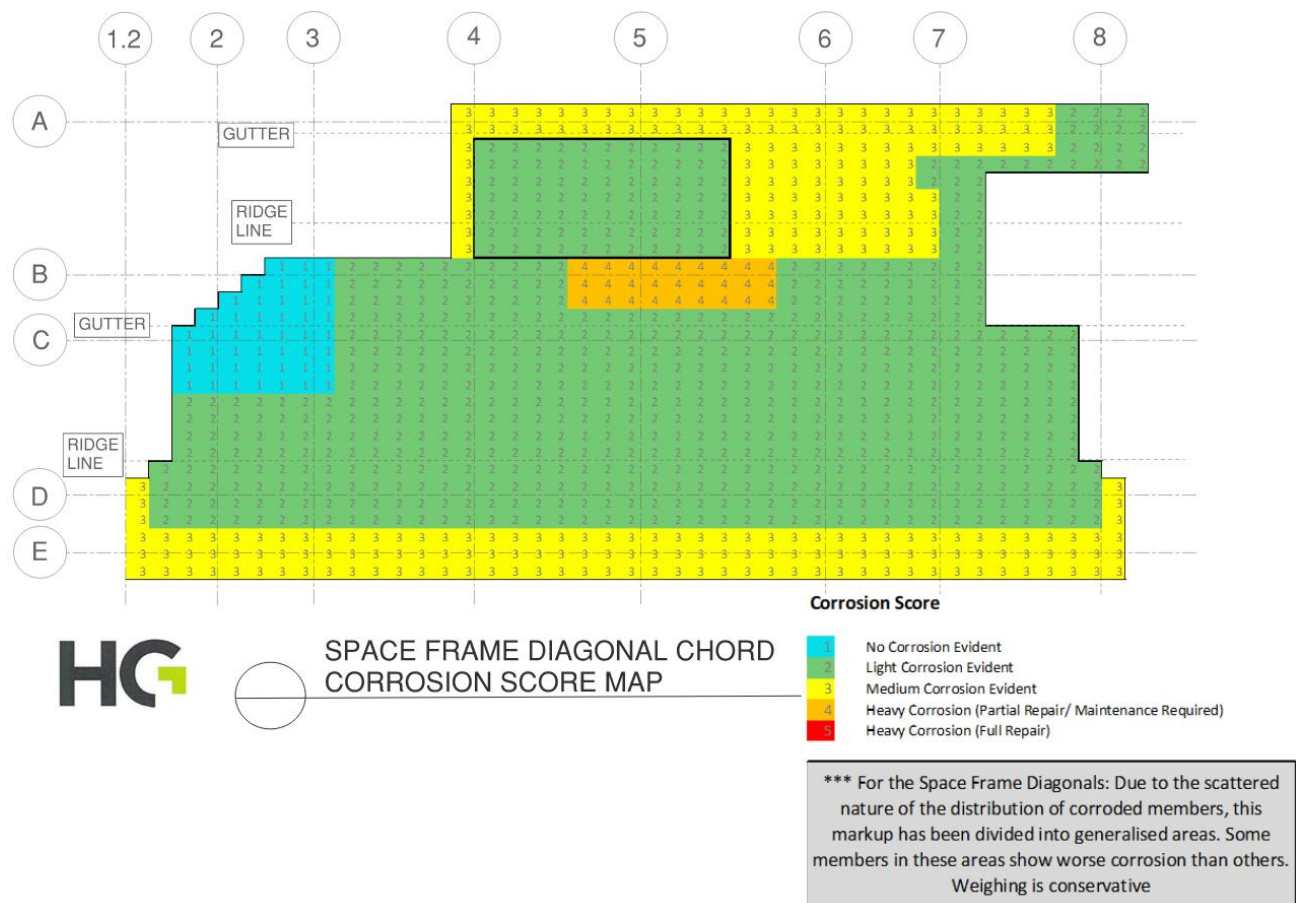
**Space Frame Diagonals Corrosion Score Map**

The diagonals are generally in good condition with a corrosion score of 1 or 2. However, there are areas of heavier corrosion located in the Southwest corner with a corrosion score of 4.

The paint in some areas was observed to have flaked off the diagonal members, which can accelerate the corrosion process.

Grease was applied to certain diagonals as a protective coating against corrosion.

- Repaint the diagonal member to prevent the start of the corrosion as most of the paint has been flaked off.

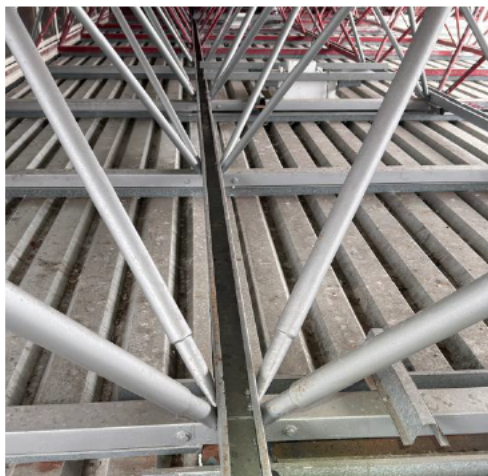
Photo 001 – Truss Diagonal. Corrosion score 1.

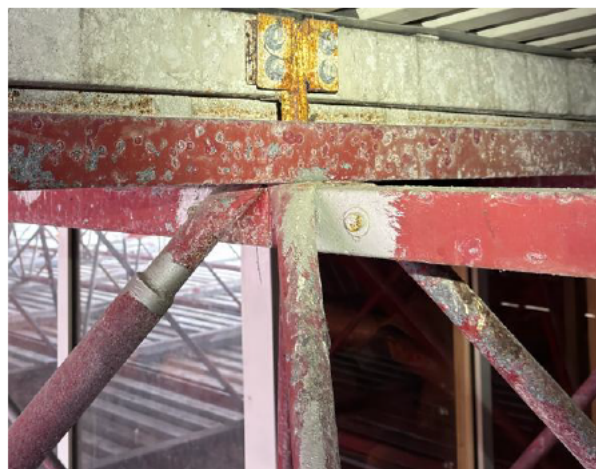
Photo 002 – Truss Diagonal. Corrosion score 4.

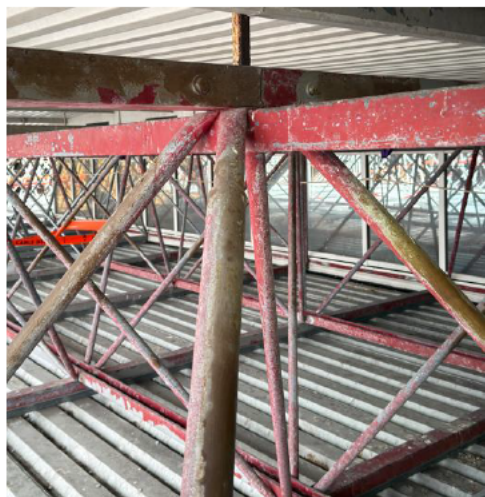
Photo 003 – Grease was applied to truss diagonal to help with the corrosion.

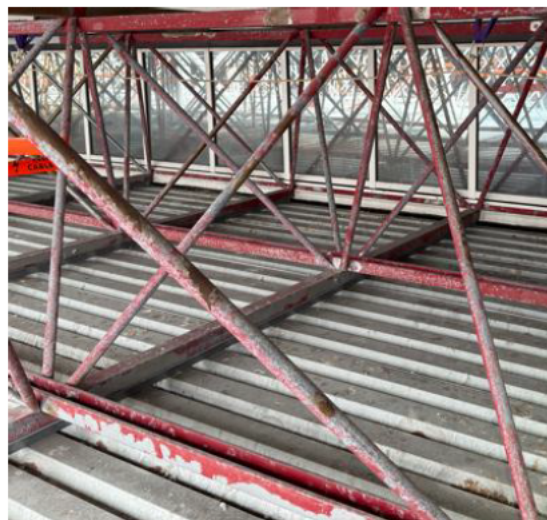
Photo 004 – Truss Diagonal. Corrosion score 4.

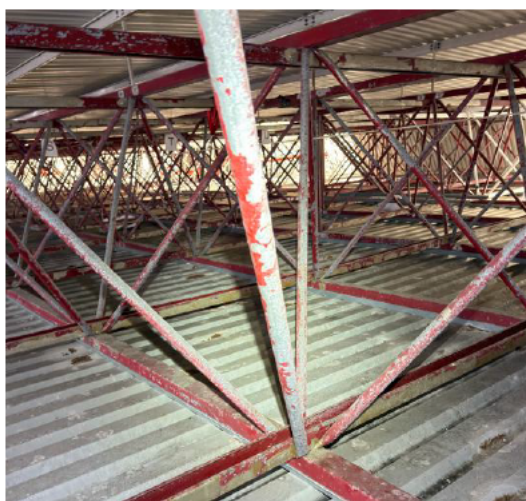
Photo 005 – Paint on truss diagonal has been stripped off.

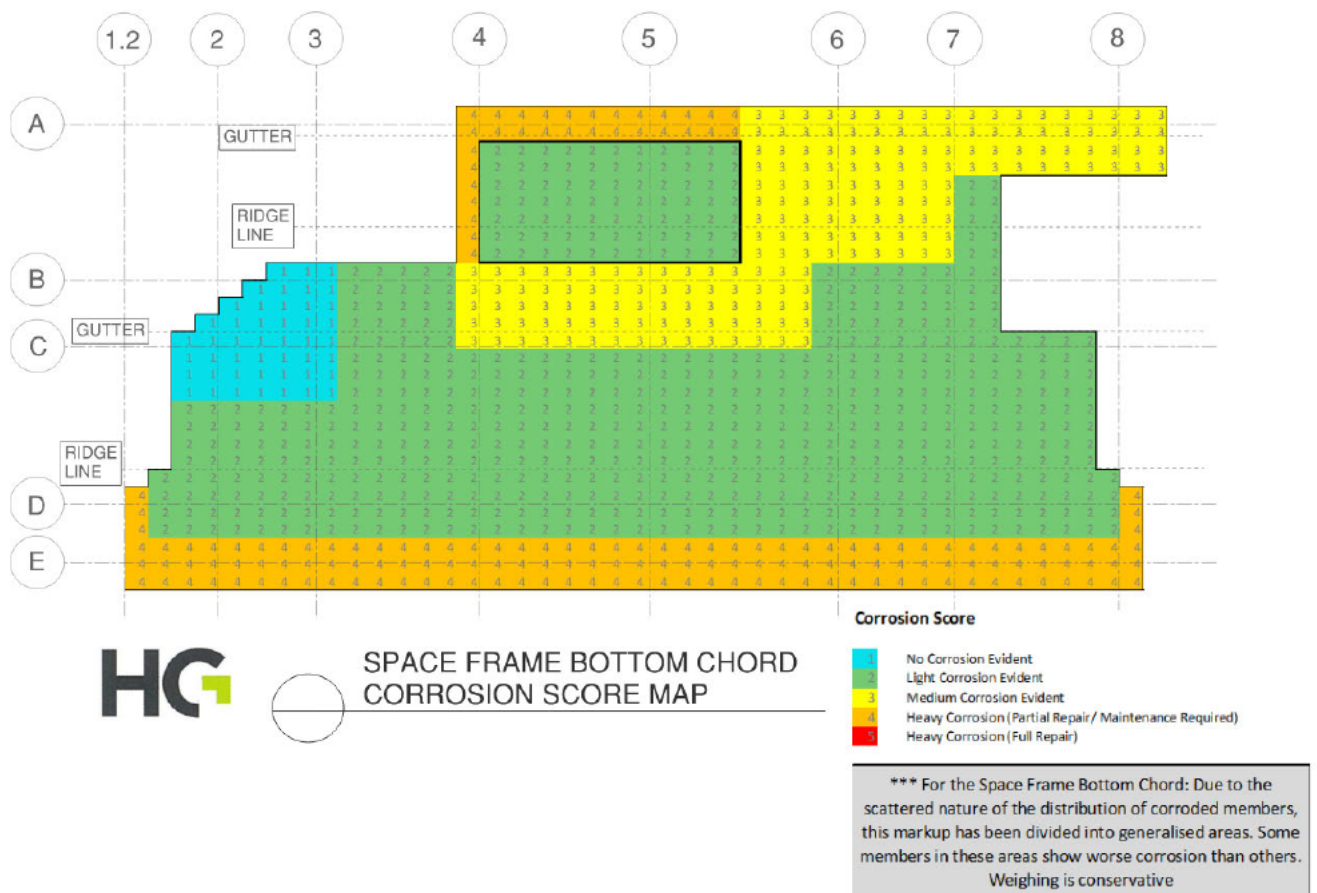
**Space Frame Bottom Chords Corrosion Score Map**

The bottom chords are generally in good condition with a corrosion score of 1 or 2. However, there are areas of heavier corrosion located in the southwest corner with a corrosion score of 4.

The paint in some areas was observed to have flaked off the bottom chord members, which can accelerate the corrosion process.

Some of the connection bolts display heavy-level corrosion.

- Repaint the bottom chord members to prevent corrosion as most paint has already flaked off.

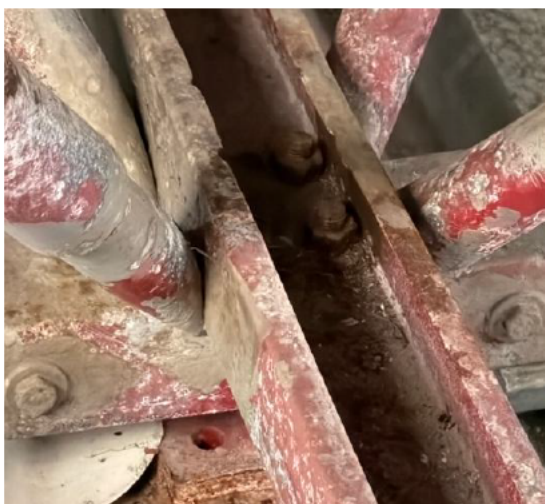
Photo 003 – Truss Bottom chord. Corrosion score 4.

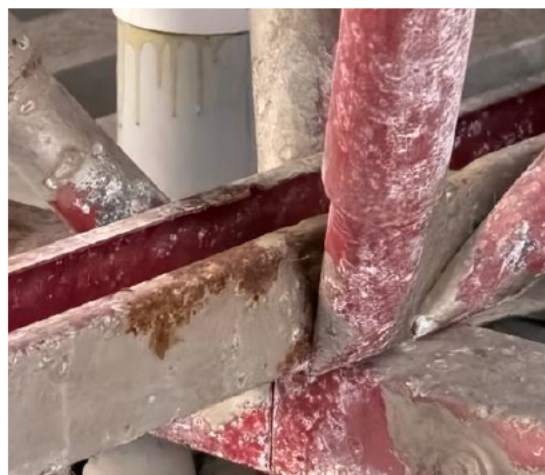
Photo 004 – Truss Bottom chord. Corrosion score 4.

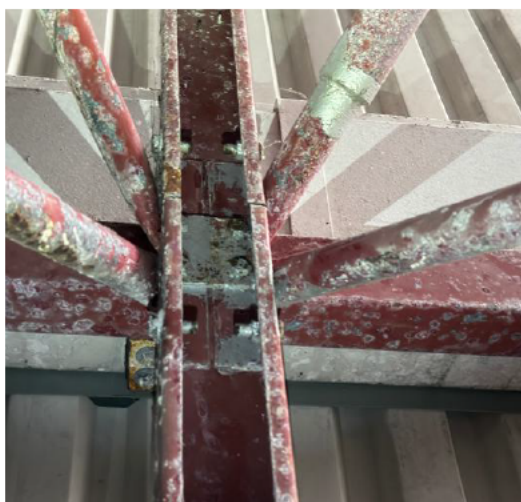
Photo 005 – Truss Bottom chord. Corrosion score 4.
