# **WATERLOO TRAIN STATION CANOPY REASSESSMENT**

Greater Wellington Regional Council

| HG DOCUMENT NO. | REP002-A2414842.01_KTT_MTL |
| DOCUMENT | Canopy Reassessment Report |

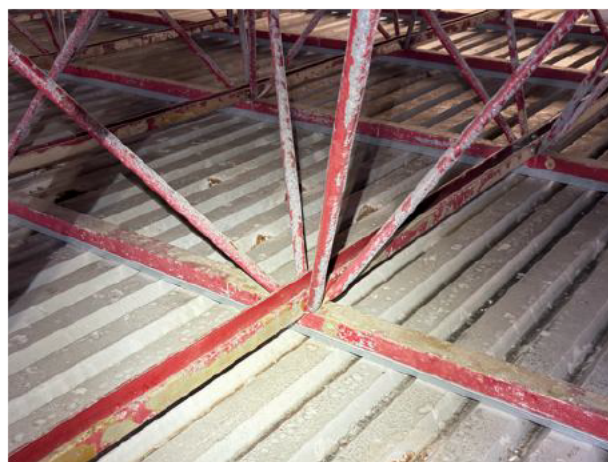
Photo 006 – Truss bottom chord. Corrosion score 1.

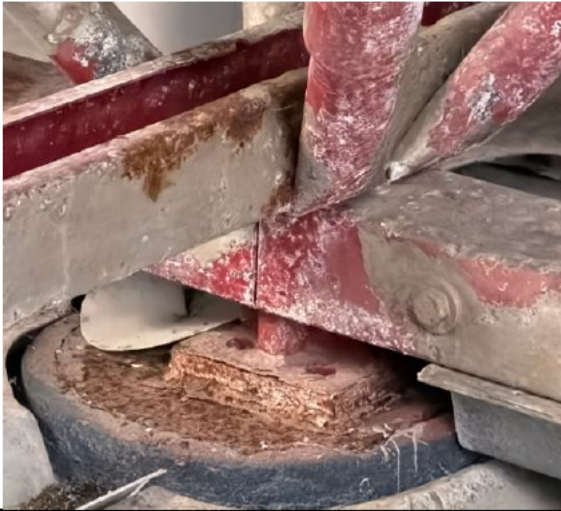
Photo 007 – Heavy corrosion between column and bottom chord. Corrosion score 4.

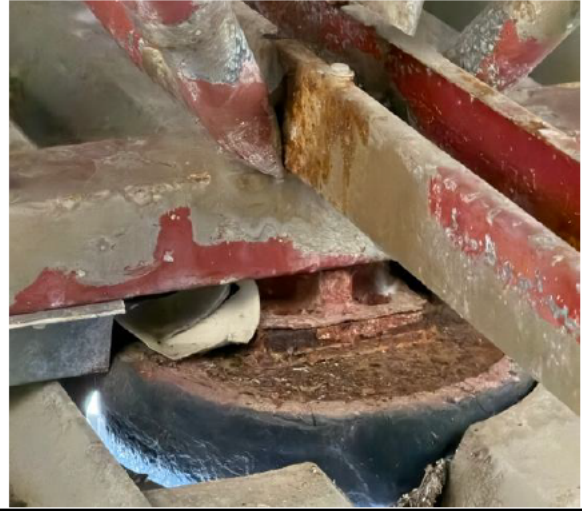
Photo 008 – Heavy corrosion between column and bottom chord. Corrosion score 4.

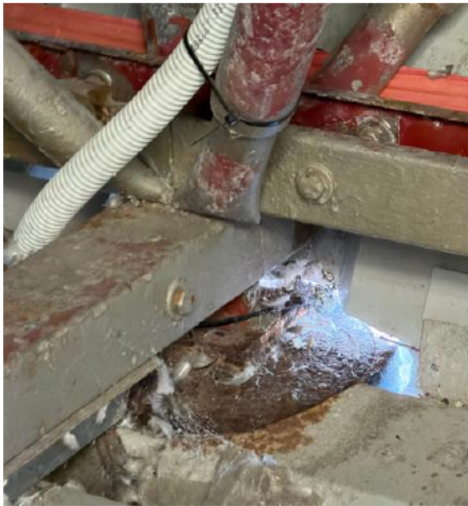
Photo 009 – Heavy corrosion between column and bottom chord. Corrosion score 4.

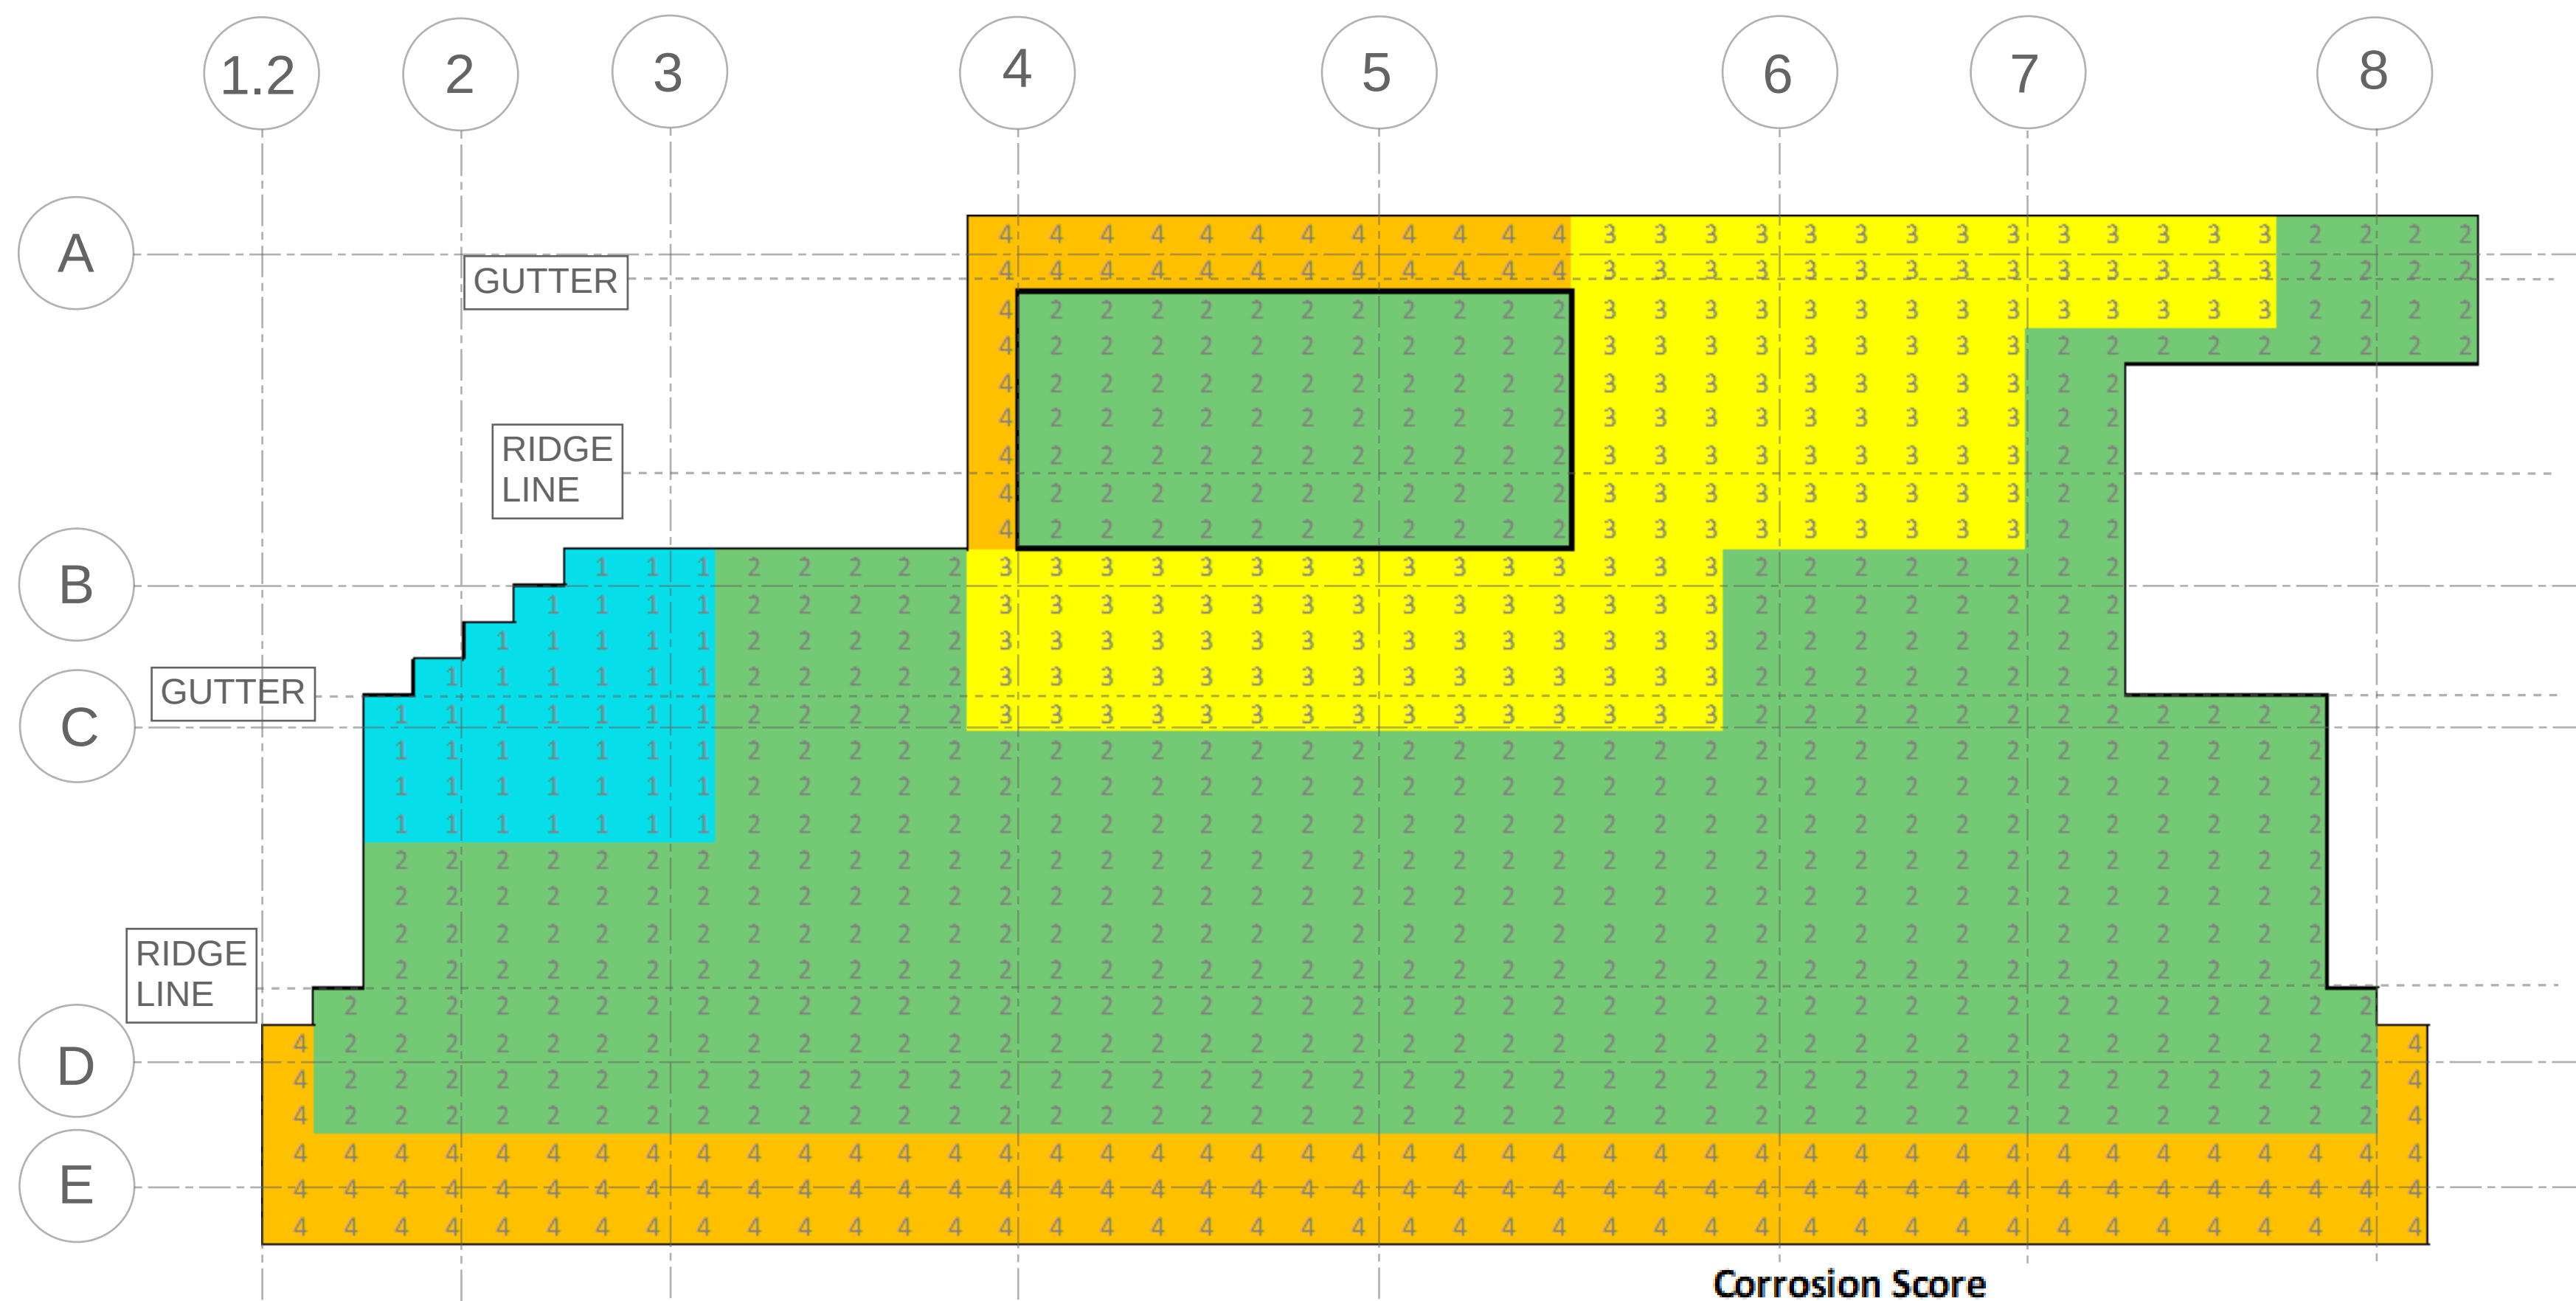
## SPACE FRAME TOP CHORD CORROSION SCORE MAP

\*\*\* For the Space Frame Top Chord: Due to the scattered nature of the distribution of corroded members, this markup has been divided into generalised areas. Some members in these areas show worse corrosion than others. Weighing is conservative

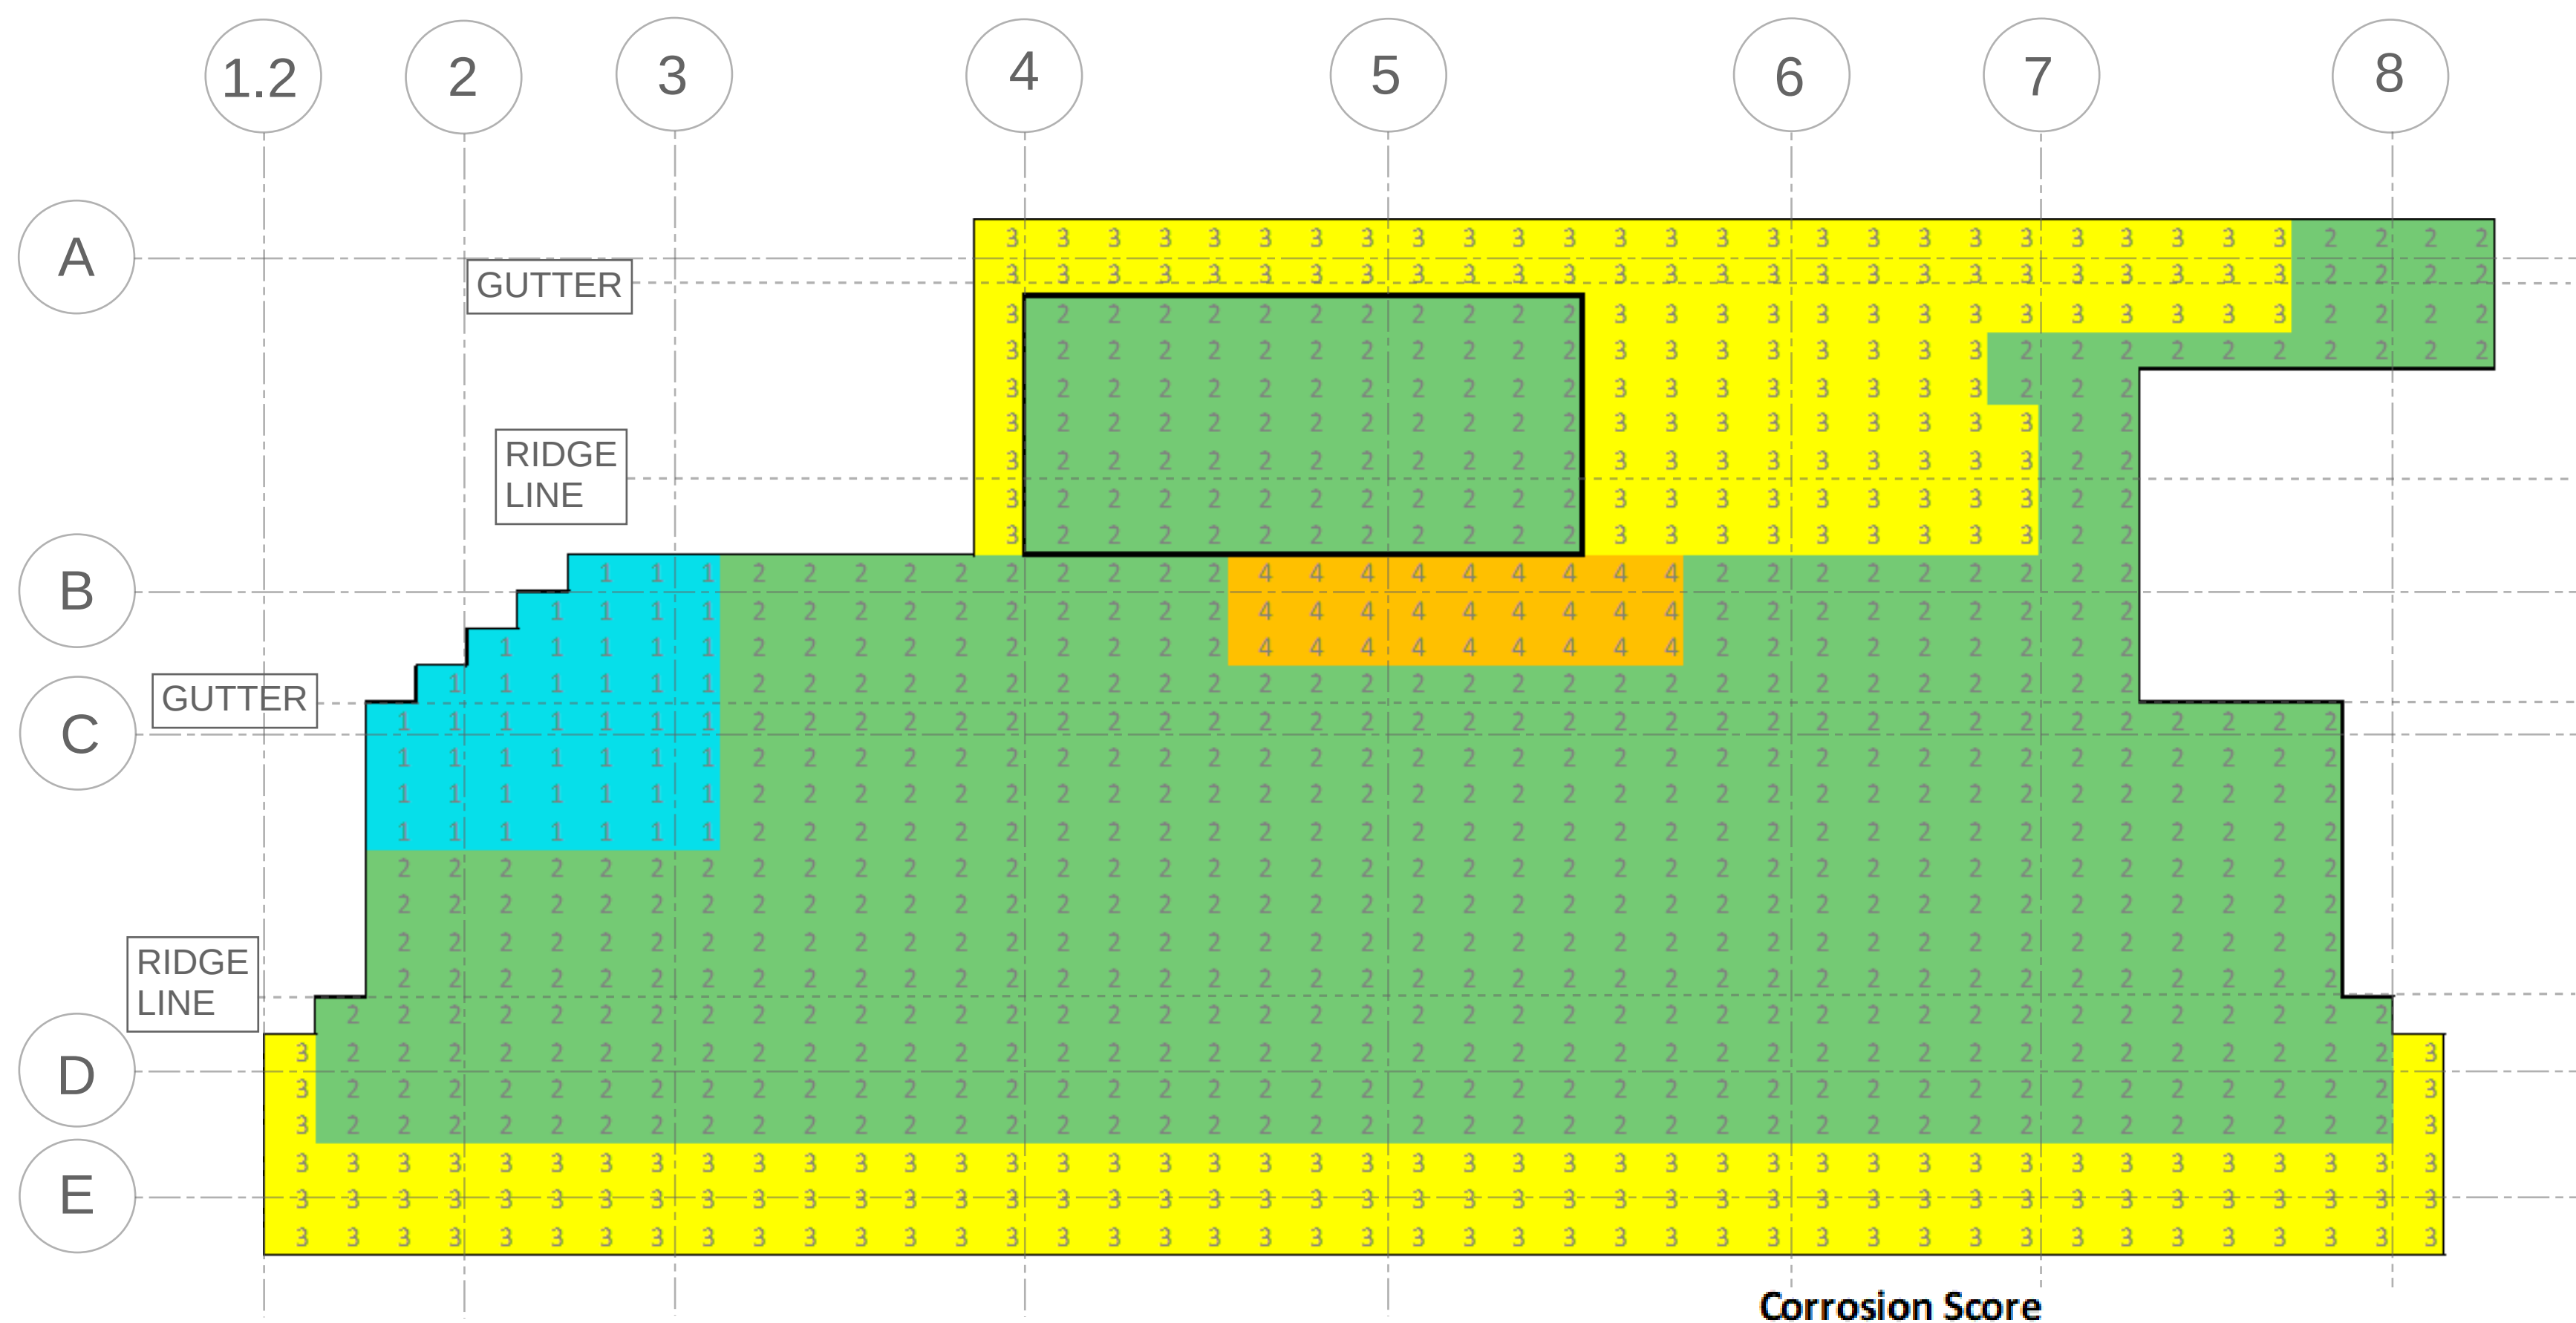
## SPACE FRAME DIAGONAL CHORD CORROSION SCORE MAP

\*\*\* For the Space Frame Diagonals: Due to the scattered nature of the distribution of corroded members, this markup has been divided into generalised areas. Some members in these areas show worse corrosion than others. Weighing is conservative

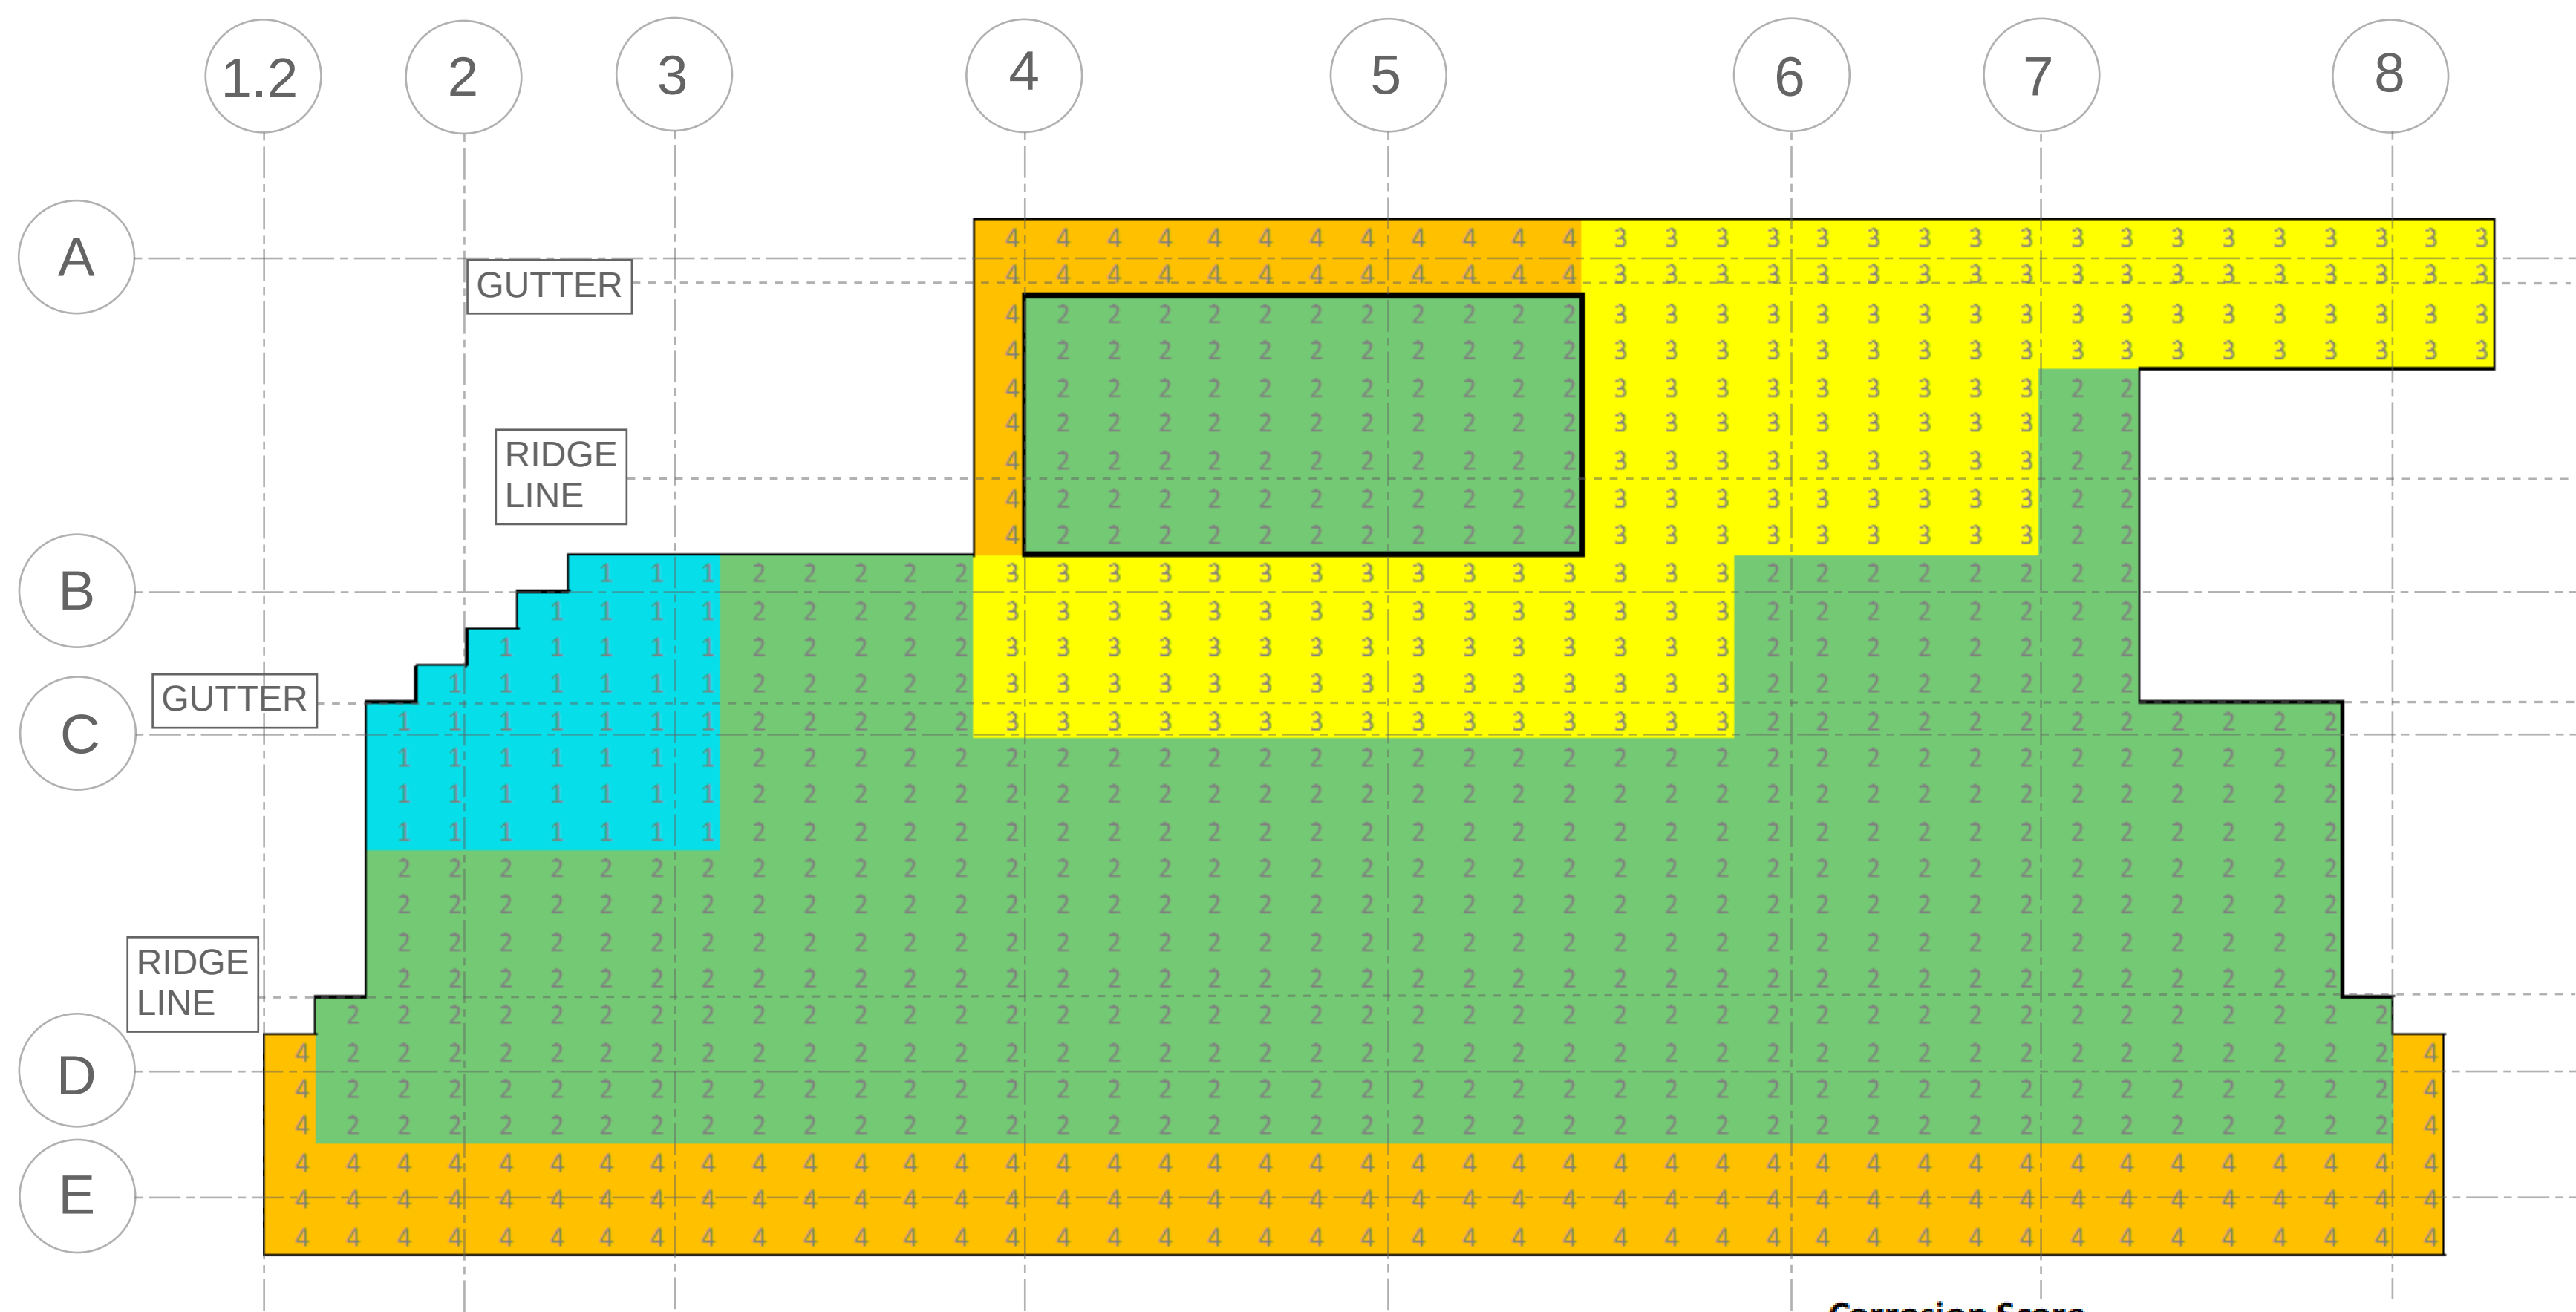
## SPACE FRAME BOTTOM CHORD CORROSION SCORE MAP

\*\*\* For the Space Frame Bottom Chord: Due to the scattered nature of the distribution of corroded members, this markup has been divided into generalised areas. Some members in these areas show worse corrosion than others. Weighing is conservative

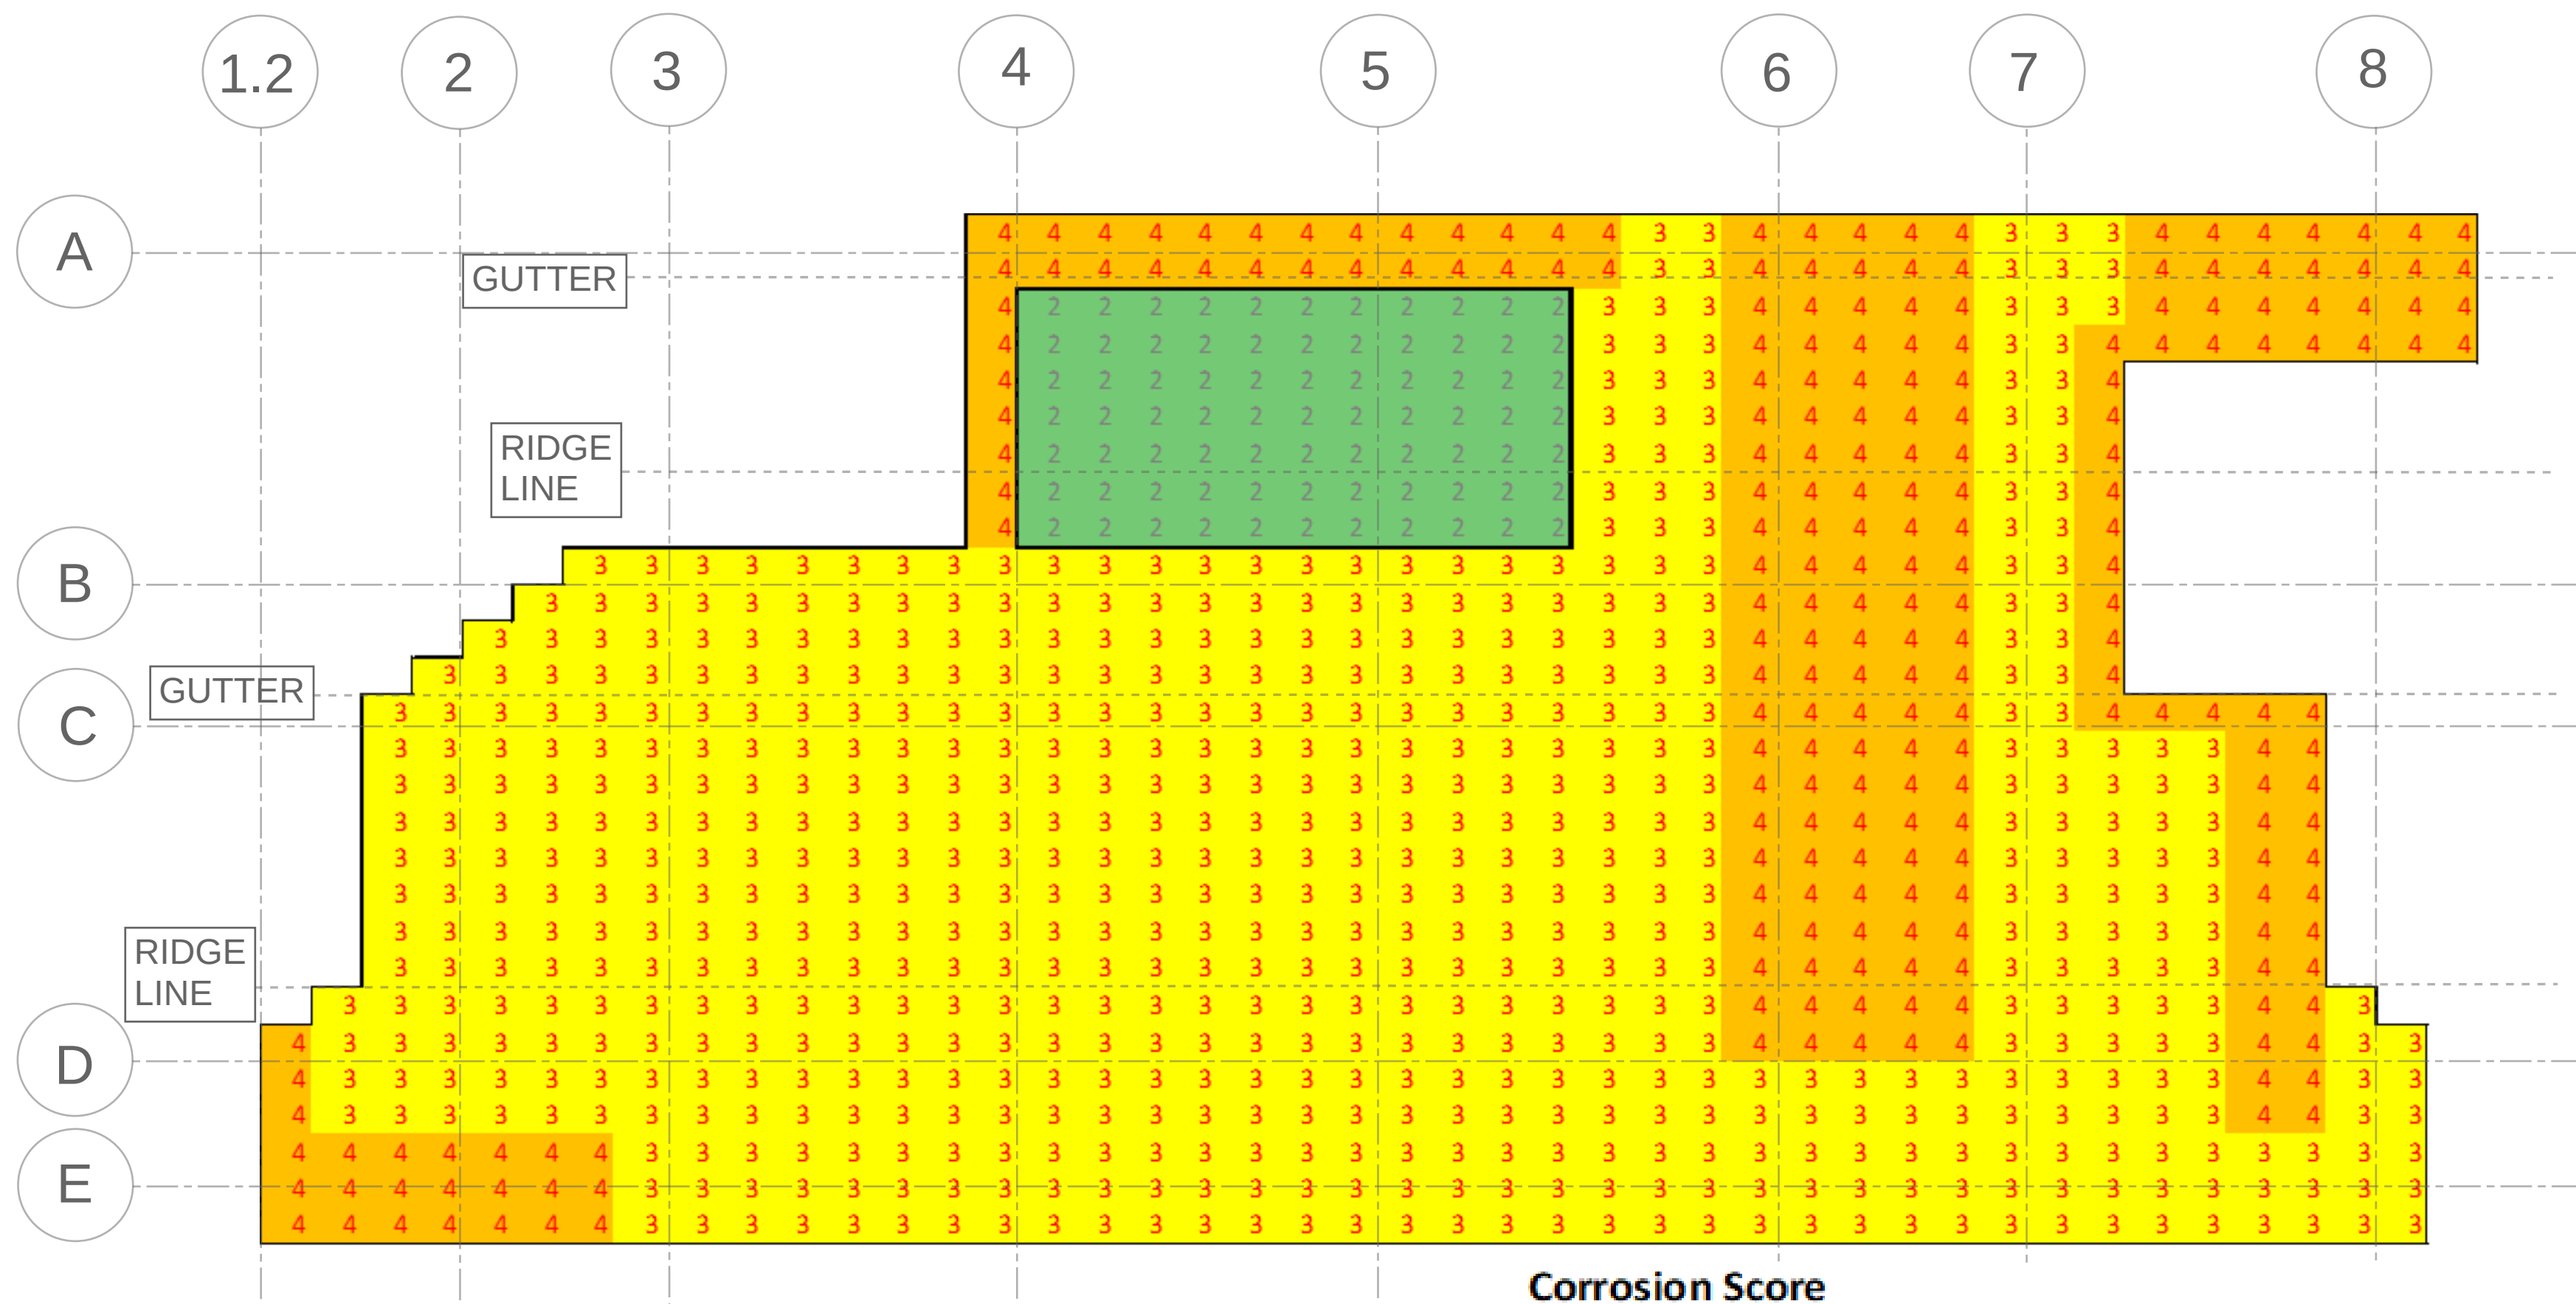
## PURLIN VERTICAL SUPPORT POSTS CORROSION SCORE MAP

\*\*\* For the Purlin Supports: Due to the scattered nature of the distribution of corroded members, this markup has been divided into generalised areas. Some members in these areas show worse corrosion than others.
