# Memorandum

| Title | Subway Investigation |

## Durability Assessment of Waterloo Station Subway Cores

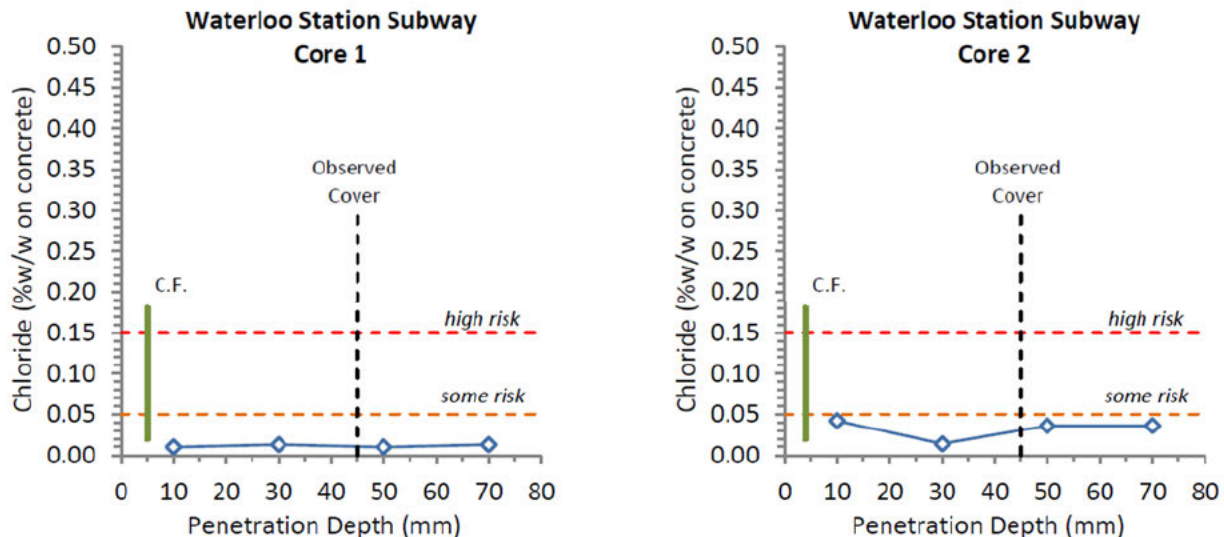
Figure 1 Excerpt WSP Durability Assessment of Waterloo Station Subway Cores 21 Aug 2025

As noted in the attached WSP report covering the analysis of the two concrete core samples taken, the carbonation front is within the concrete cover zone and the chloride concentration is relatively low and so degradation of the internal reinforcing is very unlikely to be accelerated in the near term. They did note that the chloride concentration is higher than typically expected, but still below the threshold of likelihood of corrosion developing 'some risk' as per Figure 1.

This was among the best possible outcomes, and implies that from a concrete durability perspective, there are no imminent concerns. Barring any material change to the tunnel itself (ie a medium-large seismic event or other cause of overloading of tunnel which results in substantial cracking to the tunnel) we would anticipate that the tunnel will continue to perform well from a durability perspective for the remainder of its original design life (ie another 14 years) and beyond.

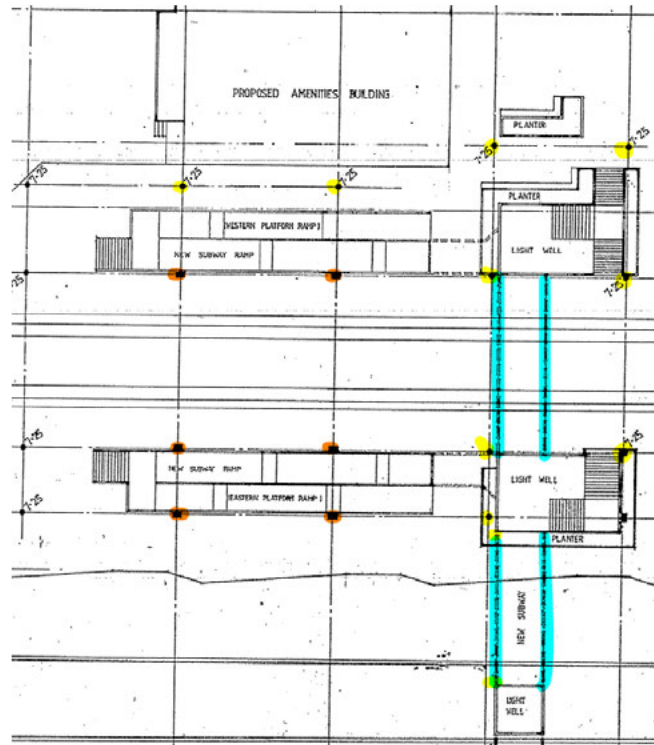
Figure 2 Excerpt Existing Drawing C55 Column Layout Plan with tunnel outline (blue), independent columns (yellow) inbuilt columns (orange)

Examination of the existing drawings show that generally the tunnel is independent of other surrounding structures, and should generally be free to move the ~160mm horizontally predicted by T&T. The existing drawings are ambiguous as to the exact setout of roof columns in relation to the tunnel, but generally there appears to be sufficient space between tunnel wall and pile supporting station roof columns such that they will act as two independent structures.

There are a small number of roof columns which are built into ramp walls, these are likely to also be subject to some lateral pressure under liquefaction and therefore impact on the roof structure. However, it is currently proposed that this roof structure will be removed, so this is not seen to be a long term risk.

Similarly it would be prudent to consider likely lateral movement when setting out any new structure in the vicinity of the tunnel.

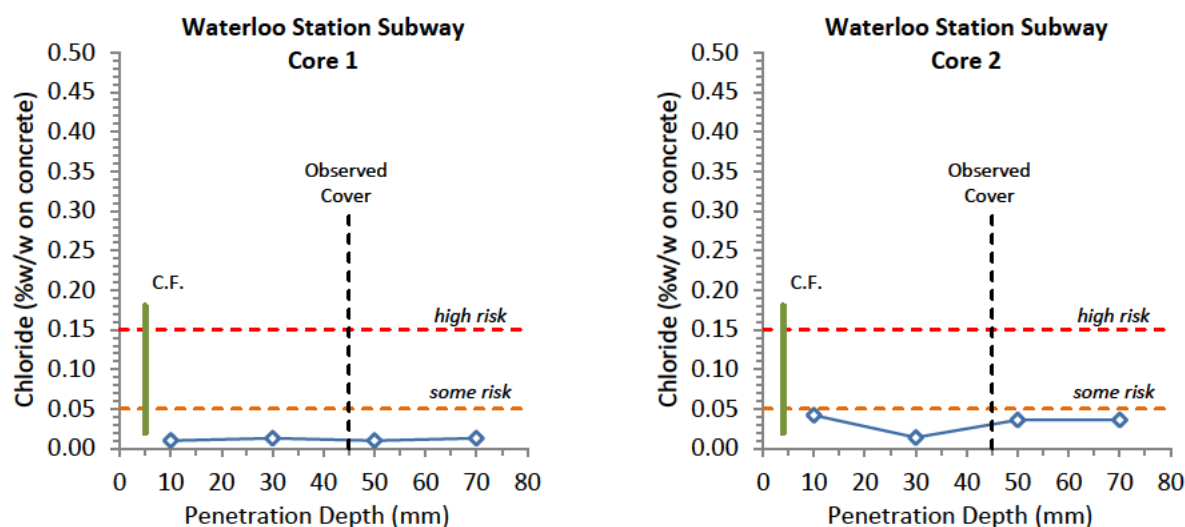
**Figure 2. Chloride contamination profiles and position of the carbonation front (from the external concrete face) measured on the provided core specimens for evaluation of the current and future reinforcement corrosion risk.**

To aid interpretation of this numerical data, the results for the individual cores are also depicted graphically as Figure 2. In these corrosion risk plots, the chloride profiles (i.e. the measured concentration vs. the midpoint of the sampling depth increment) are plotted in blue and the orange and red dashed horizontal lines indicate the UK Concrete Society's chloride concentration thresholds for various probabilities of the onset of corrosion. Chloride contamination levels that lie above the risk threshold at, or beyond, the depth of the concrete cover over the reinforcement indicates a potential threat of reinforcement corrosion.

The maximum depth of the carbonation front beneath the exterior surface of the concrete is illustrated by the position of the solid green vertical bar annotated with the label 'C.F.'. Where the carbonation front has progressed as far as, or beyond, the depth of the reinforcement, these bars lie in alkali-depleted concrete and are consequently also potentially vulnerable to corrosion.

- i. Carbonation of the concrete is minimal with no appreciable loss of alkalinity from either the exterior or interior faces of the cores that would threaten the embedded reinforcement at the observed cover depth.
- ii. There is no obvious chloride concentration profile through the cover concrete that would suggest permeation from an external environmental source that will accumulate further in the future. The background concentration in Core 2 is typically somewhat more elevated than would be expected from the normal contribution of routinely used Wellington ready-mix concrete constituents but at an observed maximum of 0.042% w/w is not sufficiently high as to pose a realistic risk for initiation of

reinforcement corrosion providing the bars are thoroughly encapsulated within well-consolidated concrete. This appears to be the case, with no appreciable excessive voidage or gross compaction defects noted to affect the supplied cores.

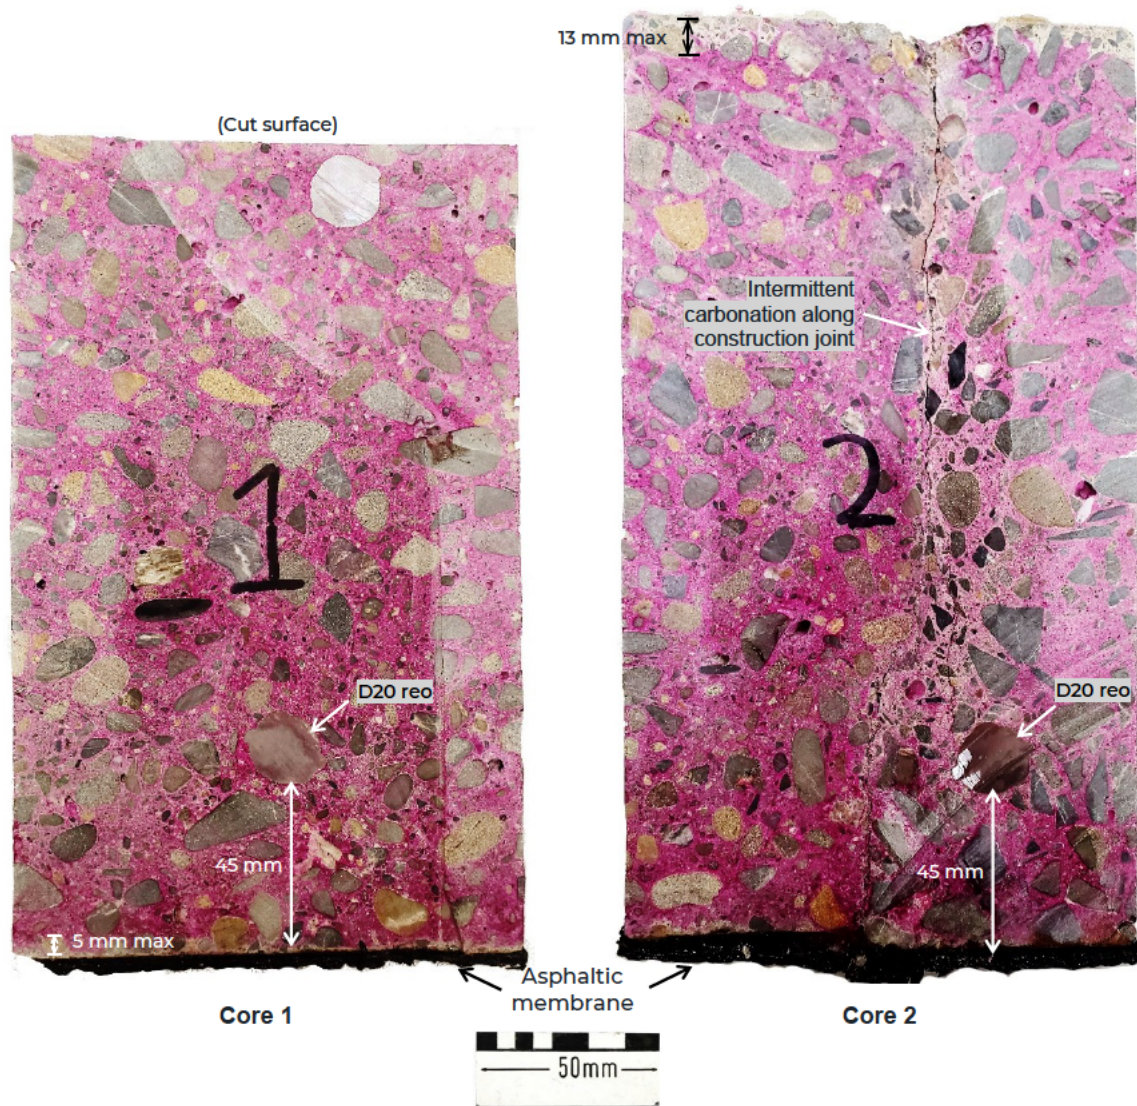
Illustrative photographs of the longitudinal slices cut through the cores to determine carbonation depth recorded following application of the phenolphthalein indicator solution are reproduced as Figure 3. The coarse aggregate is a quite heavily-weathered alluvial greywacke with a maximum particle diameter of 13 mm. Core 2 has intersected a prominent construction joint extending the full length of the specimen. The reinforcement intersected in both cores is 20 mm diameter deformed bars with a measured cover of 45 mm from the exterior surface. The original interior face of Core 1 is not preserved with the sample delivered displaying a cut surface.

- iii. Consistent with these findings, there is no evidence for active corrosion initiation on any of the reinforcing bars intersected by the cores.
