## Waterloo Station

### Geotechnical Factual Report

Greater Wellington Regional Council

Tonkin & Taylor Ltd

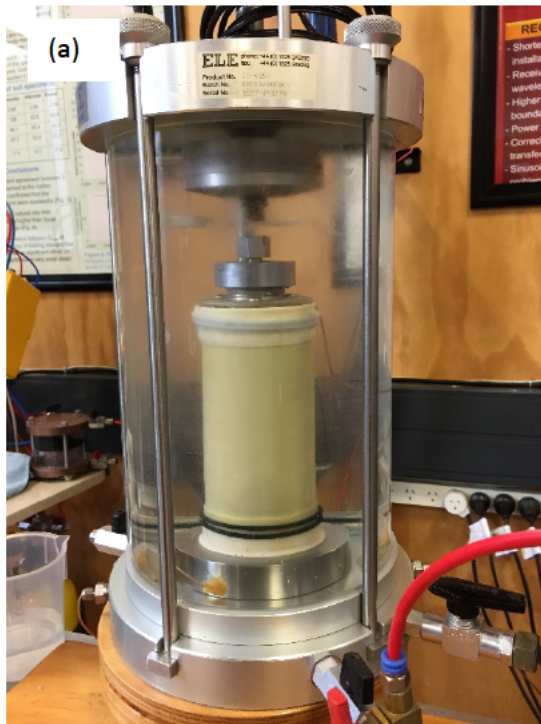
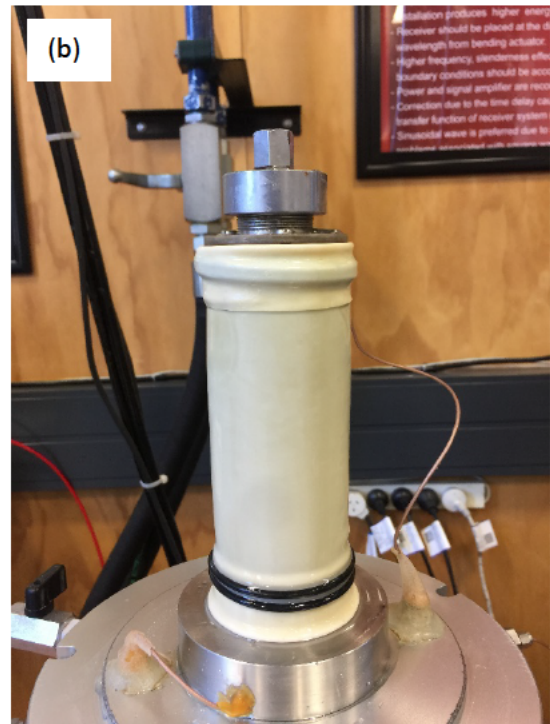
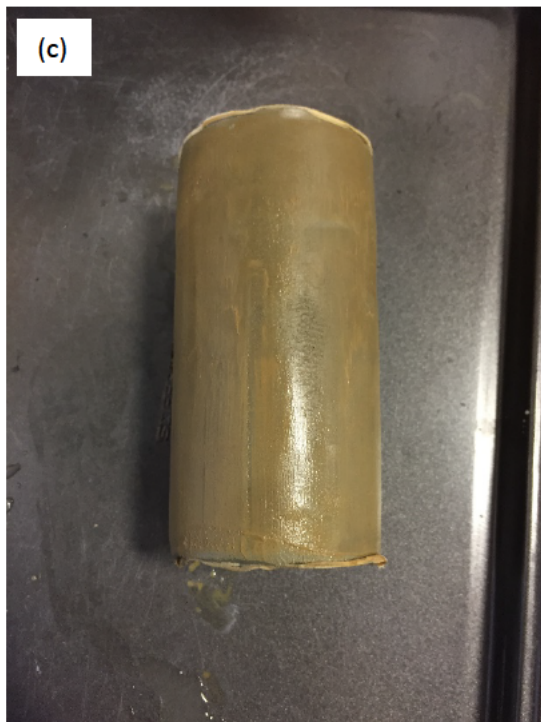
**Figure 3: Condition of the specimen: (a) after undrained cyclic loading and before post-monotonic loading; (b) after post-monotonic loading; (c) after post-monotonic loading without the membrane.**

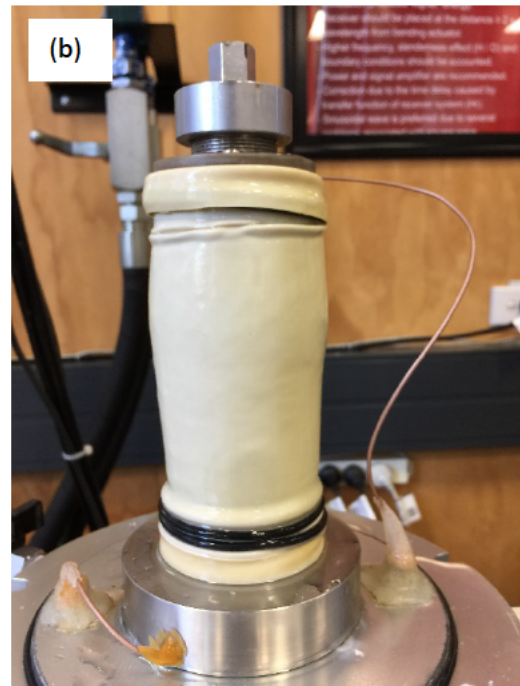
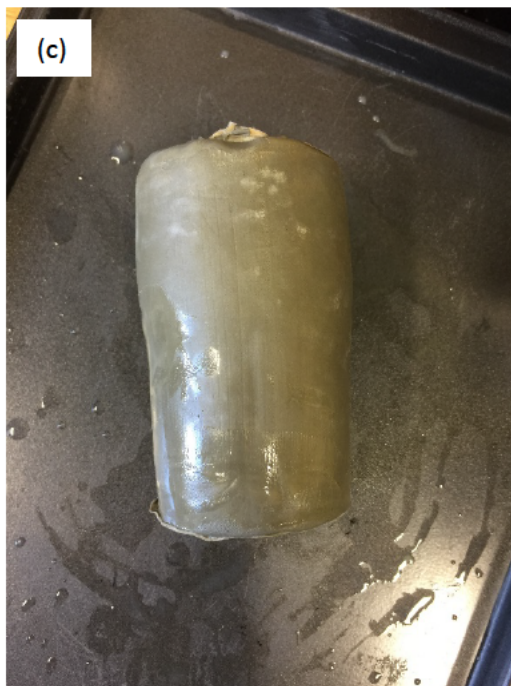
**Figure 3: Condition of the specimen (a) after undrained cyclic loading and before post-monotonic loading; (b) after post-monotonic loading; (c) after post-monotonic loading without the membrane.**

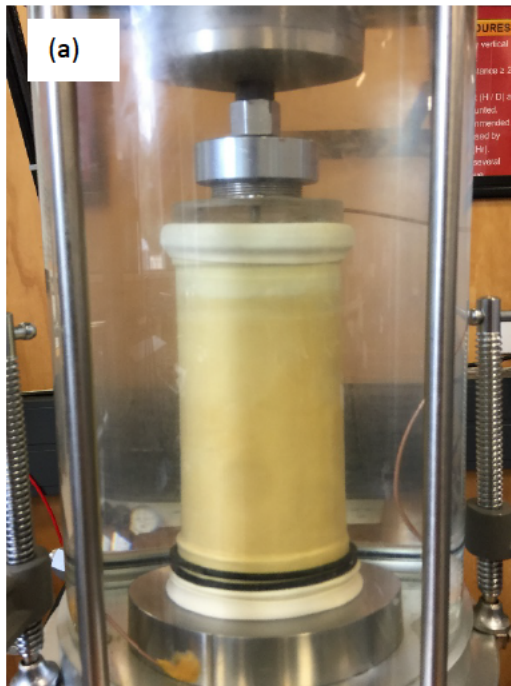
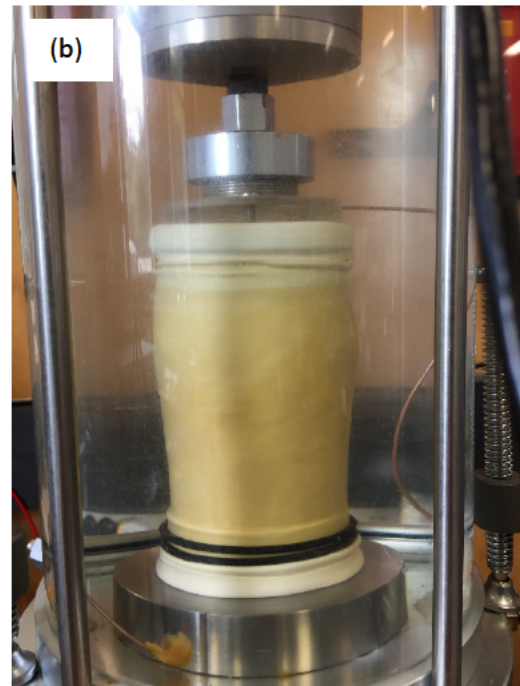
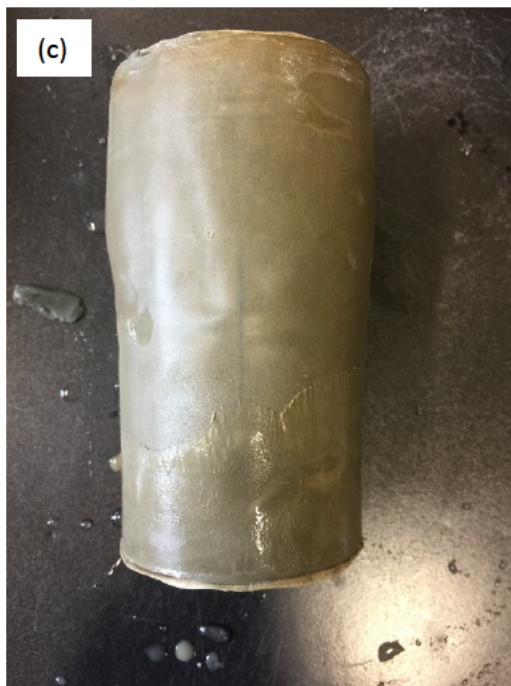
**Figure 3: Condition of the specimen: (a) after undrained cyclic loading and before post-monotonic loading; (b) after post-monotonic loading; (c) after post-monotonic loading without the membrane.**

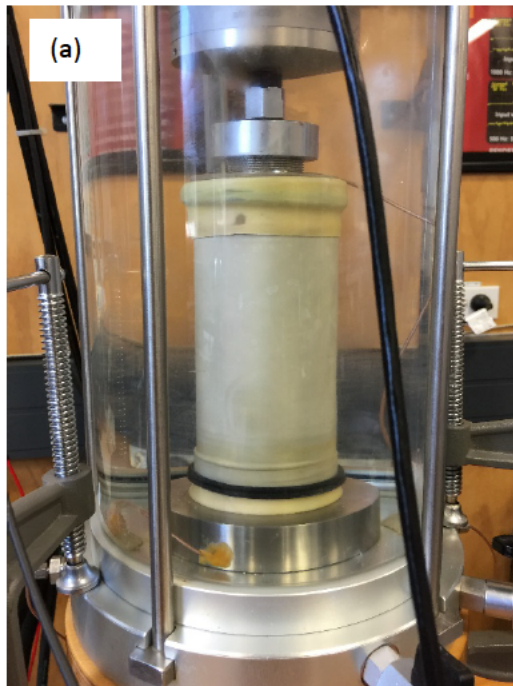
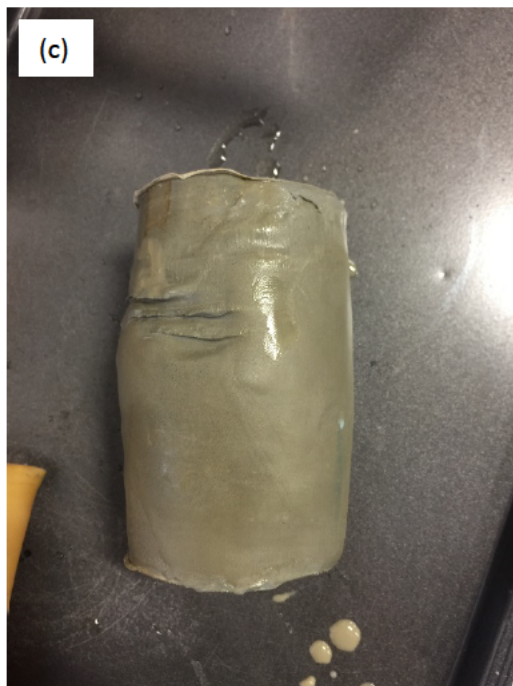
**Figure 3: Condition of the specimen (a) after undrained cyclic loading and before post-monotonic loading; (b) after post-monotonic loading; (c) after post-monotonic loading without the membrane.**
