Project Number: 3-WW019.11

# Waterloo WTP Ground Improvement Geotechnical Site Investigations Factual Report

17 May 2021

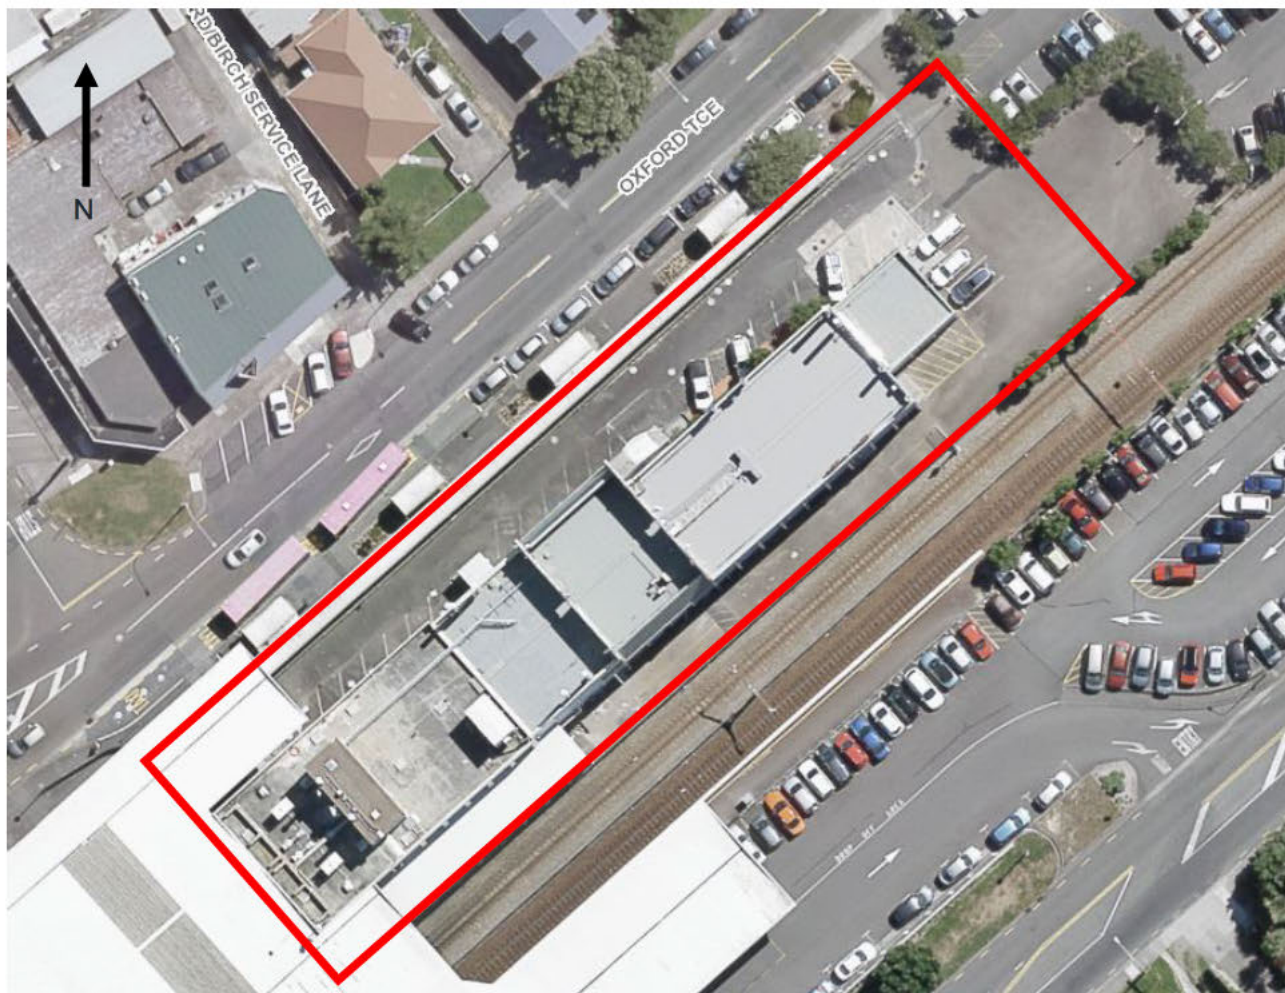
Figure 1: Waterloo Water Treatment Plant site.

The site is located at 44D Oxford Terrace, Lower Hutt (Figure 1). The surrounding topography is flat and lies at an elevation of approximately 6 m above mean sea level. The site is adjacent to Waterloo Railway Station to the south west and railway line to the south east.

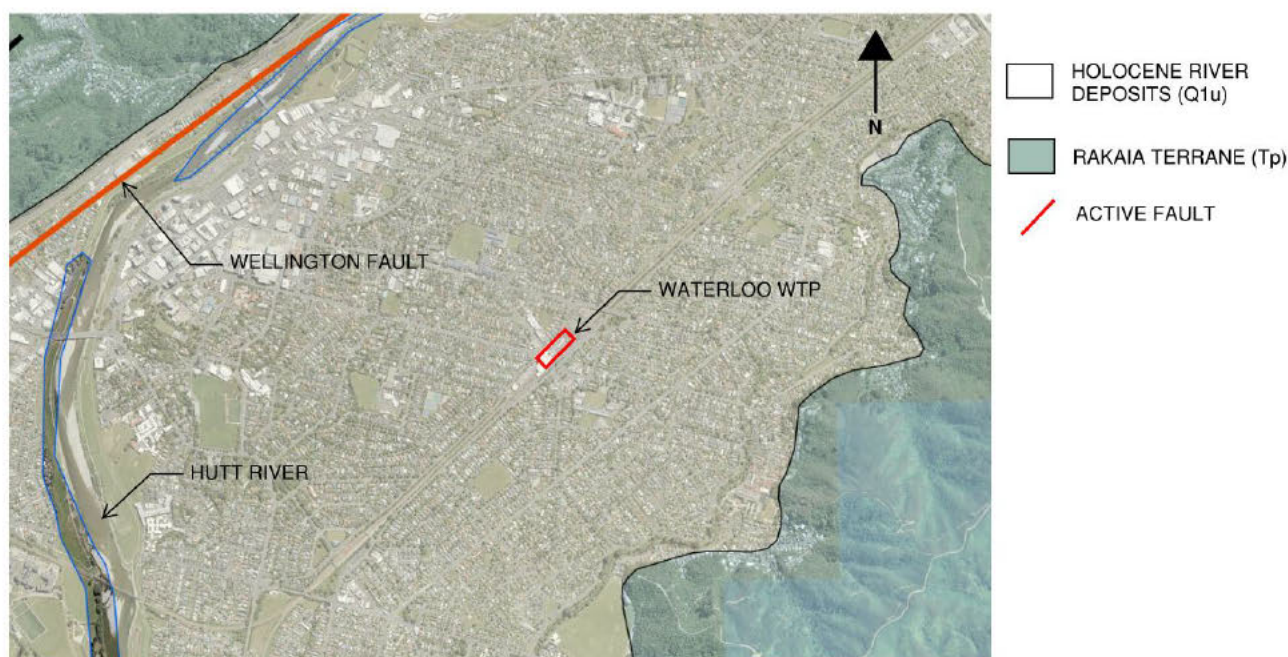
Figure 2: Geological Map (GNS, 2020)

According to the 1:250,000 geological map 10 of the Wellington area (Begg & Johnston, 2000), the site is underlain by Holocene River Deposits and well sorted floodplain gravels (Q1a) (Figure 2). These gravels are made up of Taita Alluvium, Petone Marine Beds and Waiwhetu Artesian Gravel, Wilford Shell Bed, Waimea Glacial & Karoro Interglacial, Moera Basal Gravel, Nemona Glacial Gravels and older deposits. The total thickness of these units is expected to be in the order of 400 m (Boon et. al, 2011), varying throughout the Hutt Valley. The underlying basement rock is Wellington Greywacke.

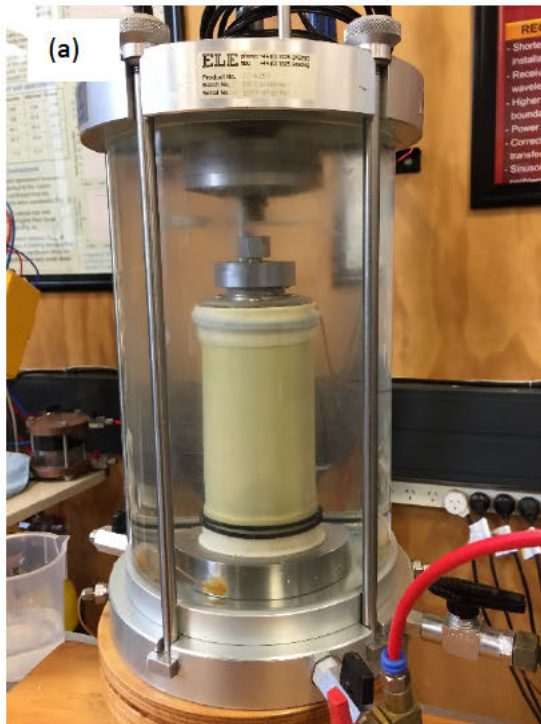
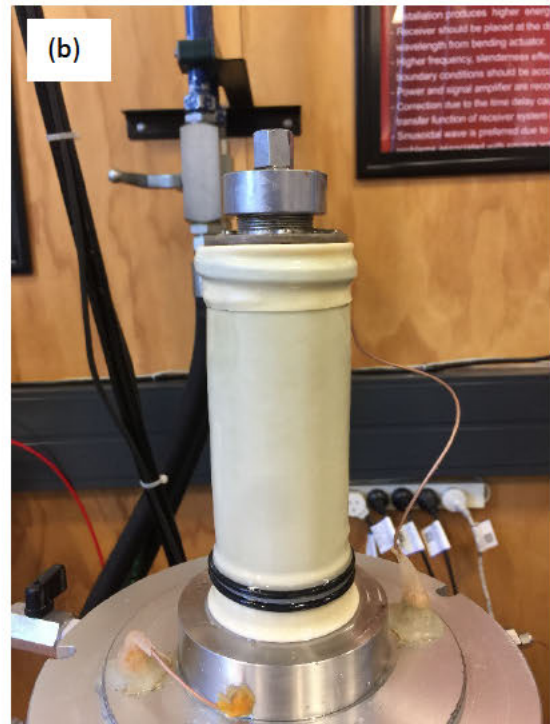
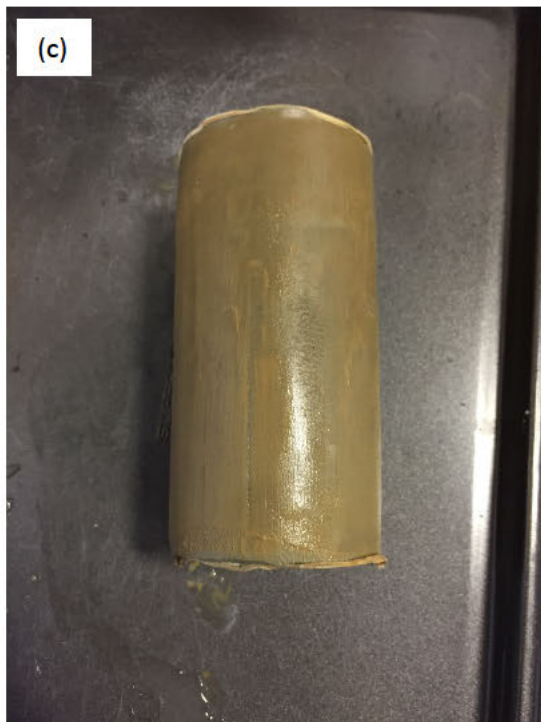
**Figure 3: Condition of the specimen: (a) after undrained cyclic loading and before post-monotonic loading; (b) after post-monotonic loading; (c) after post-monotonic loading without the membrane.**

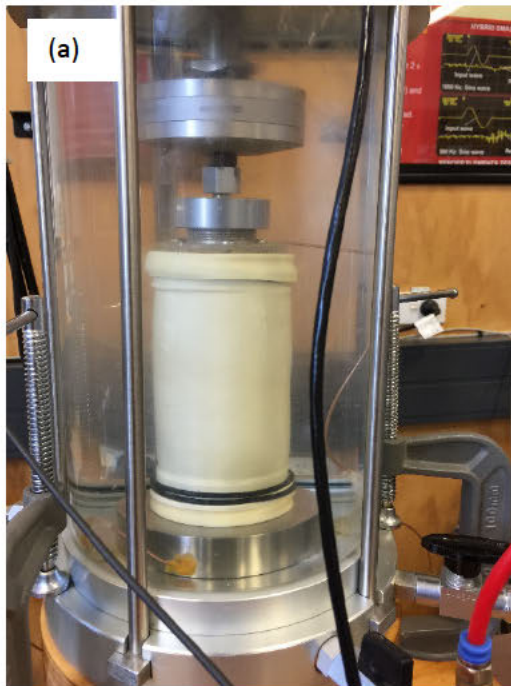
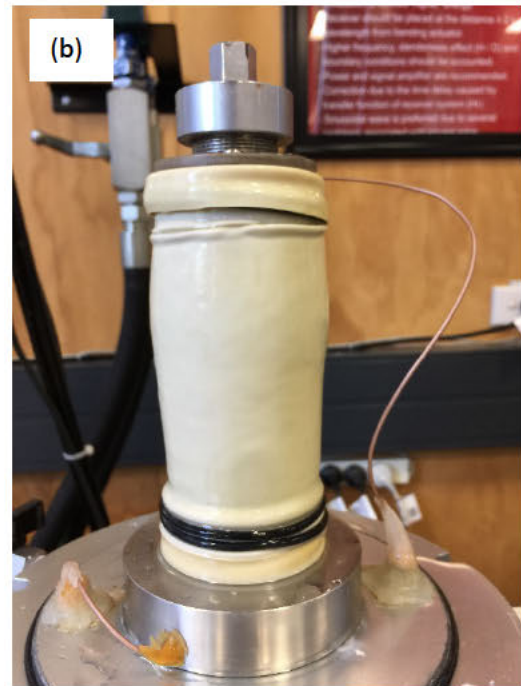
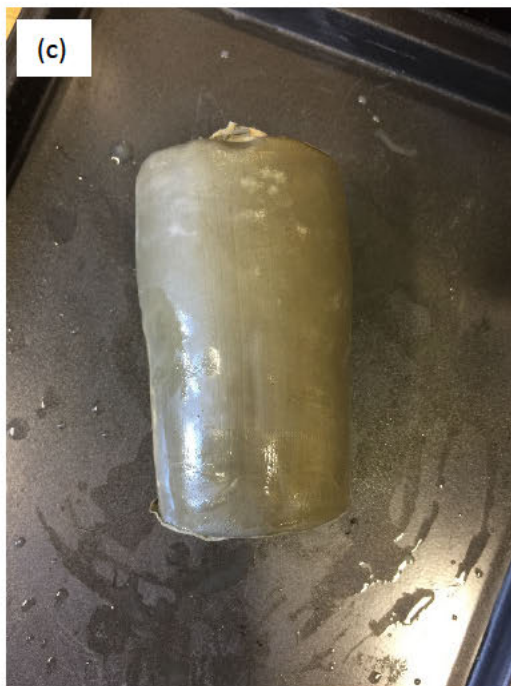
**Figure 3: Condition of the specimen (a) after undrained cyclic loading and before post-monotonic loading; (b) after post-monotonic loading; (c) after post-monotonic loading without the membrane.**

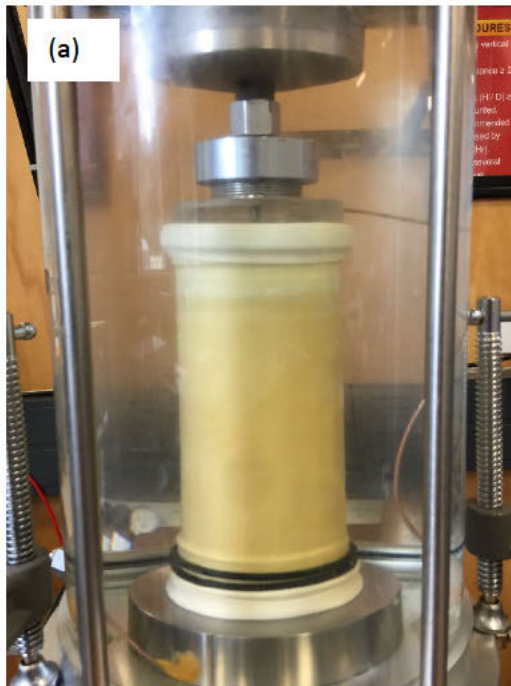
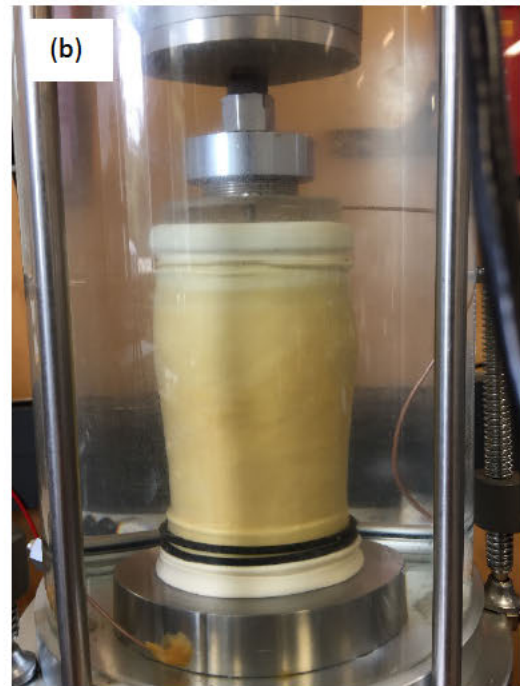
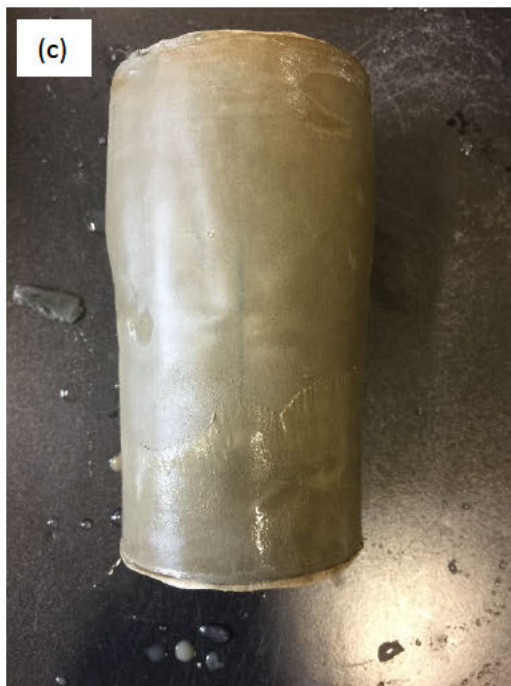
**Figure 3: Condition of the specimen: (a) after undrained cyclic loading and before post-monotonic loading; (b) after post-monotonic loading; (c) after post-monotonic loading without the membrane.**

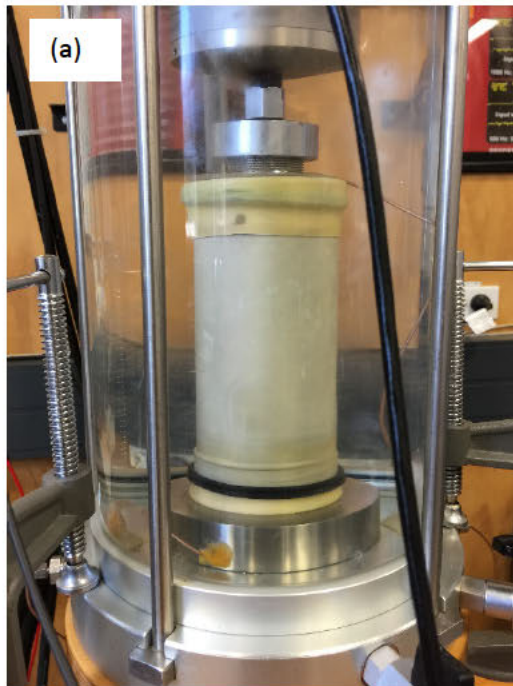
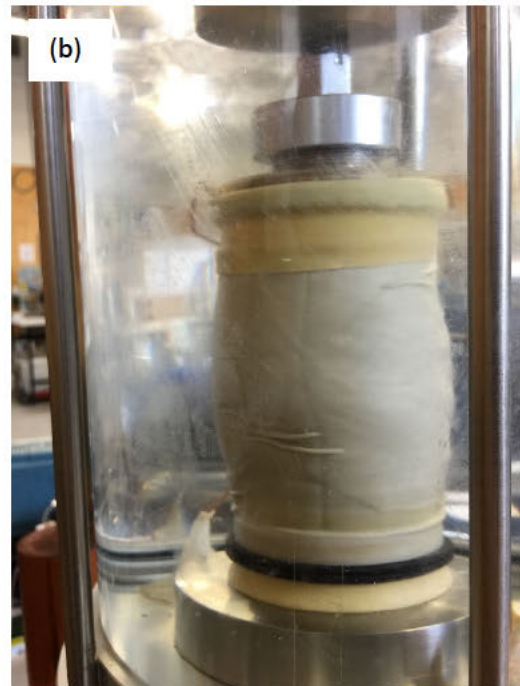
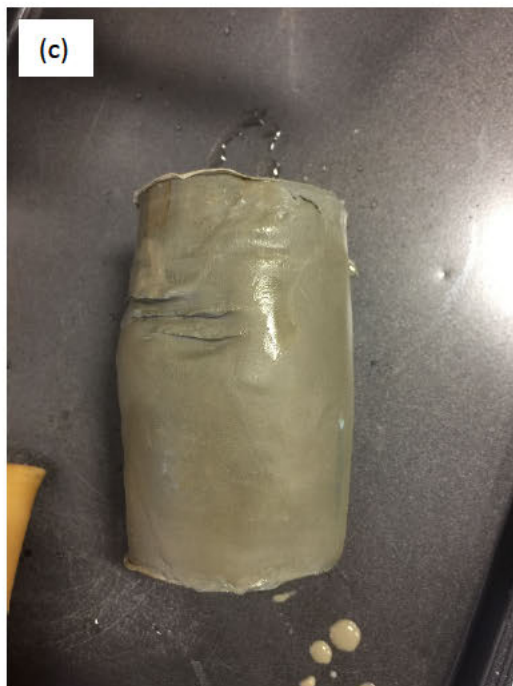
**Figure 3: Condition of the specimen (a) after undrained cyclic loading and before post-monotonic loading; (b) after post-monotonic loading; (c) after post-monotonic loading without the membrane.**
