# **WATERLOO TRAIN STATION CANOPY REASSESSMENT**

Greater Wellington Regional Council

| <b>DOCUMENT</b> | Canopy Reassessment Report |

| <b>DATE OF ISSUE</b> | 20/05/2024 |

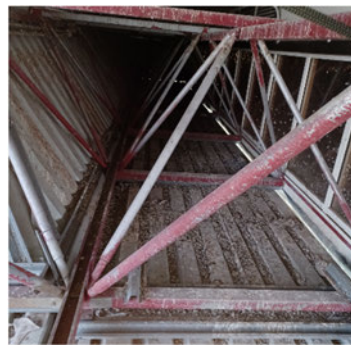
On the northeast side, most of the bottom roof sheeting and walls are covered by Pigeon droppings, accelerating the corrosion process.

Accumulated Pigeon droppings

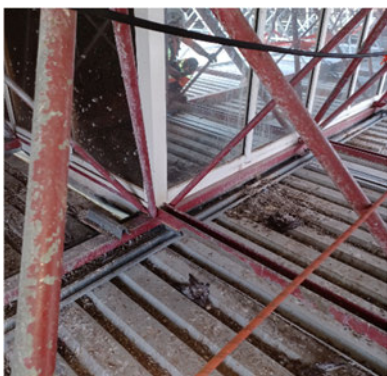
Accumulated Pigeon droppings
