# **WATERLOO TRAIN STATION CANOPY REASSESSMENT**

Greater Wellington Regional Council

| HG DOCUMENT NO. | REP002-A2414842.01_KTT_MTL |
| DOCUMENT | Canopy Reassessment Report |

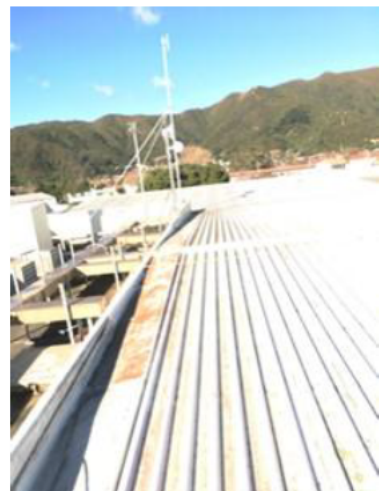
Some screws have been replaced in sections where roof sheeting was recently renewed, hold-down screws in other areas show heavy corrosion.

Photo 007 – Roof hold down screws in most areas show heavy corrosion with corrosion level score 4.

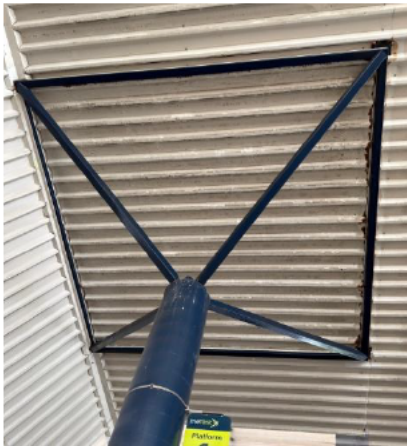
The lower roof sheeting presents corrosion along sheet overlaps, with localized corrosion noted between gridlines GL 4-6 and GL C-D.

Photo 014 – Corrosion at the roof sheeting (Truss Level) between GL 4-6/ GL C-D. Corrosion score 3.

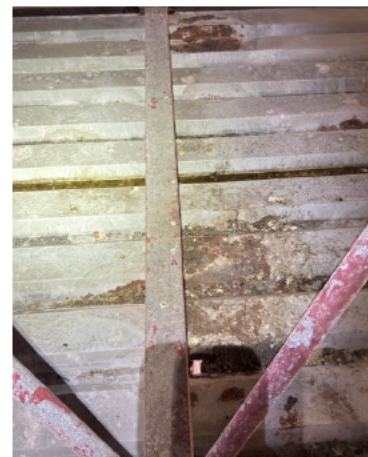
The vertical flat roof sheeting on the North side of the station (ticketing side) is fixed to a new timber plank, which is attached to the purlin's vertical support post; however, it is in a severely corroded condition, with a corrosion rating of 4.

Photo 017 – Roof sheeting at Northern side of the station. Corrosion score 4.

We estimate that maintenance to some of these elements will be required immediately where we rated the corrosion score to 4 to prevent more extensive repairs (possibly even member replacement) being required.

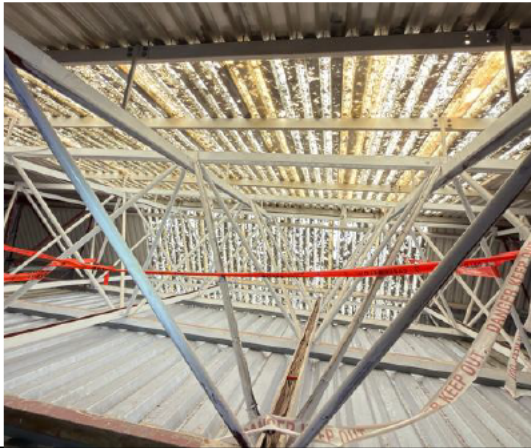
Photo 026 – Translucent sheeting covered in moss.

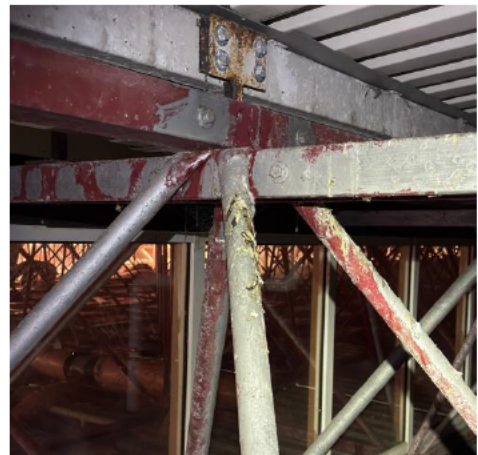
Photo 029 – Pigeon droppings at the lower roof on the eastern side.

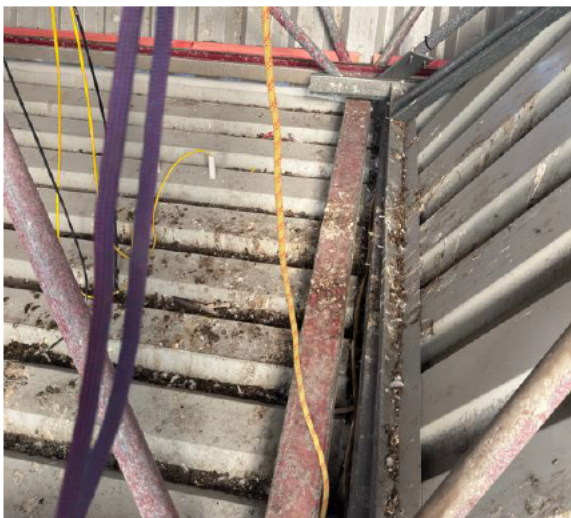
Photo 030 – Pigeon droppings at the lower roof on the eastern side. Opening for birds to enter the roof.

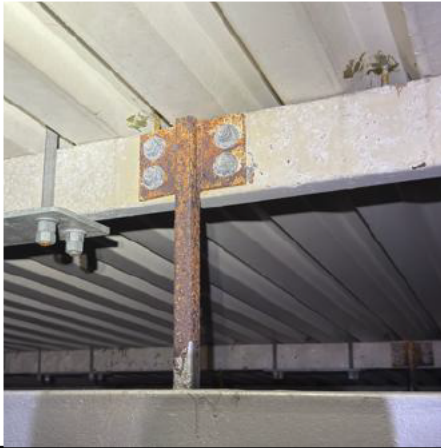
Photo 008 – Purlin Vertical Support Post. Corrosion score 3.

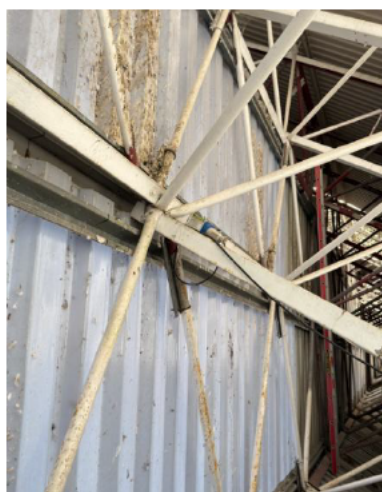
Photo 006 – Truss diagonal. Corrosion score 3.

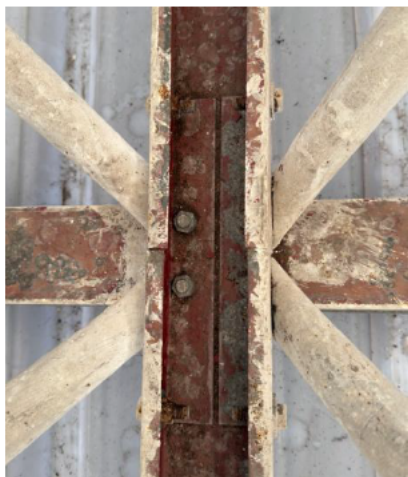
Photo 002 – Truss Bottom chord. Corrosion score 4.

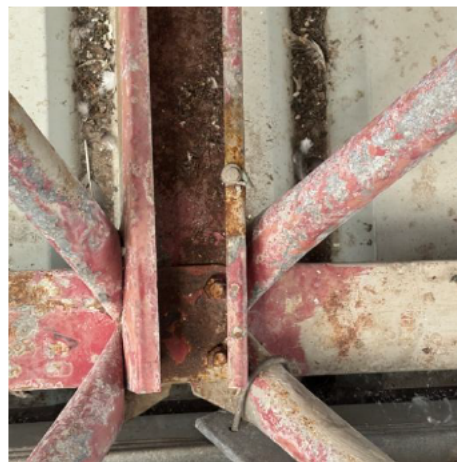
Photo 003 – Truss Bottom chord. Corrosion score 4.
